Request for Qualifications (Architect / Engineer)

Project Name	<u>Perry Stadium Phase II Renovations</u>	Response Deadline	<u>10/23/15</u>	<u>2:00 pm</u>	local time
Project Location	<u>Bowling Green State University</u>	Project Number	<u>BGU-156153</u>		
City / County	<u>Bowling Green / Wood</u>	Project Manager	<u>Brian Swope</u>		
Owner	<u>Bowling Green State University</u>	Contracting Authority	<u>Local Higher Education</u>		
Delivery Method	<u>N/A</u>	Prevailing Wages	<u>State</u>		
No. of paper copies requested (stapled, not bound)	<u>3</u>	No. of electronic copies requested on CD (PDF)	<u>1</u>

BGSU Doyt Perry Stadium, Bowling Green, Ohio/// FACILITY CONDITIONS ASSESSMENT

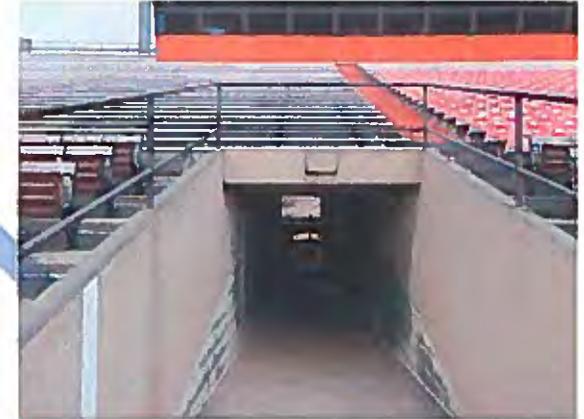
Figure 4- View of Ramped Walkway with Hand Rails

The construction on the top surface appears to be in acceptable condition. There are noticeable chalking and weathering issues with the CMU walls along the sides, but the walking surface has no visible issues.

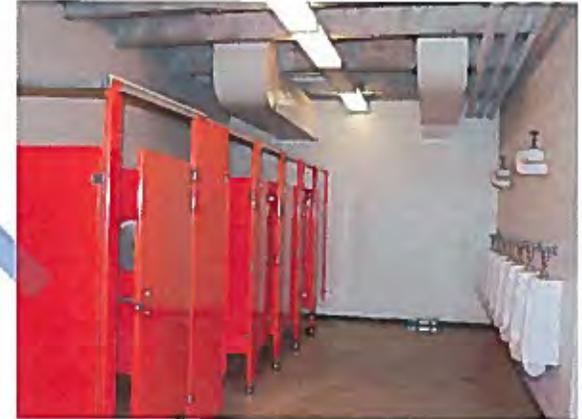
PUBLIC TOILETS: The existing facility contains a total of (4) Men's and (4) Women's Toilet Rooms. Generally these spaces were in good condition. The painted, floor mounted toilet partitions were in good condition and the ones tested appeared stable and structurally sound. A few locations showed signs of attempts to provide wheelchair accessible stalls, although it was observed that these did not appear to fully comply. These rooms also lacked the required ambulatory stalls and many of the toilet accessories were mounted higher than allowed (refer to figures 8 and 9). The rooms themselves had more than adequate turning clearances, however the existing entry and exit doorways do not. The quantity of existing toilets is well below the current code requirements and would need to be resolved in any future renovation.

Figure 8- Public Toilets- Toilets + Urinals

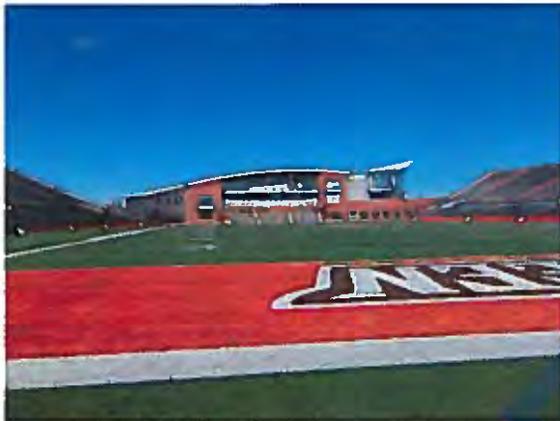
FIELD TURF: The traditional grass field was replaced with Field Turf in 2007. The condition of the Field Turf appears to be in good condition. There were no visible defects or issues with the turf (refer to figure 10).

Figure 10- South End Zone looking North across Field Turf field

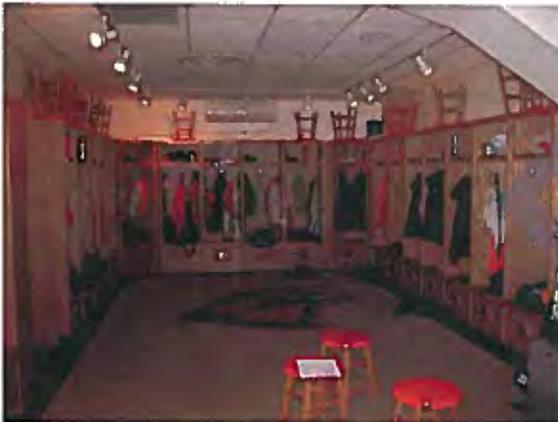
FALCON'S TEAM LOCKER ROOMS (Track/Cross Country, and Men's Soccer): The various BGSU teams noted above located within the facility are generally dated and in need of revisions (refer to figures 14 and 15).

Figure 14- View of BGSU Men's Soccer Lockers

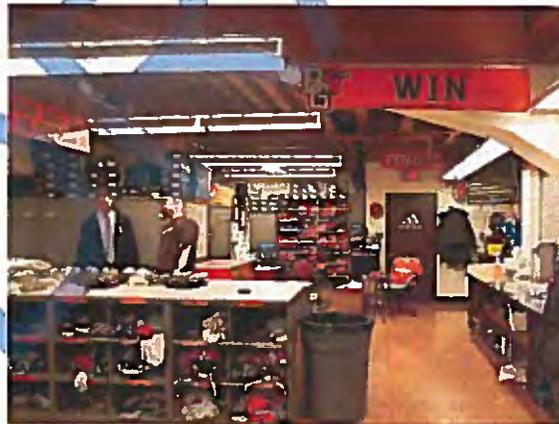
FALCON ATHLETIC EQUIPMENT ROOM: The Athletic Equipment Storage room appears to be well organized and able to support the intended uses. The addition of more space would allow for a higher capacity storage system (refer to figure 16).

Figure 16- View of Athletic Equipment Storage Room

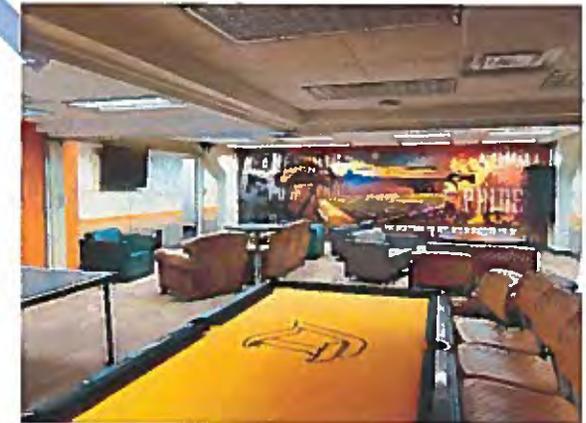
PLAYER'S LOUNGE: The Player's Lounge appears to be very small in size for the number of athletes it should serve. The current layout appears to have four activities, but it would be difficult to accommodate the number of people needed. The room is also dividable into three smaller spaces for multiple meetings. We would recommend that this room be increased in size to allow for more comfort and relaxation for the athletes (refer to figure 17).

Figure 17- View of Player's Lounge

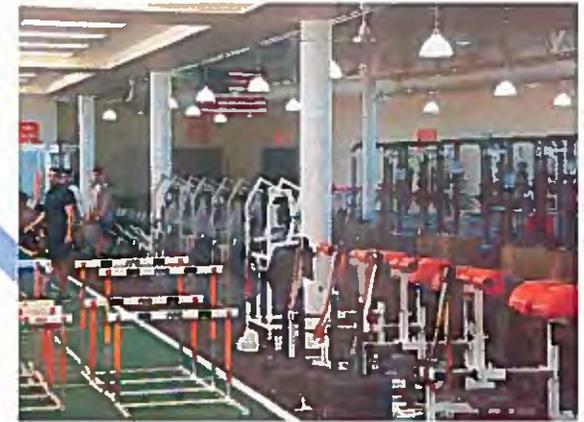
WEIGHT ROOM (located in the Sebo Center): The Weight Room for all associated BGSU sports is located in the Sebo Center and was also constructed in 2007. The room seems well equipped and in good condition. The issue is that the room is primarily used by the football team and the other sports have limited access for using this space. It would be recommended to either increase the size of the room or to provide a separate room for the other sports to utilize (refer to figure 21).

Figure 21- View of Sebo Weight Room

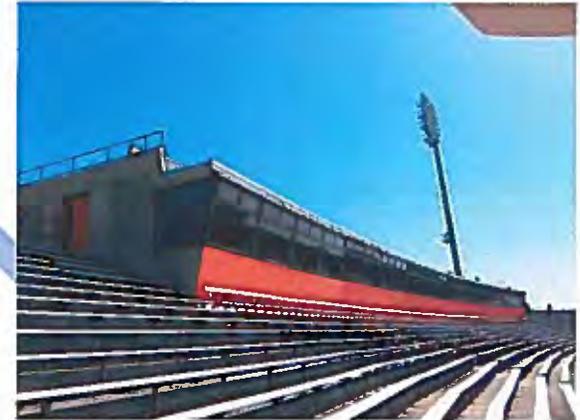
SELECT SEATS/SUITES (EAST SIDE): Along the East Side of the grandstands, there are (8) Suites and (1) President's Suite contained in a single story structure, it is accessed from the elevator and thru the seating bowl (refer to figure 28). The Suites contain two rows of seating with sloped glass toward the field. The sizes of the suites are very small in comparison to other football facilities. They are dated and lack space to provide much beyond the seats viewing the event. We would recommend a Suite Renovation to start within the next 3-5 years that would create a fresh new look for the Suites and associated spaces. The glass facing the field contains large vertical mullions that block some of the view (refer to figures 29 and 30). The President's Suite, with the associated Lounge area behind, seems appropriate for its use.

Figure 28- View of East Side Select Seats/ Suites

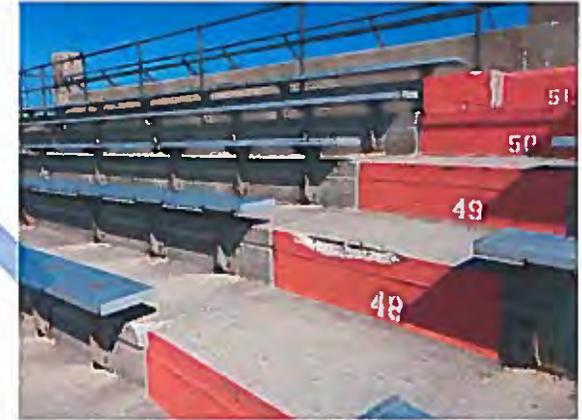
STADIA: The precast stadia appears to have no coating over most of the seating bowl. There are a number of locations that have a traffic coating applied over occupied areas. This coating appears to have been repaired multiple times over the years, as the water damage underneath is visible. We would recommend a heavy duty coating be applied over all surfaces to help protect the concrete. There are areas of the precast that have been damaged by water penetration and require repair (refer to figure 37). The seating bowl does not have a center aisle railing which has improved safety results and is required by the Building Code. We would recommend adding this missing aisle railing to improve usability to an aging population.

Figure 37- View of Stepped Aisle

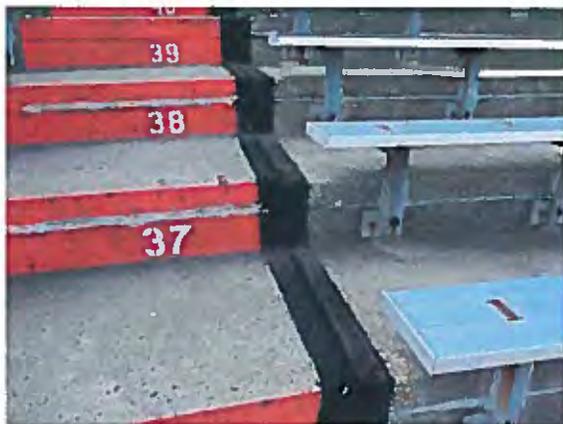
Figure 38- View of Seating Bowl Sealant/ Joint

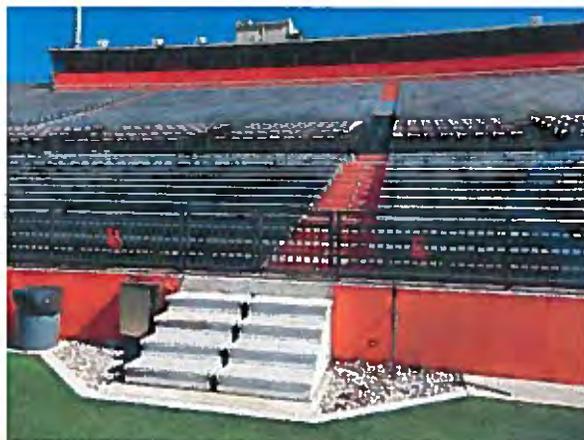
FIELD ACCESS STAIRS/ EGRESS TO FIELD: The seating bowl relies on egress into the field in the event of emergency to accommodate all the spectators. These stairs (7) locations per side do not provide the required railings. These railings should be provided (refer to figure 39).

Figure 39- Field Access Stairs

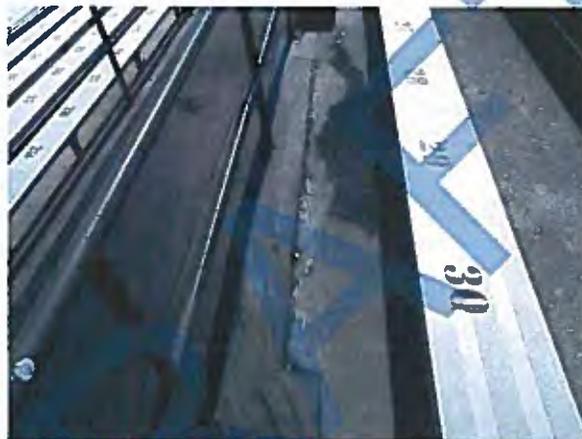
TRAFFIC COATING/ WATERPROOFING: Various methods of waterproofing and traffic coatings have been installed over the occupied areas. In some areas, a membrane has been installed, but it is obvious that water has gotten under the membrane and is trapped between the concrete. This membrane has now delaminated from the concrete. We would recommend that this membrane be removed and the traffic coating be reviewed at all locations (refer to figure 40).

Figure 40- View of Delaminated Membrane

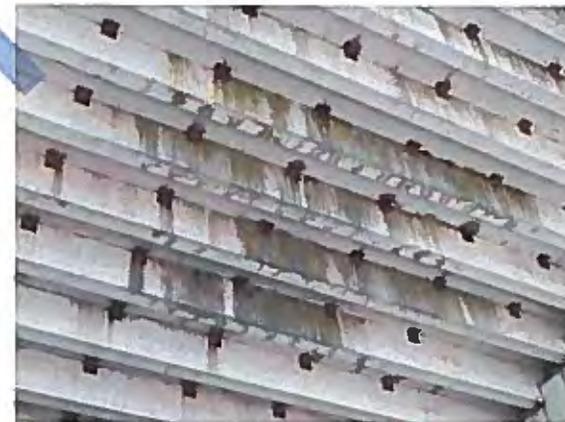
Figure 43- Steel Connector Typical Corrosion of Exposed connectors

- *Testing: Desai/Nasr recommends removing two to five of these clip angles and their bolts to determine the condition of the bolts and inserts and rate of steel deterioration. Test results to be used to estimate the remaining life and what, if any, remedial measures are required to slow or stop this corrosion (short term).*

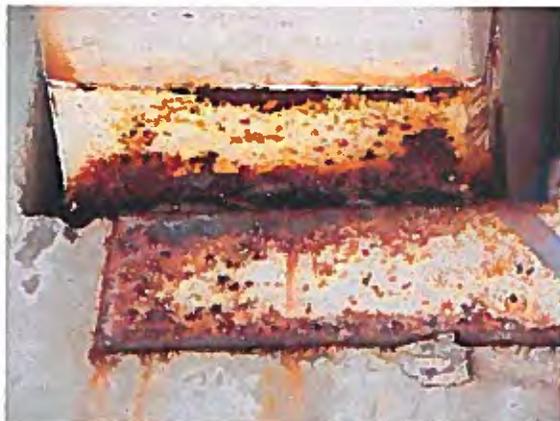
During construction, steel shim stacks were used to level the precast risers and make up construction tolerances. These shim packs vary greatly in number and thickness of plates used. In an attempt to comply with the original details, the shim packs were welded together and to the embedded steel inserts. This steel assembly was observed to be moderately to severely corroded. The most severe corrosion was observed where the shim packs are high and/or where the shim plates were thin (refer to figure 45).

Figure 45- Corrosion at Thin Shim Plate - Welded completed Deteriorated

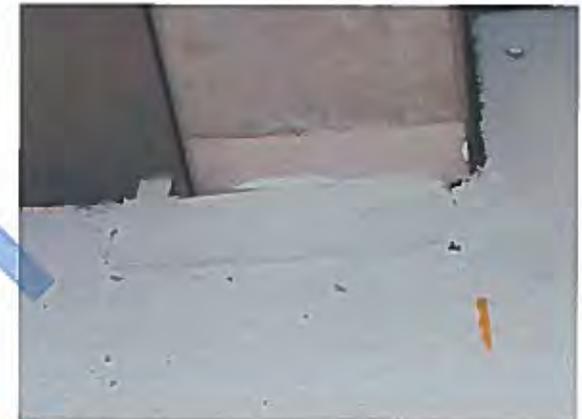
The only location where no corrosion of the embedded plates was observed was at the expansion joint where the plates were not welded together (refer to figure 47).

Figure 47- No Corrosion at Expansion Joint - No Welds

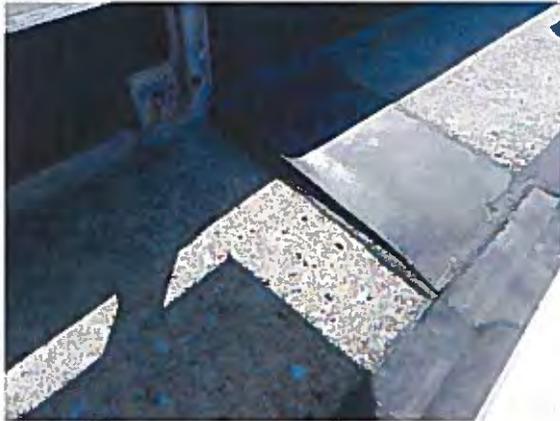
Figure 53- Waterproofing Membrane at Joint – Failure

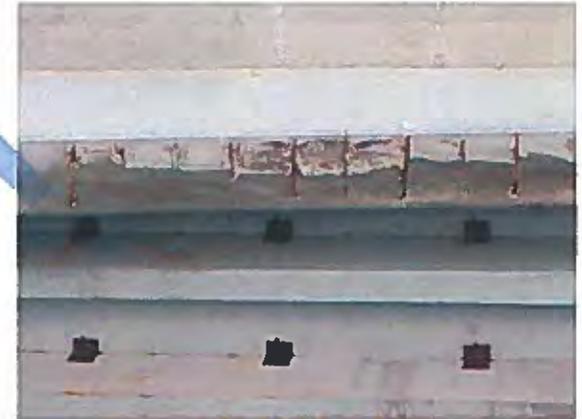
MAIN LOAD BEARING FRAMES: Minor spalling of concrete due to insufficient cover to shear ties was observed at two elevated beams (refer to figure 56).

Figure 56 – Concrete Spalling at Main Frame Beam

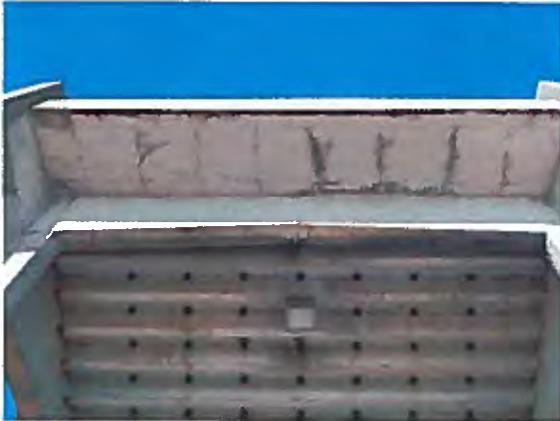
Figure 57- Shrinkage Cracking in Concrete

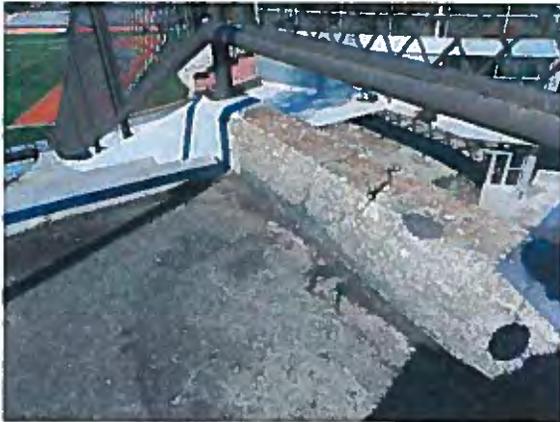
Figure 58- Deterioration of Slab and Curb

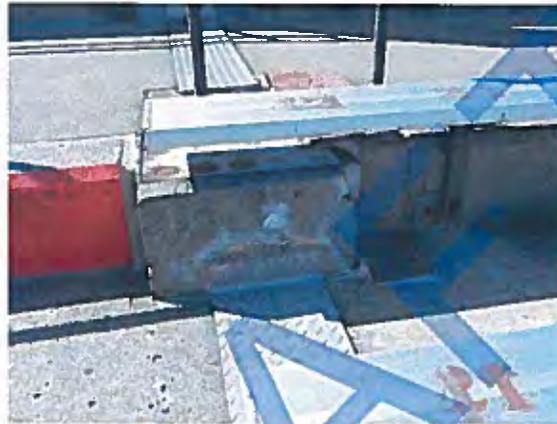
embedded steel plate (refer to figure 59). The probable cause of this concrete deterioration is freeze/thaw cycling in concrete with no entrained air.

Figure 59- Deterioration of Exposed Concrete Column at Embed Plate

Comment: The damaged concrete should be removed, the exposed steel cleaned, a corrosion inhibiting bonding agent applied and area patched with a suitable trowel applied mortar (short term).

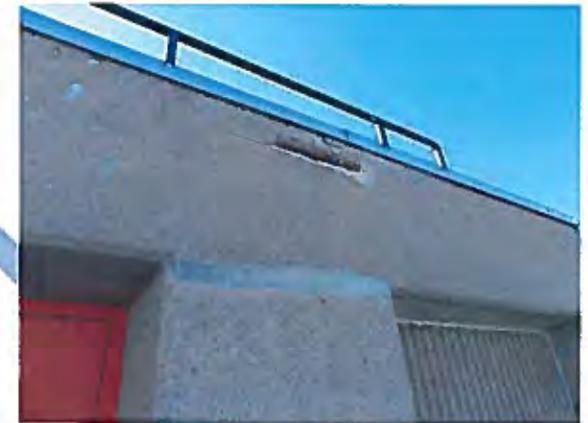
Figure 60- Spalling of Concrete Encasement at Embedded Steel Beam

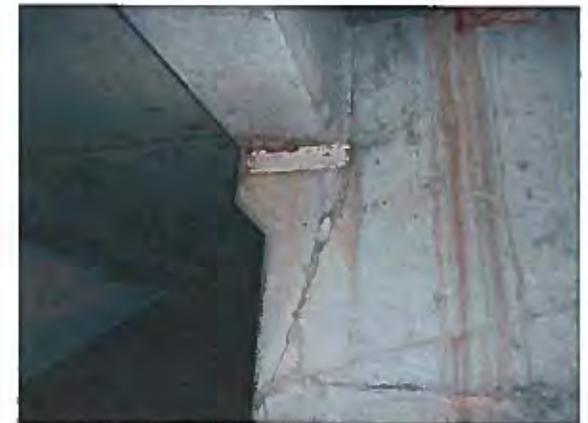
Figure 61- Cracking and Failure of Corbel

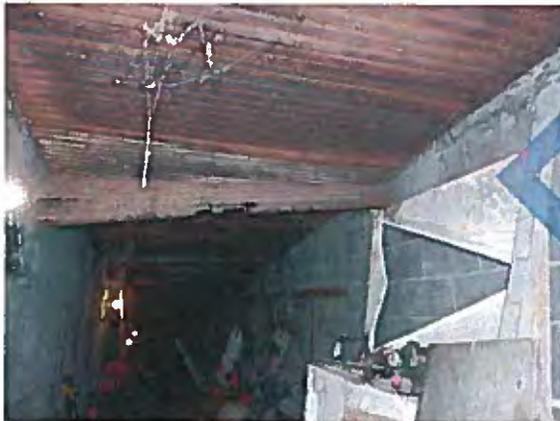
Figure 67- Delaminating steel Form Deck

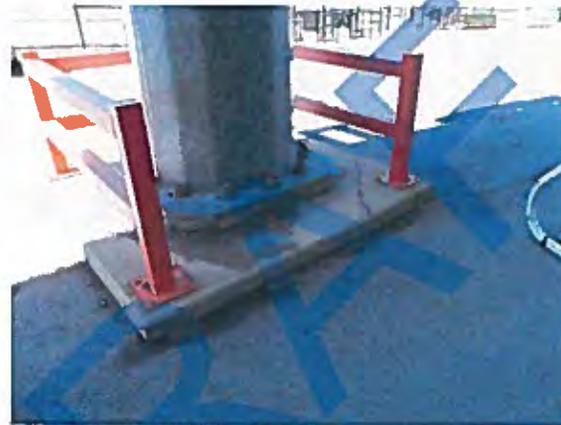
Figure 68- Light Pole Support Base Cracking and Grout Deterioration

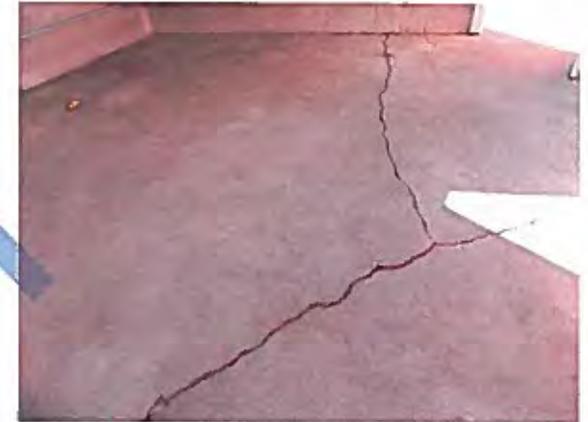
Figure 69- Frost Heave at Slab on Grade in Concessions

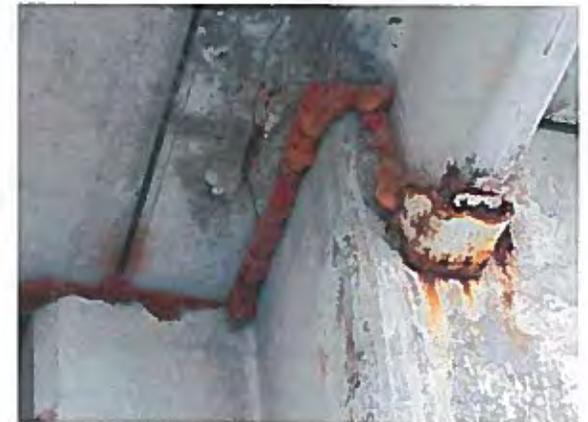
Figure 70- Cracking of Concrete and Corrosion of Steel Embeds

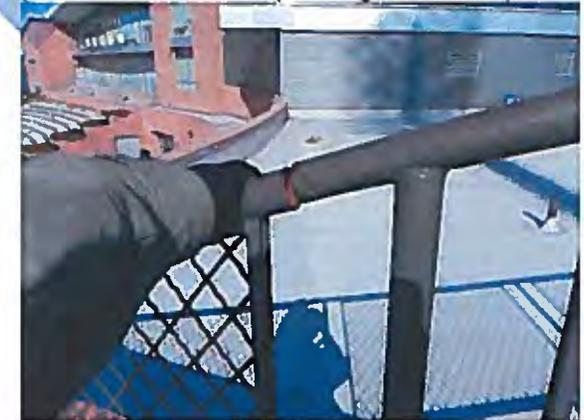
Figure 74- Split in Guardrail Top Rail

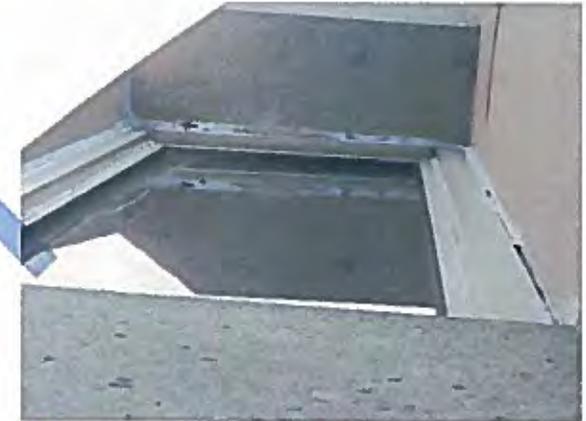
Figure 78- Window Sealant Joint - Deteriorated

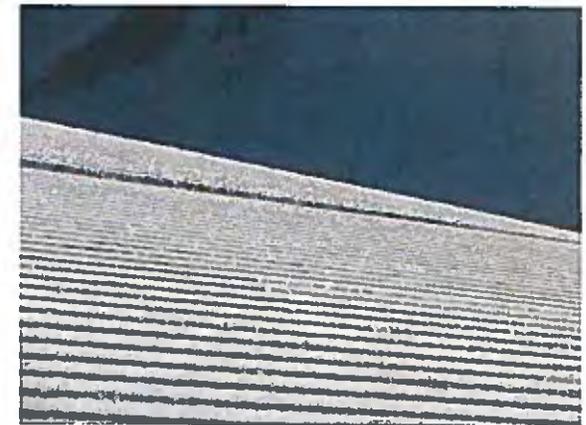
Figure 79 - Bulge in Precast Panel

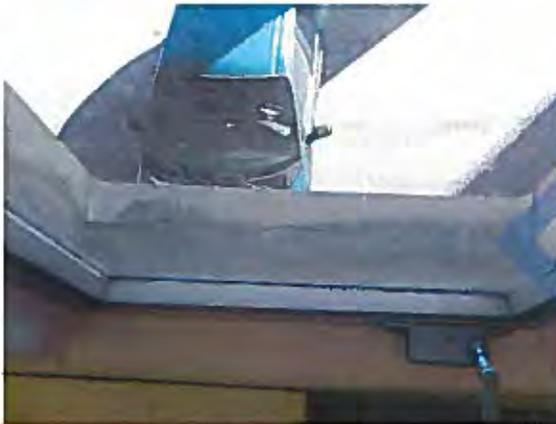
Figure 80- Crack in Precast Window Surround

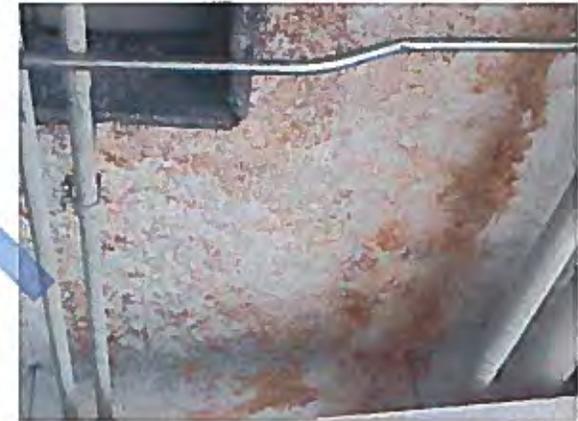
Figure 82 - Mold/Discoloration of Spray on Insulation

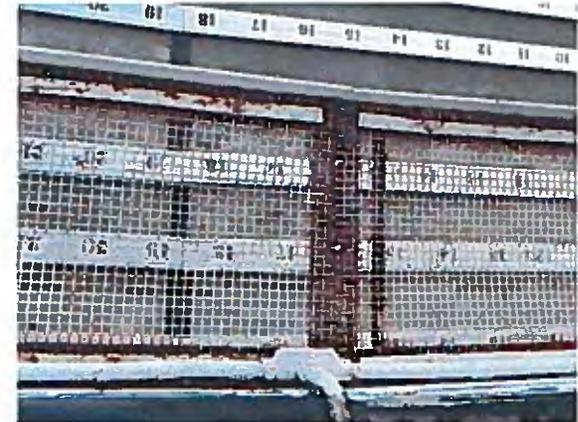
Figure 83- Corrosion of Steel Mesh Sunscreen
