# RFQ Question and Answer List

Project Name Perry Stadium Phase 1 Repairs/Upgrades Project Number BGU 156088  
Project Location Bowling Green State University

# BGSU Doyt Perry Stadium, Bowling Green, Ohio/// FACILITY CONDITIONS ASSESSMENT

ARCHITECTURAL 04/11/13

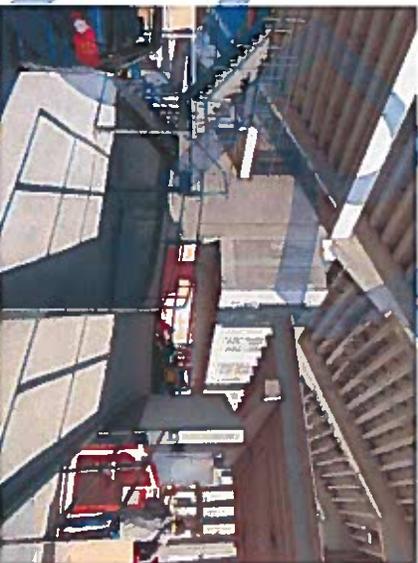
Figure 3- View of Ramped Walkway to Seating Bowl

**PUBLIC RAMPED WALKWAYS:** The seating bowl is primarily accessed from (8) large ramped walkways, with a distinctive "Y" shaped entry into the seating bowl (refer to figure 3). These ramps are at a slope of 1" rise over 10" of run, as indicated on the original drawings, but they contain no landings, it is one constant slope for approx. 9 feet of vertical rise. The slope angle of the arrangement do not comply with current building and accessibility codes, which would require a maximum slope of 1" rise over 12" of run and a landing for every 30" of rise. In the case of this location, you would be required to provide (4) 5'-0" long level landings and revise the slope of the ramp. This would add almost 40 feet to the overall length of these ramps at each location. Handrails would also be required on each side to comply with the current building codes (refer to figure 4).

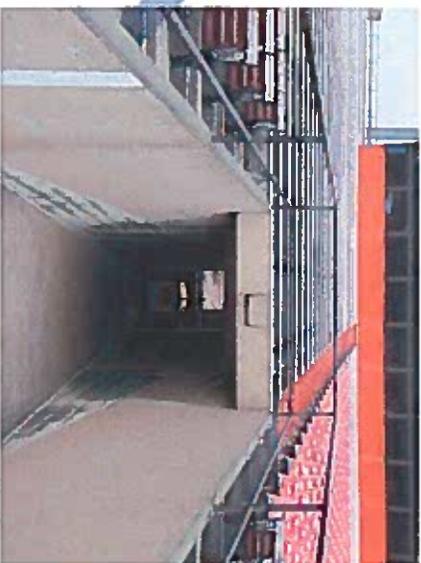
Figure 4- View of Ramped Walkway with Hand Rails

The construction on the top surface appears to be in acceptable condition. There are noticeable chalking and weathering issues with the CMU walls along the sides, but the walking surface has no visible issues.

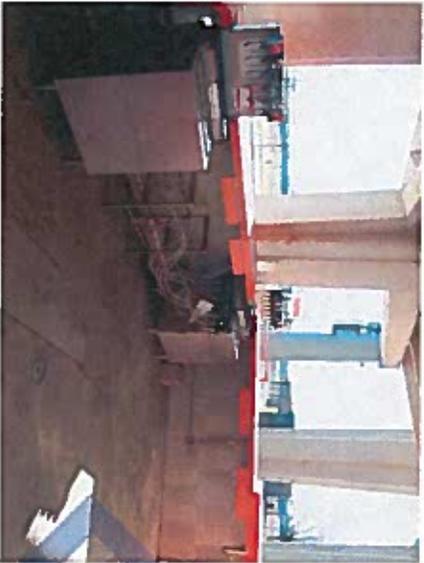
Figure 6- Interior of Concession Stand

**CONCESSION STANDS:** The existing facility contains (8) freestanding concession stands with canopies located at the base of the ramped walkways (refer to figures 6 and 7). It is unclear how many point of sales (POS) machines are setup for each location, but 2-4 POS per stand seems reasonable. This would mean a total amount of 32 POS, which equates to approx. 1 POS for every 718 spectators. This is a very high ratio for a current college facility. We would recommend that the ratio should be closer to 1:200, which would mean a total amount of 115 POS, or an increase of around 83 POS. The public counter height is 3'-6" and would need to have a lowered portion at 3'-0" max. to comply with the current accessibility codes.

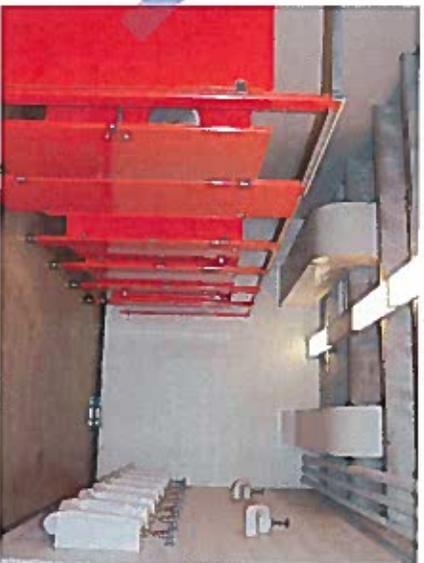
Figure 8- Public Toilets- Toilets + Urinals

**PUBLIC TOILETS:** The existing facility contains a total of (4) Men's and (4) Women's Toilet Rooms. Generally these spaces were in good condition. The painted, floor mounted toilet partitions were in good condition and the ones tested appeared stable and structurally sound. A few locations showed signs of attempts to provide wheelchair accessible stalls, although it was observed that these did not appear to fully comply. These rooms also lacked the required ambulatory stalls and many of the toilet accessibles were mounted higher than allowed (refer to figures 8 and 9). The rooms themselves had more than adequate turning clearances, however the existing entry and exit doorways do not. The quantity of existing toilets is well below the current code requirements and would need to be resolved in any future renovation.

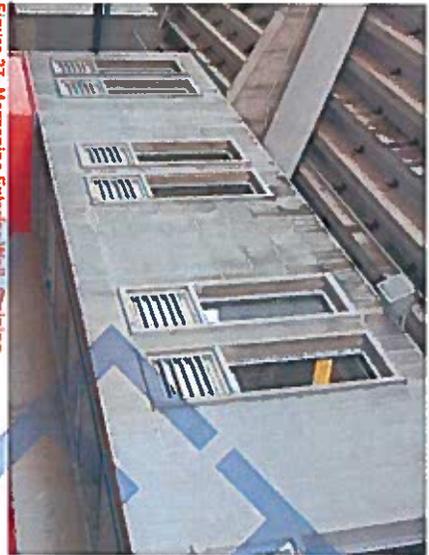
The Mezzanine Level is enclosed with CMU walls and have small windows for each office area. These offices have separate mechanical units mounted under the windows with an attached louver. Based on the existing drawings, it is not clear if any coating or sealer was installed over the exterior surface. The exterior wall is showing signs of water intrusion, noticeable from the visible staining seen on the walls (refer to figure 27). We would recommend the walls be cleaned and an appropriate sealer or coating be applied to limit water from entering the wall system. The construction of the Mezzanine also has an overhang condition that has the floor slab exposed to the exterior, we would suggest an insulated soffit be constructed to provide a more complete envelope.

Figure 27- Mezzanine Exterior Wall Staining

The windows appear to be original to the facility and are 3/16" gray tinted single pane units per the drawings. These units should be replaced with insulated glass and associated sealant in order to extend the life of the facility. The insulation of the walls and roof should be increased as well.

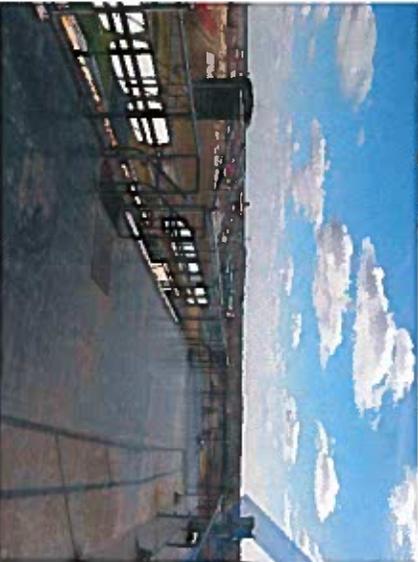
**ROOFING:** The single ply roofing above the Suite and Pressbox Levels appears generally in good condition. There are some minor areas that felt spongy when walking over, we would suggest a more formal review of the roofing from the manufacturer to determine the remaining life of the current roofing, we would estimate at least 5-8 years with some minor repairs (refer to figure 31).

Figure 31- View of Roof above PressBox

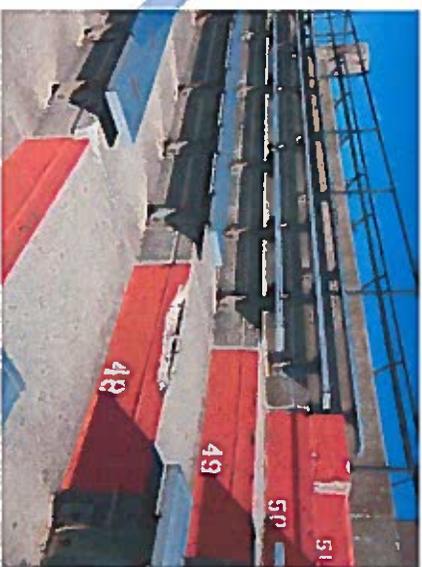
**STADIA:** The precast stadia appears to have no coating over most of the seating bowl. There are a number of locations that have a traffic coating applied over occupied areas. This coating appears to have been repaired multiple times over the years, as the water damage underneath is visible. We would recommend a heavy duty coating be applied over all surfaces to help protect the concrete. There are areas of the precast that have been damaged by water penetration and require repair (refer to figure 37). The seating bowl does not have a center aisle railing which has improved safety results and is required by the Building Code. We would recommend adding this missing aisle railing to improve usability to an aging population.

Figure 37- View of Stepped Aisle

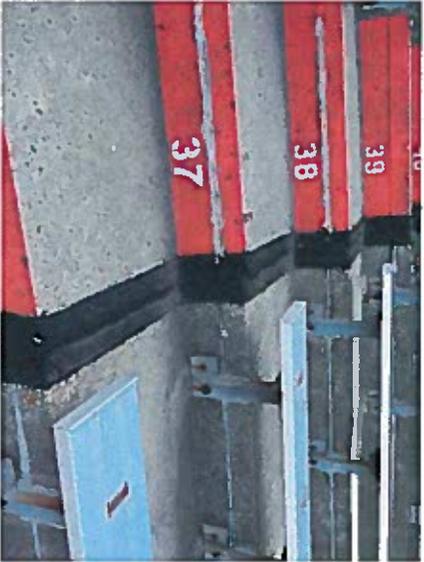
**SEATING JOINT SEALANT:** The sealant installed within the seating bowl is in various states of decline, as part of any major renovation, the sealant should be removed and replaced complete (refer to figure 38).

Figure 38- View of Seating Bowl Sealing Joint

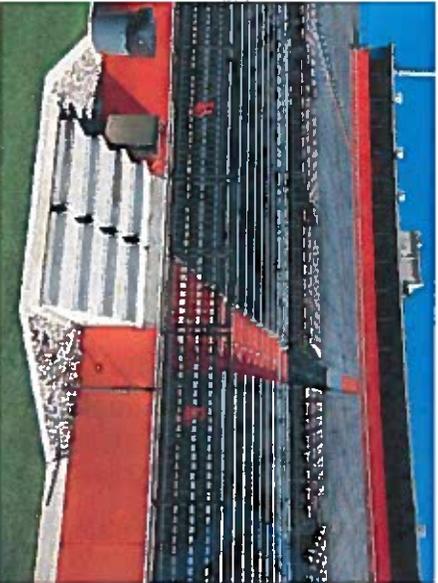
**FIELD ACCESS STAIRS/ EGRESS TO FIELD:** The sealing bowl relies on egress into the field in the event of emergency to accommodate all the spectators. These stairs (7) locations per side do not provide the required railings. These railings should be provided (refer to figure 39).

Figure 39- Field Access Stairs

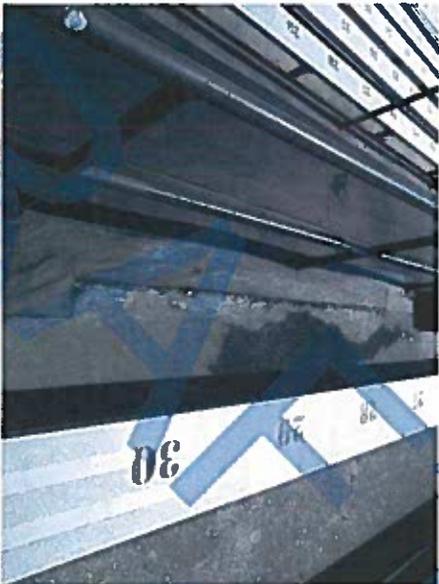
**TRAFFIC COATING/ WATERPROOFING:** Various methods of waterproofing and traffic coatings have been installed over the occupied areas. In some areas, a membrane has been installed, but it is obvious that water has gotten under the membrane and is trapped between the concrete. This membrane has now delaminated from the concrete. We would recommend that this membrane be removed and the traffic coating be reviewed at all locations (refer to figure 40).

Figure 40- View of Delaminated Membrane

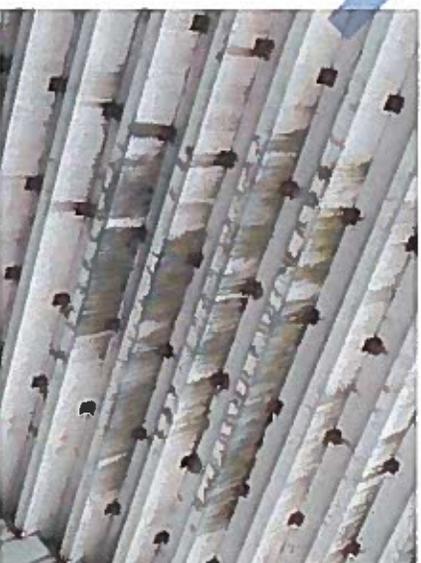
Few connectors were found to be in near to original condition (refer to figure 42). However, majority of the connectors that connect precast risers together show signs of corrosion.

Figure 43: Steel Connector Typical Corrosion of Exposed connectors

- *Testing: Desai/Nasir recommends removing two to five of these clip angles and their bolts to determine the condition of the bolts and inserts and rate of steel deterioration. Test results to be used to estimate the remaining life and what, if any, remedial measures are required to slow or stop this corrosion (short term).*

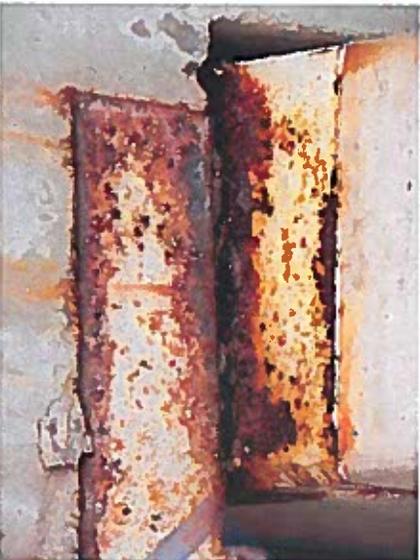
During construction, steel shim stacks were used to level the precast risers and make up construction tolerances. These shim packs vary greatly in number and thickness of plates used. In an attempt to comply with the original details, the shim packs were welded together and to the embedded steel inserts. This steel assembly was observed to be moderately to severely corroded. The most severe corrosion was observed where the shim packs are high and/or where the shim plates were thin (refer to figure 45).

**Figure 45- Corrosion at Thin Shim Plate – Welded completed Deteriorated**

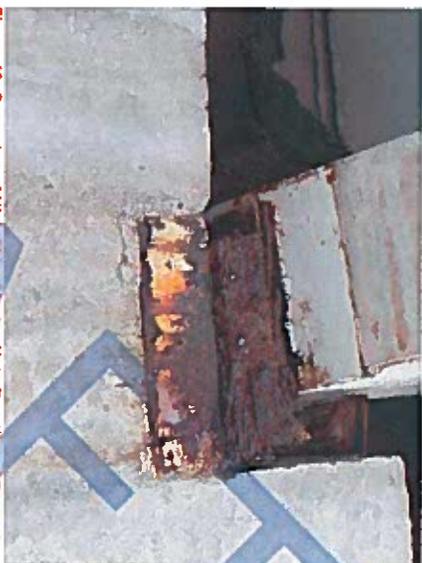
**Figure 46- Corrosion of High Shim Stack – Note Rotation of Precast Beam**

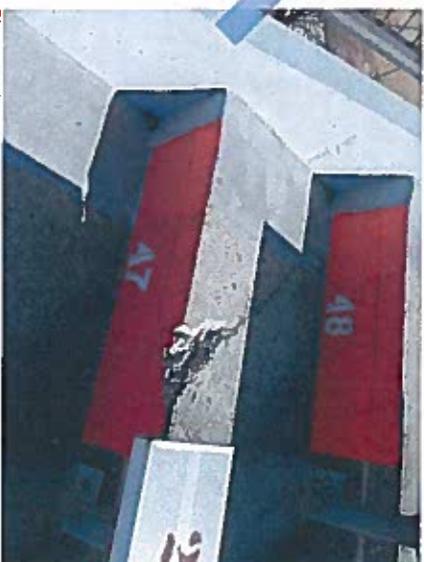
Small areas of spalled concrete were observed on the top side of the stadia. The majority of spalls were observed in the access aisles that carry most of the foot traffic (refer to figure 52).

Figure 52- Precast Riser - Spalling

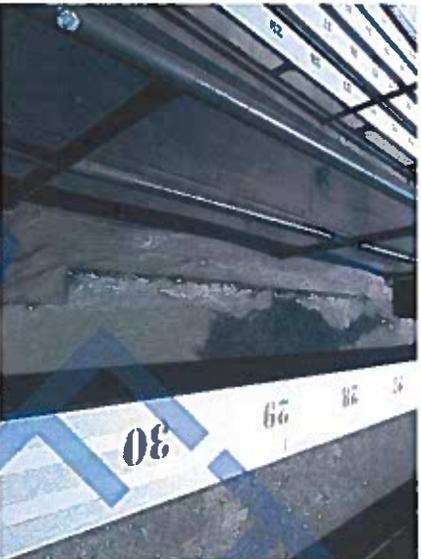
Figure 54 - Waterproofing Membrane at Precast Top - Failure

**Comment:** To reduce the amount of water leaking through the structure into occupied spaces below and corroding the steel connections, a traffic coating is recommended to be applied to the entire top surface of the elevated precast risers and cast-in-place top slab areas. This work should only be carried out after all the other structural issues identified have been addressed (short term/future depending on severity of leaks).

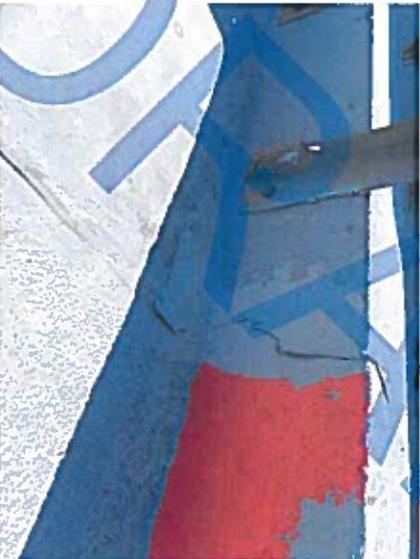
Figure 55 - Applied Traffic Coating - Failure at Joint

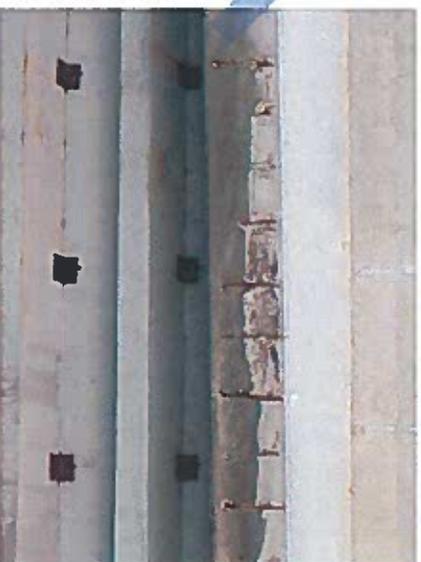
**MAIN LOAD BEARING FRAMES:** Minor spalling of concrete due to insufficient cover to shear ties was observed at two elevated beams (refer to figure 56).

Figure 56 - Concrete Spalling at Main Frame Beam

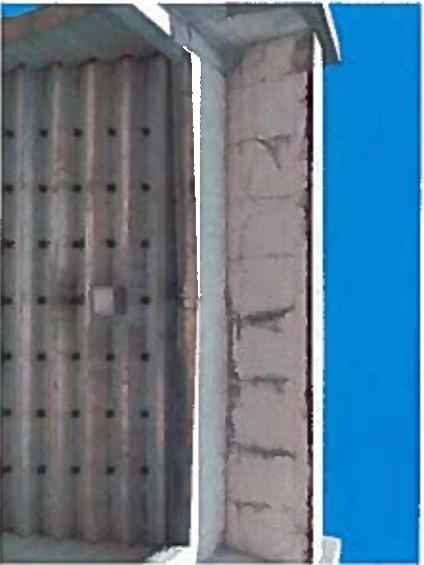
Figure 57- Shrinkage Cracking In Concrete

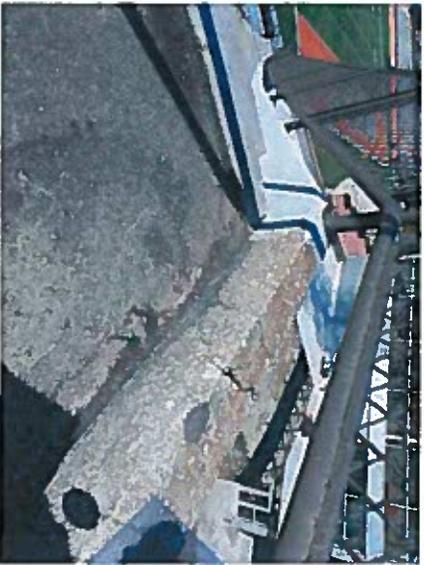
Figure 58- Deterioration of Slab and Curb

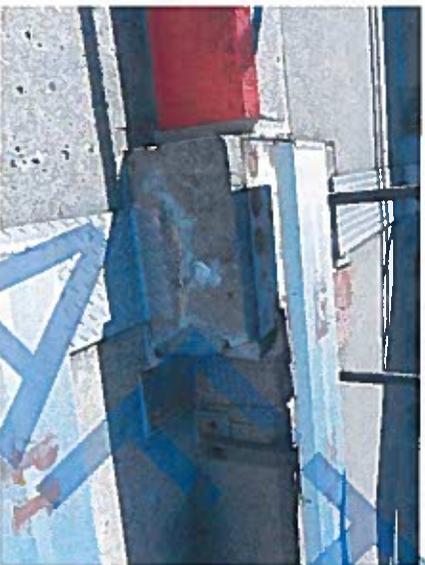
embedded steel plate (refer to figure 59). The probable cause of this concrete deterioration is freeze/thaw cycling in concrete with no entrained air.

Figure 59- Deterioration of Exposed Concrete Column at Embed Plate

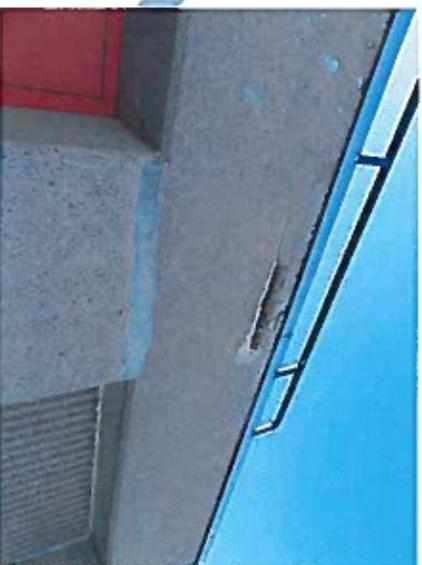
Figure 60- Spalling of Concrete Encasement at Embedded Steel Beam

**Comment:** The damaged concrete should be removed, the exposed steel cleaned, a corrosion inhibiting bonding agent applied and area patched with a suitable trowel applied mortar (short term).

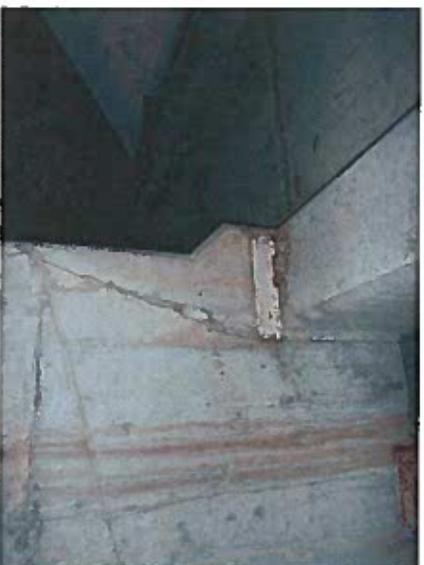
In the concessions kitchen area below the west stadia a shear crack was observed in the corbel. This crack is a sign of shear failure (refer to figure 61).

Figure 61- Cracking and Failure of Corbel

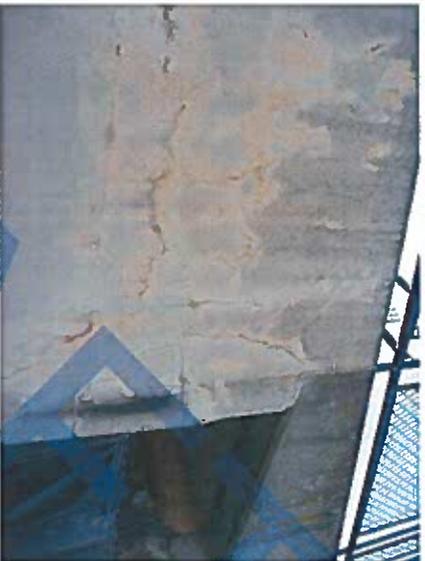
Figure 63- Deterioration of Concrete Return Walls

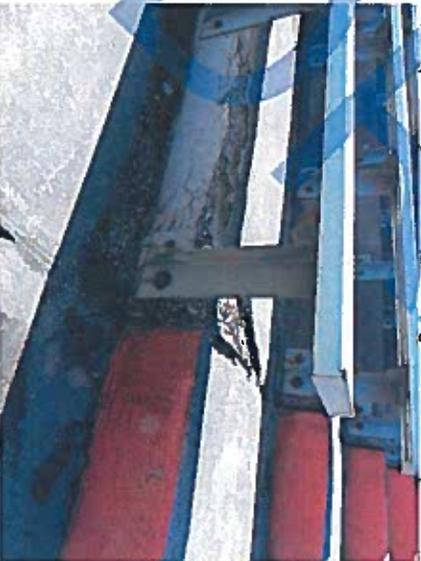
Damage and deterioration of the concrete was also observed on the second and third riser of the stadia, the side retaining walls and steps down to the field (refer to figures 64 and 65).

Figure 64- Deterioration of Cast-in-Place Concrete Risers

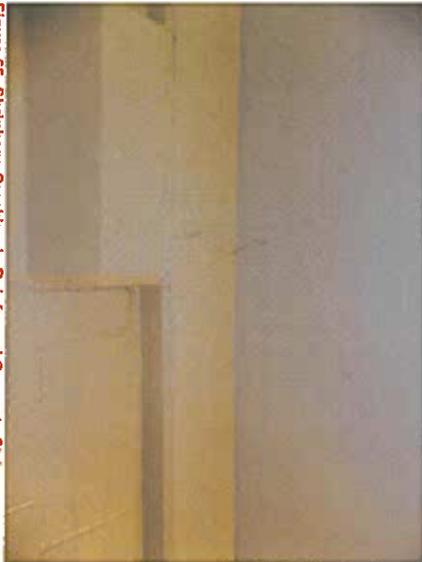
Figure 66- Shrinkage Cracking in Reinforced Concrete Slab

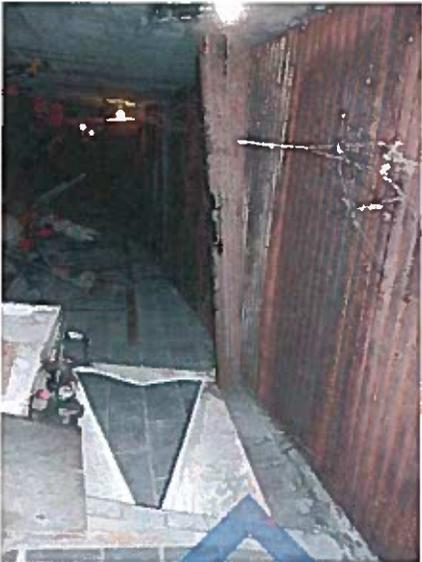
The sloping cast-in-place concrete access ramps are supported by CMU side walls. To form the slabs during construction light steel corrugated form deck was used (refer to figure 67). Over-time, this form deck has severely corroded and is peeling away from the concrete.

Figure 67- Delaminating steel Form Deck

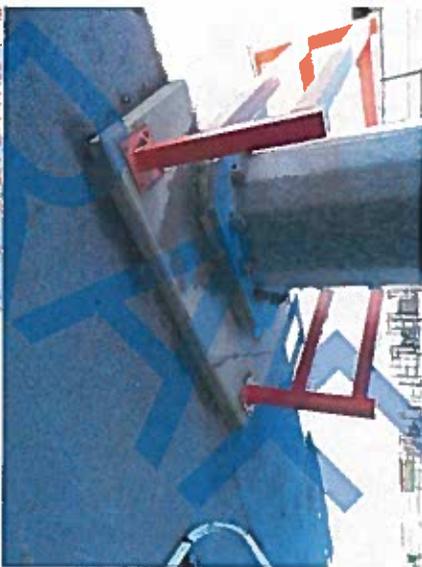
Minor deterioration of the grout bed below the light pole base plates was observed. Cracking of the concrete base slab has occurred at one location (refer to figure 68).

Figure 68- Light Pole Support Base Cracking and Grout Deterioration

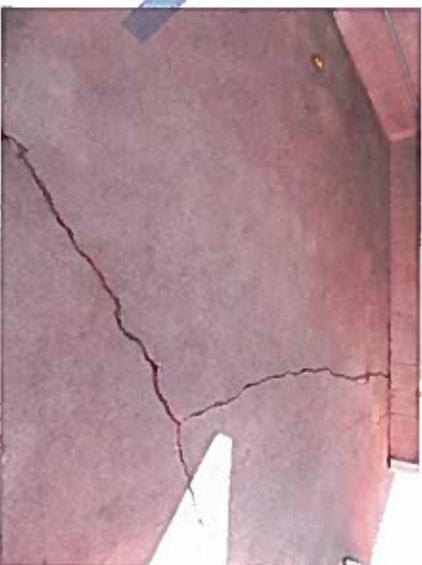
Figure 69- Frost Heave at Slab on Grade in Concessions

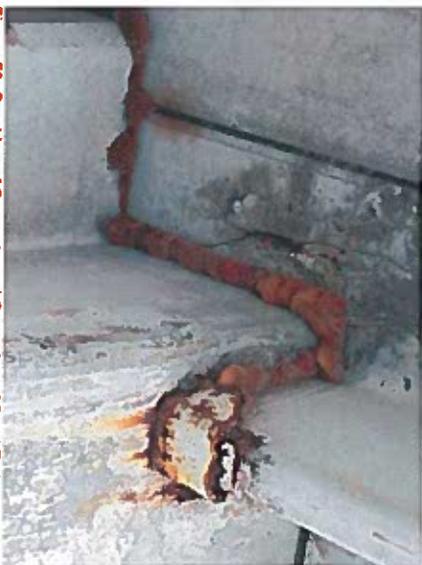
Figure 70- Cracking of Concrete and Corrosion of Steel Embeds

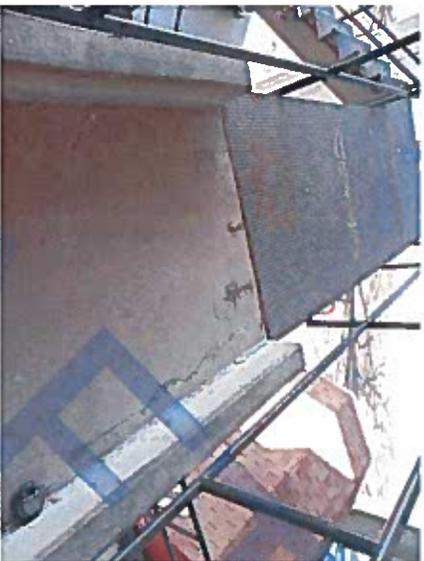
Figure 72 - Minor Corrosion of Checkered Plate Stair

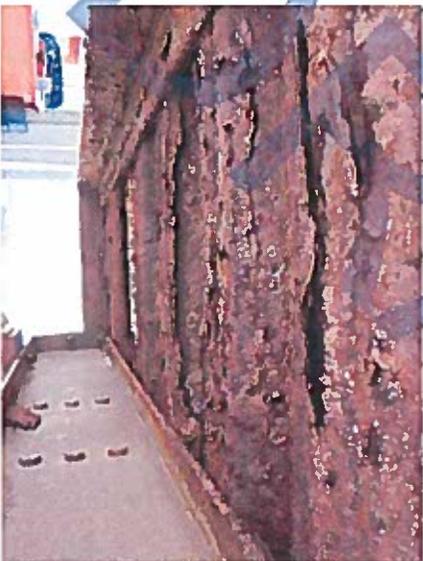
Figure 73 - Severe Corrosion of Steel and Deck at Bridge Stair

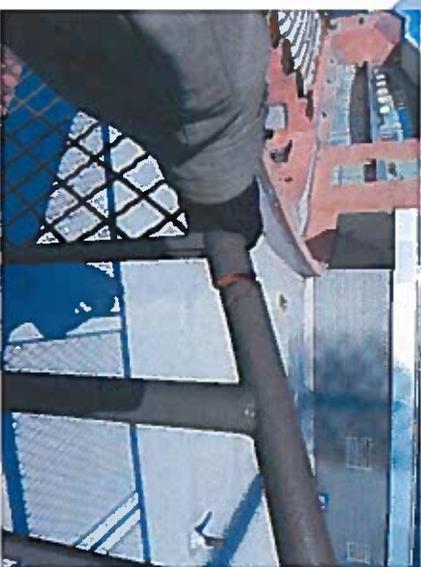
Figure 74 - Split in Guardrail Top Rail

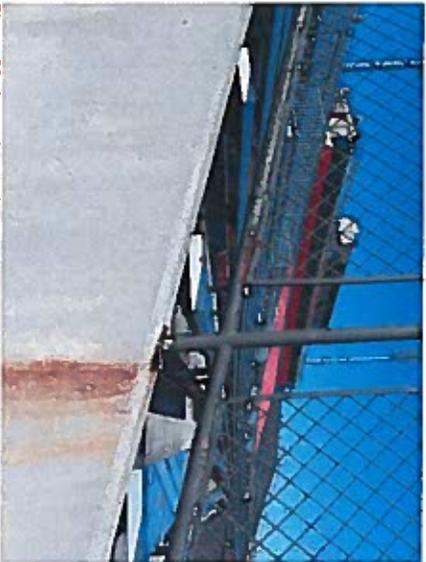
**Figure 75- Corrosion of Embed Plates and Steel Mesh Framing**

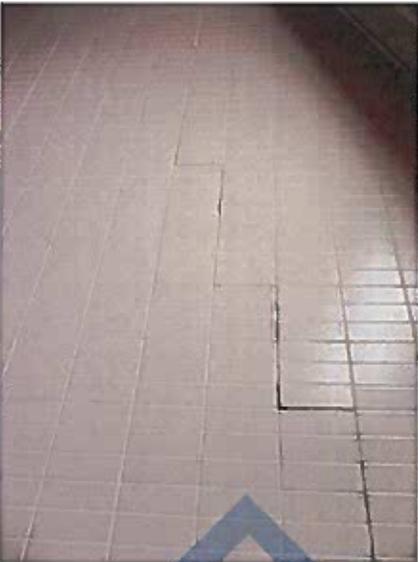
**Figure 76- Stepped Crack in CMU Wall**

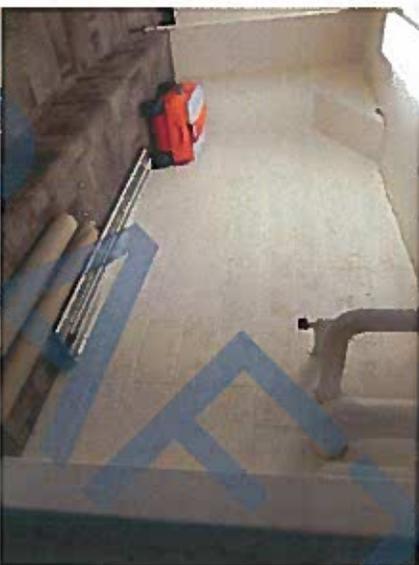
**Figure 77: Moisture Penetrating into CMU Wall From Above**

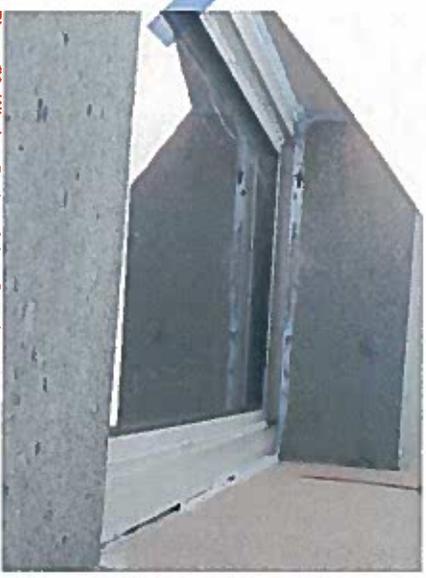
**Figure 78- Window Sealant Joint - Deteriorated**

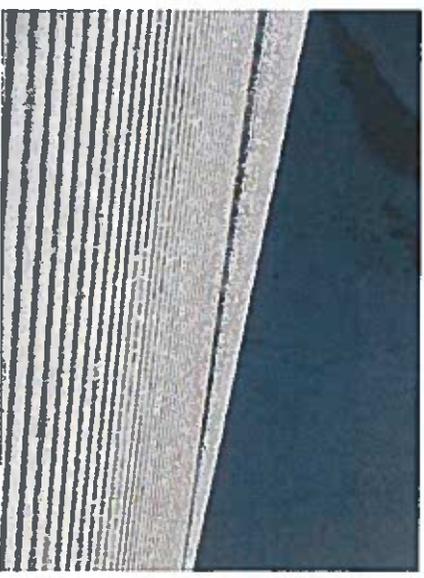
**Figure 79 - Bulge in Precast Panel**

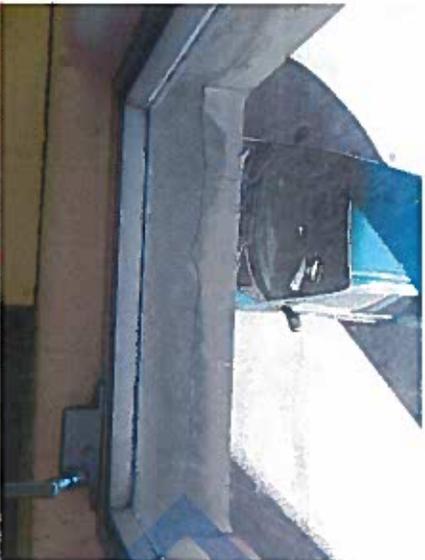
Figure 80- Crack in Precast Window Surround

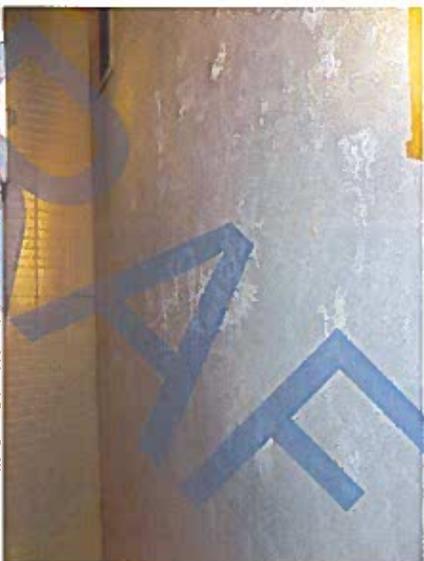
Figure 81 Humidity Corroding Underside of Hard Pan Ceiling

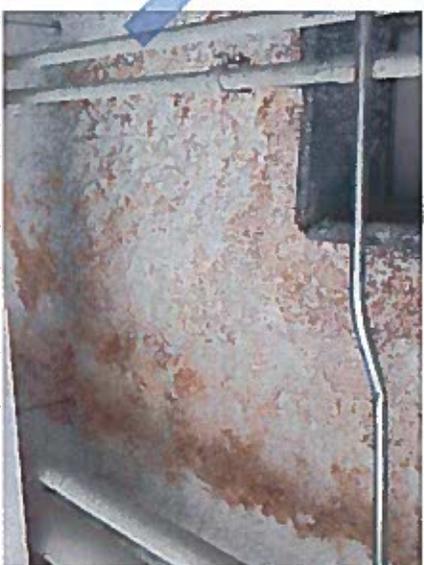
Figure 82 - Mold/Discoloration of Spray on Insulation

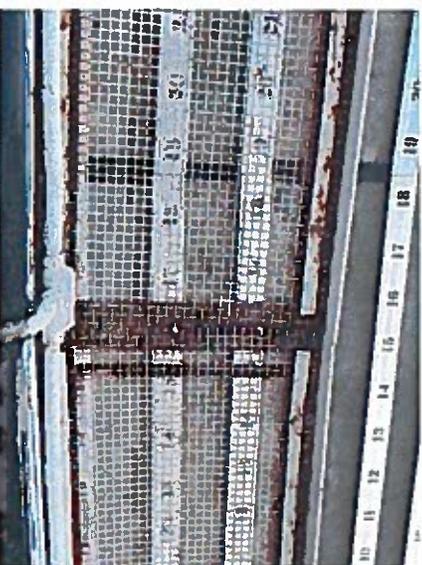
Figure 83- Corrosion of Steel Mesh Sunscreen
