Managing Maintenance and Post Construction Issues

**BASA School Facilities and Safety Conference
March 15, 2017**

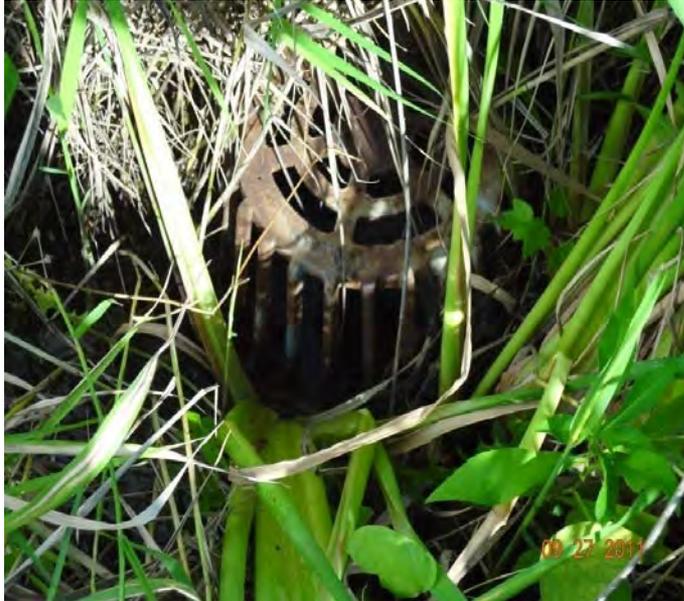
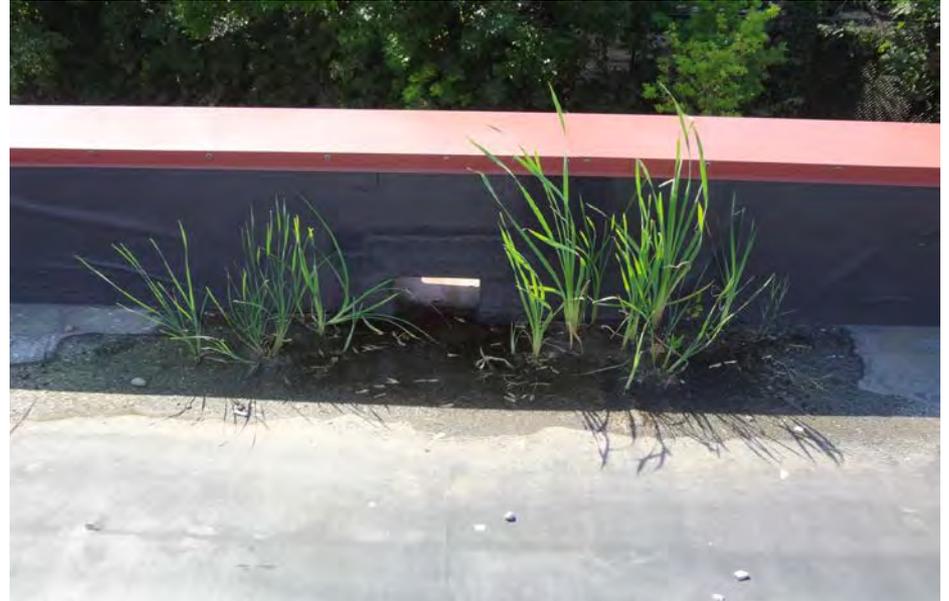
“Green Roof”?

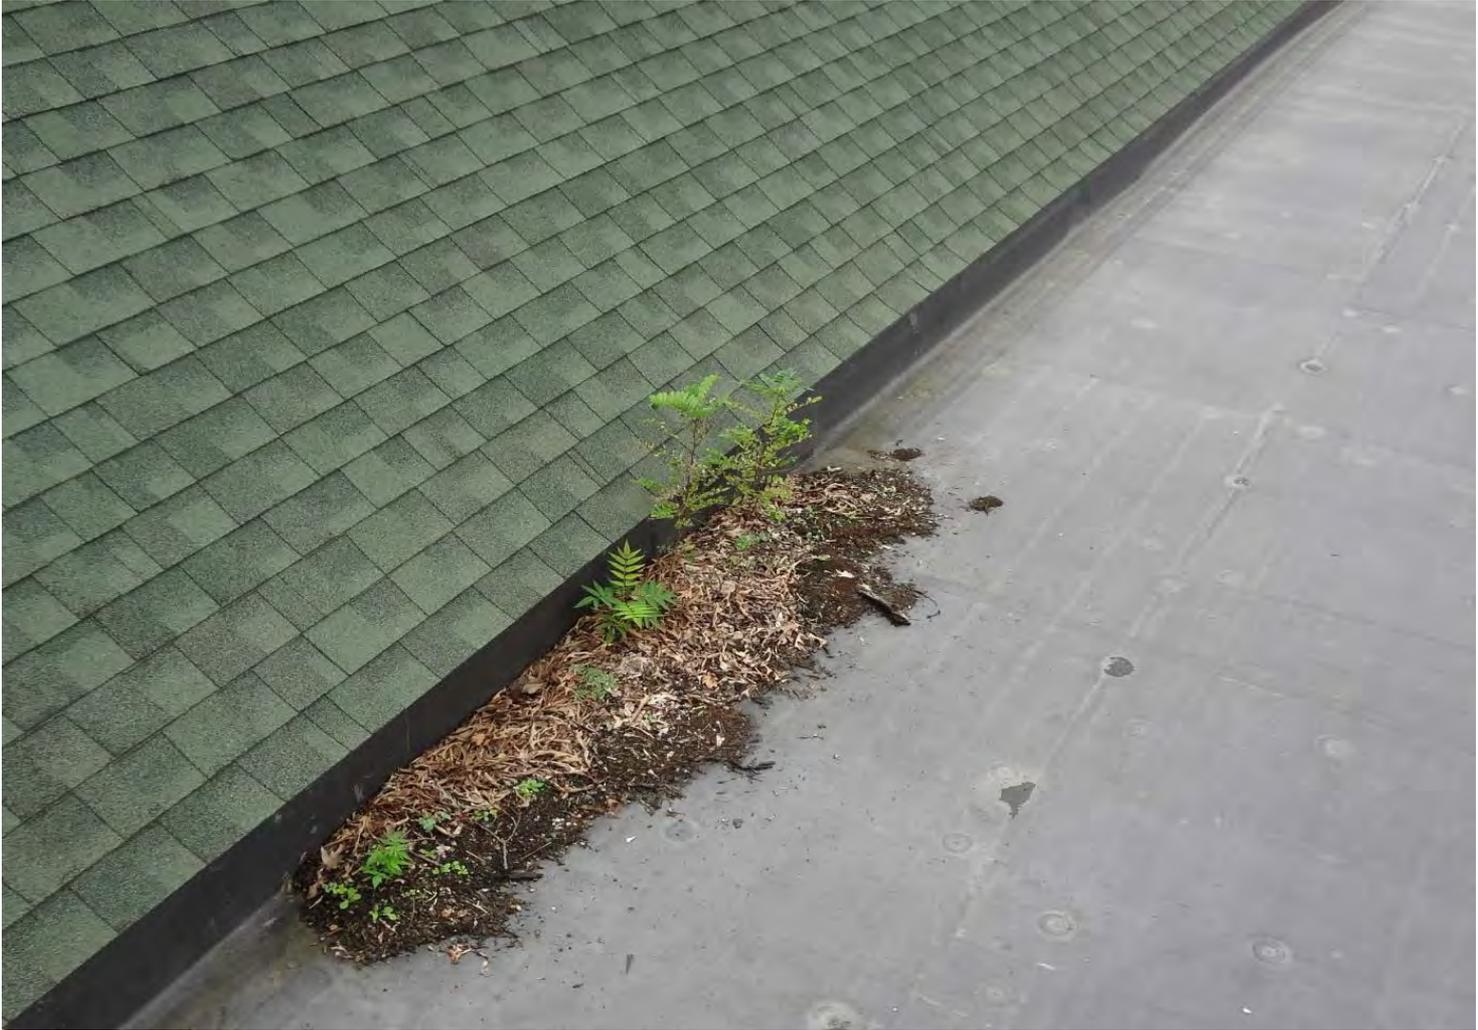
Vegetation

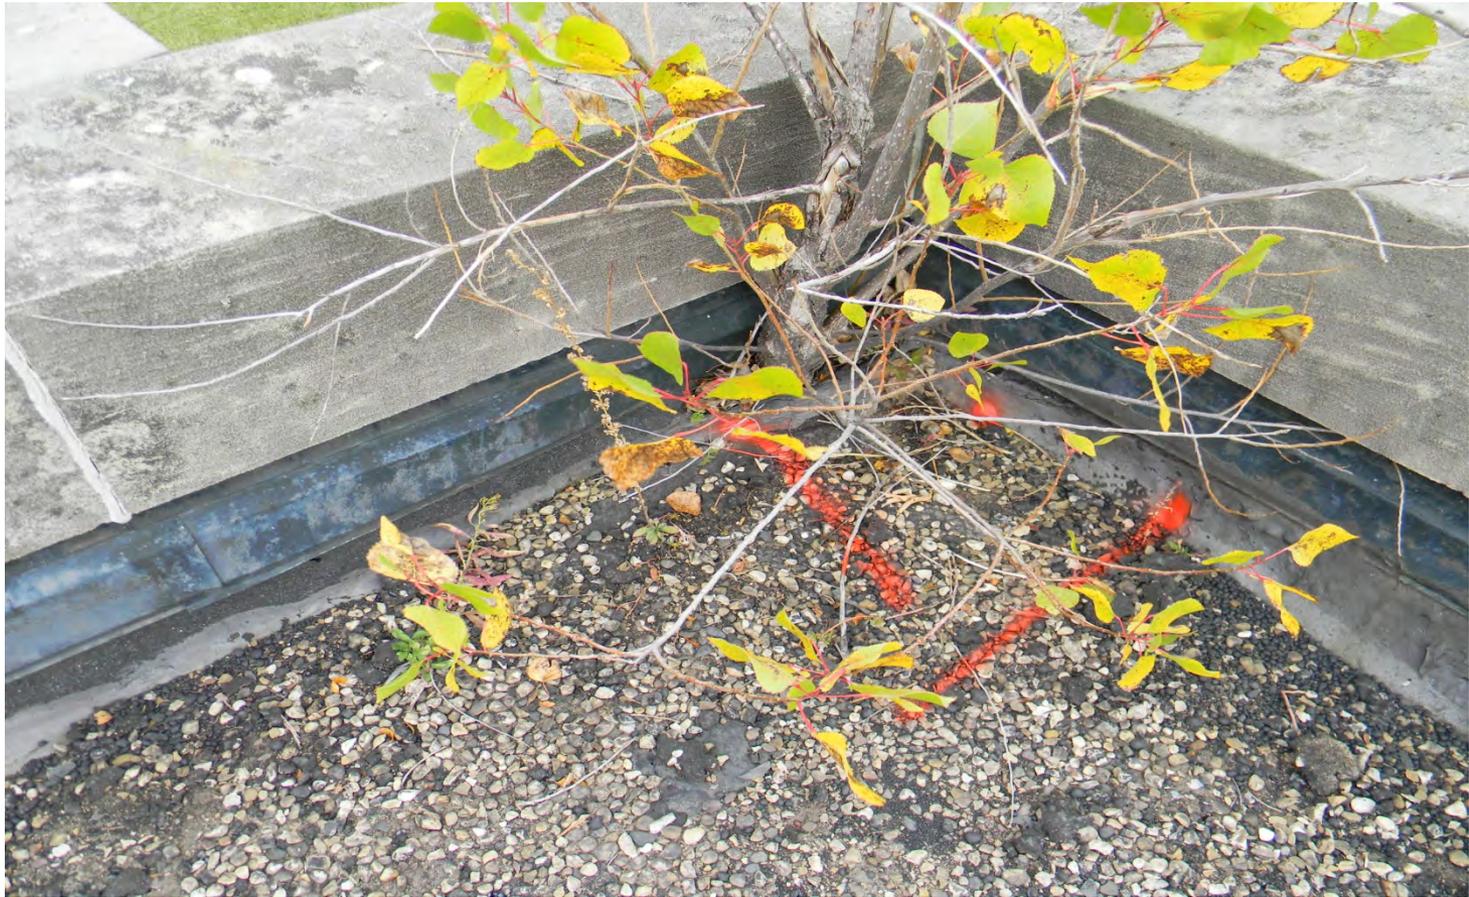
Vegetation

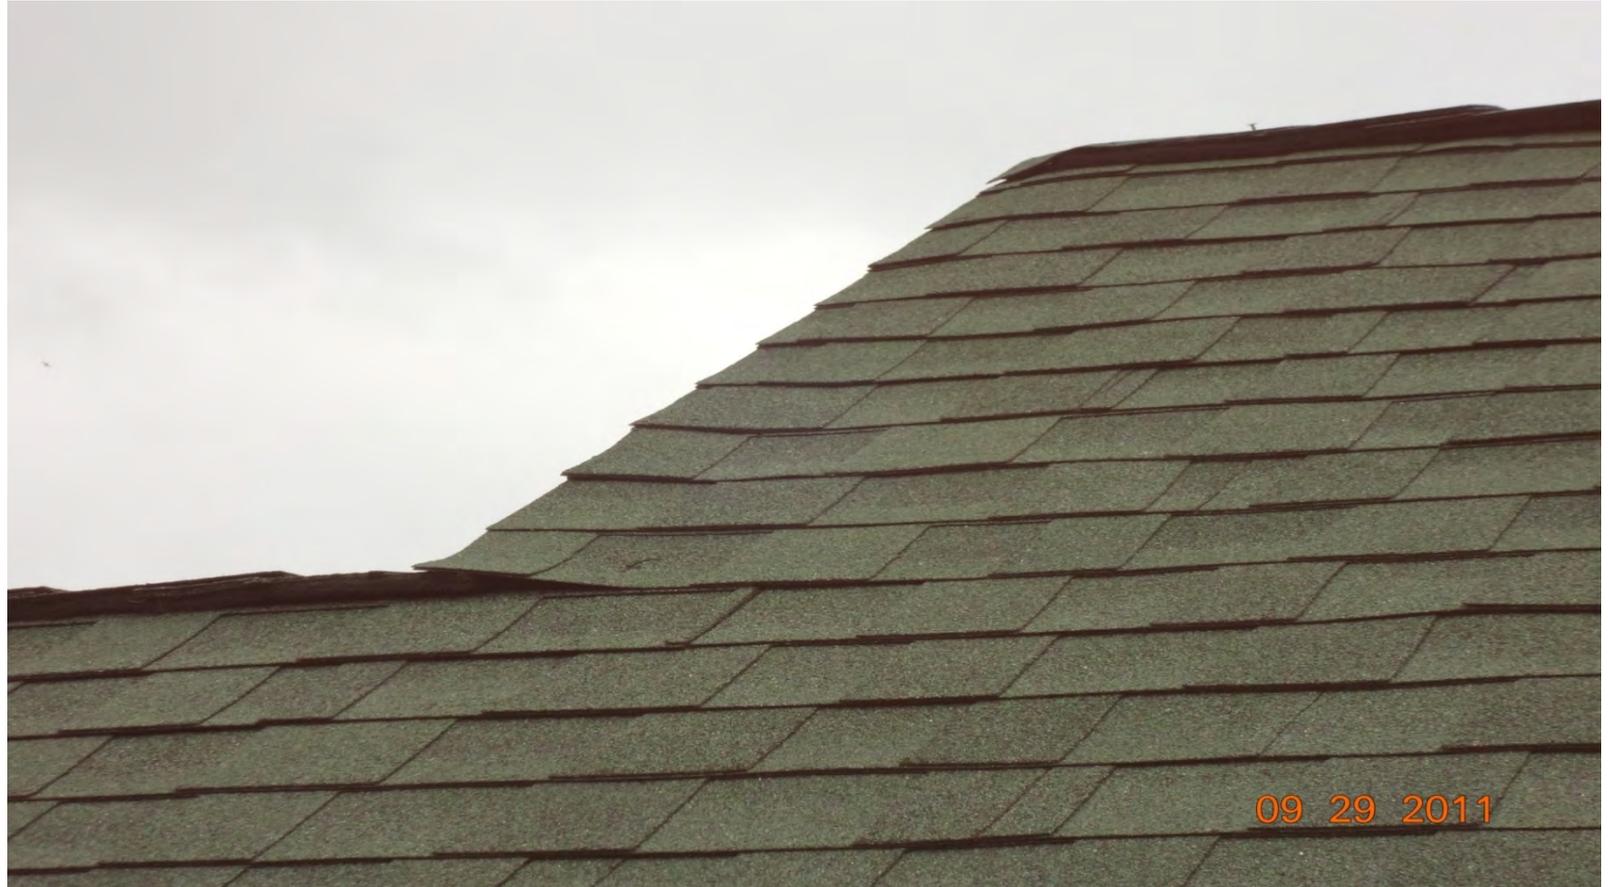
Shingles Beginning to Curl, Nails Popping on Ridge Cap

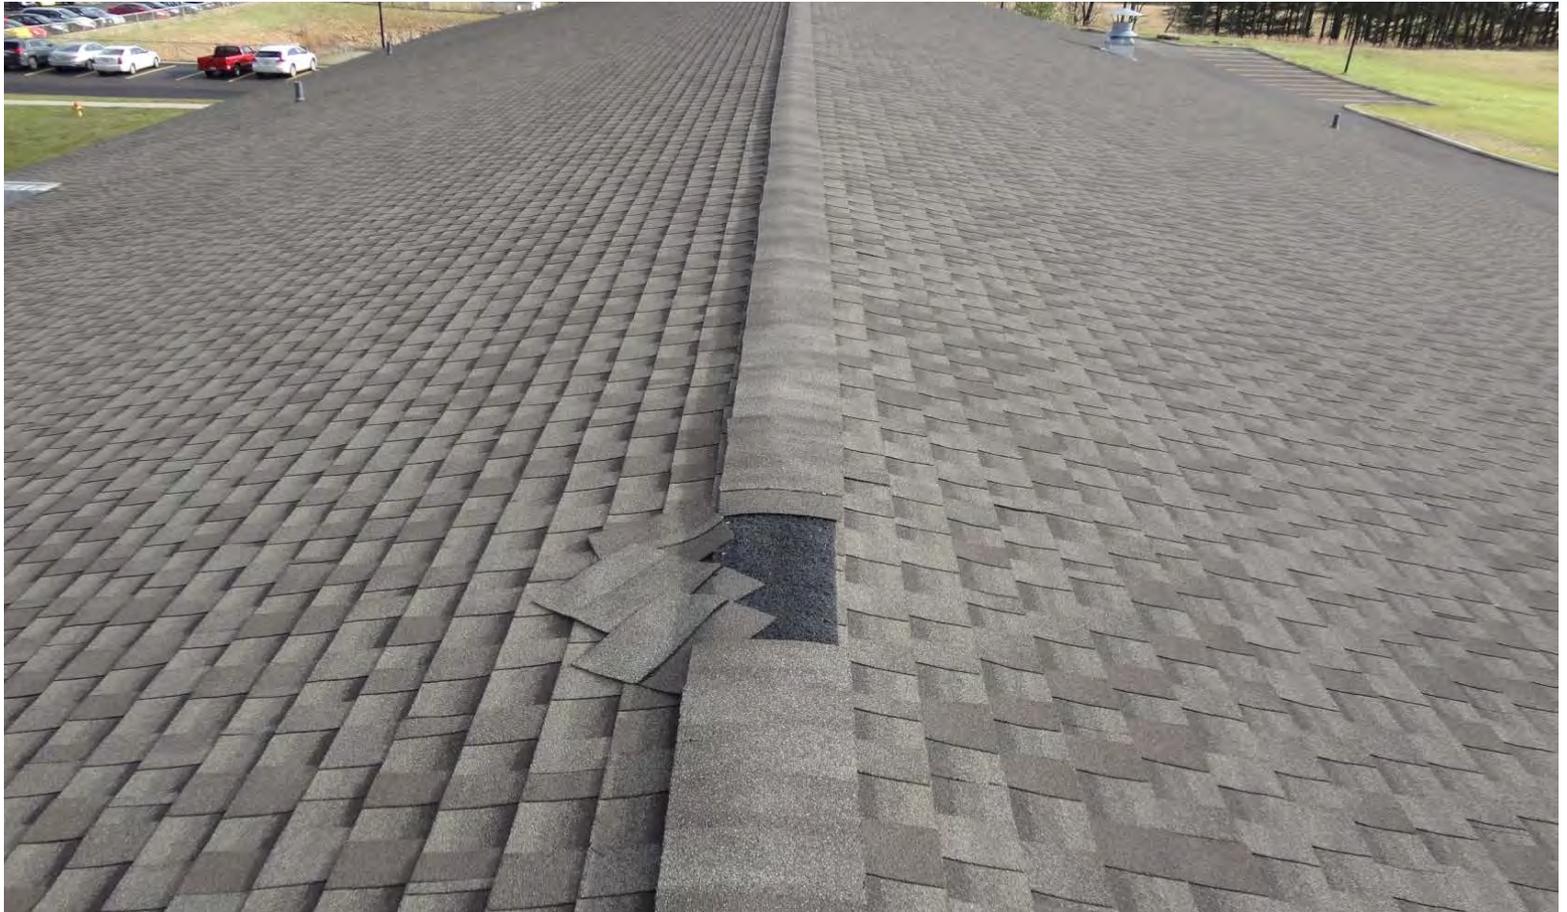
Detached Shingles on Ridge Cap

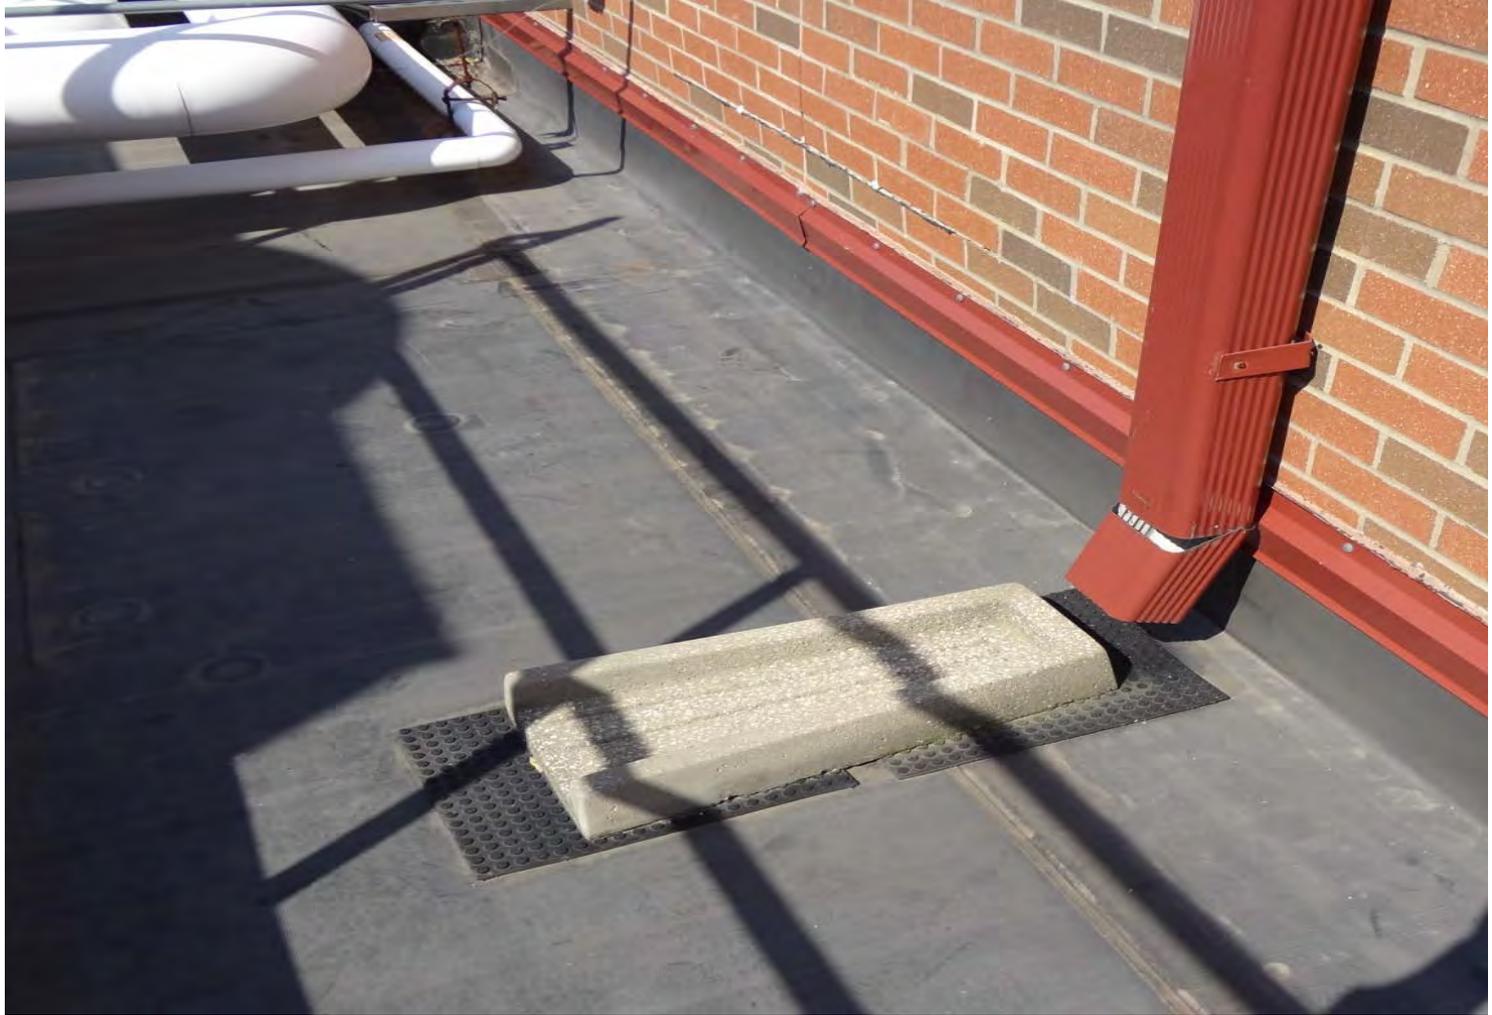
Damaged Downspout

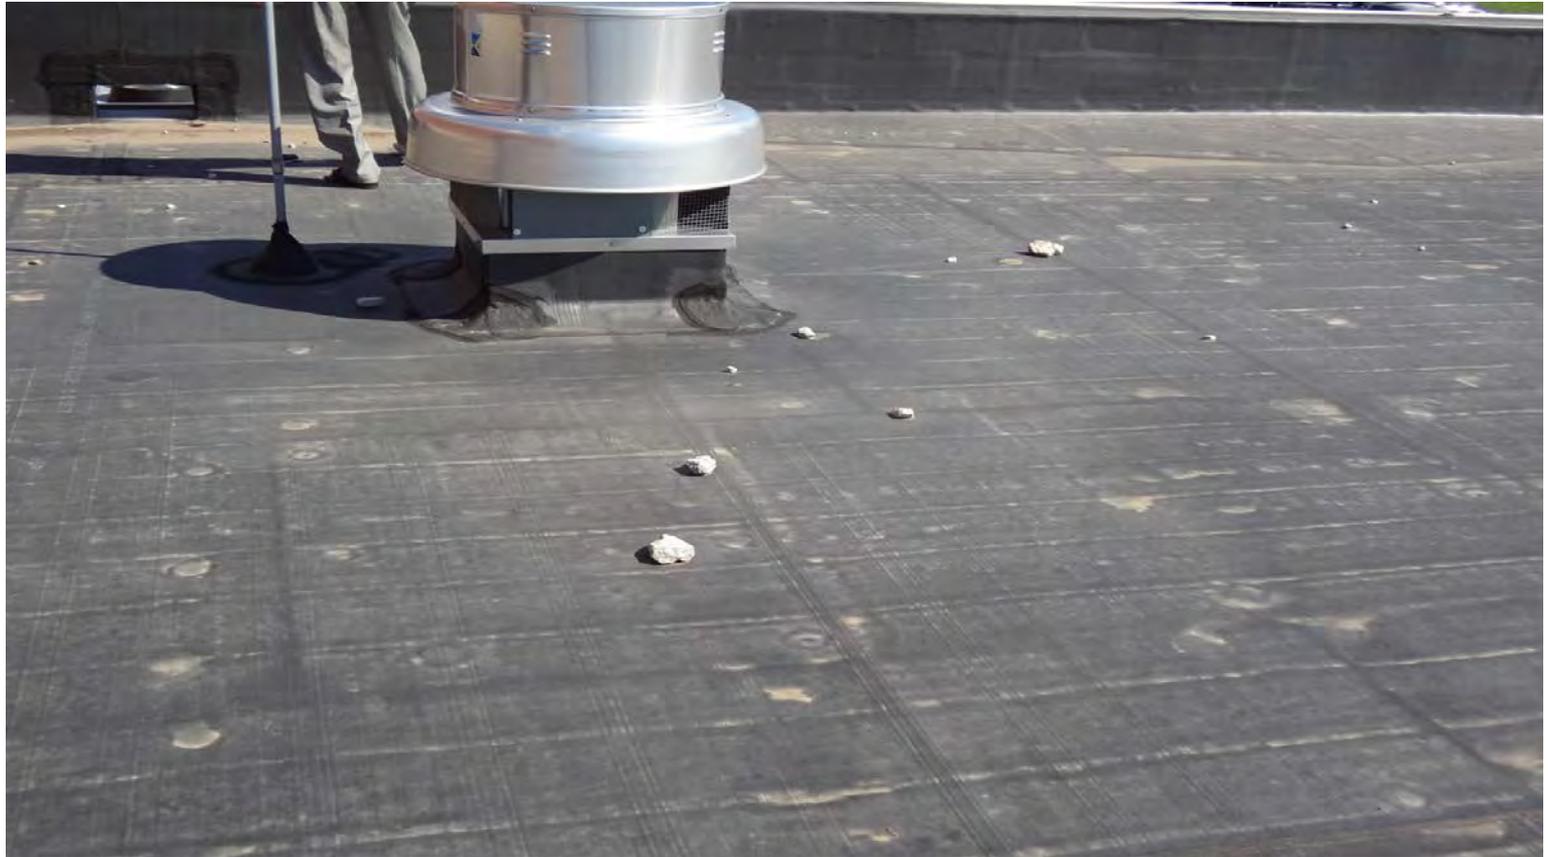
Objects on Roof

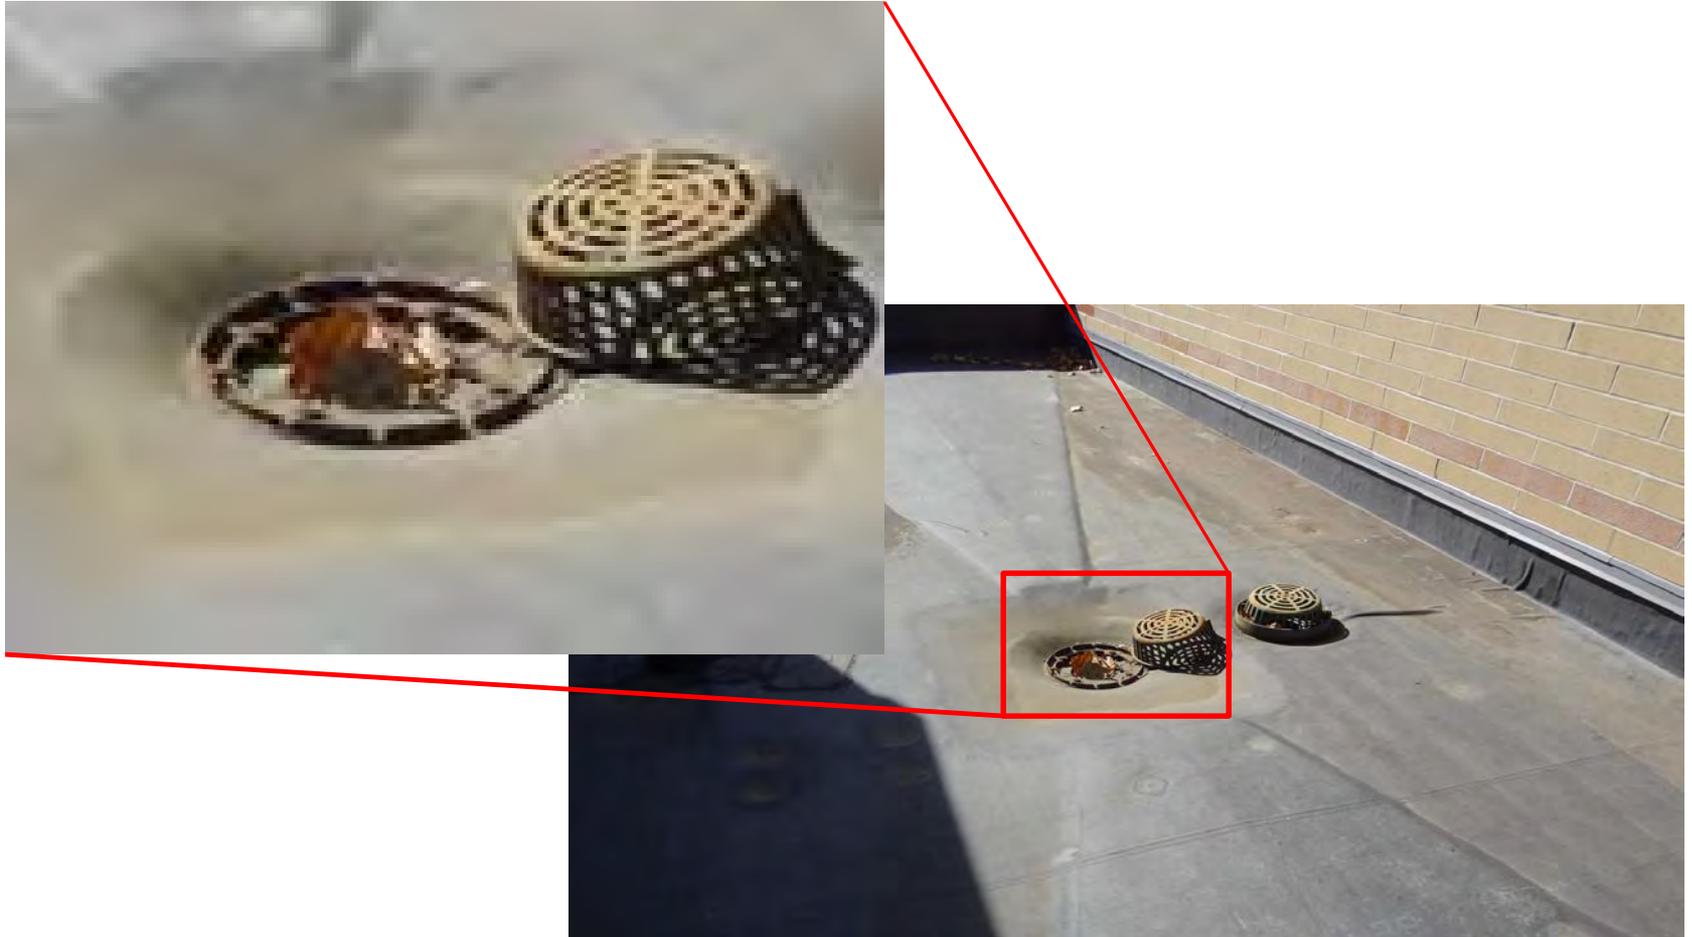
Drain Cover

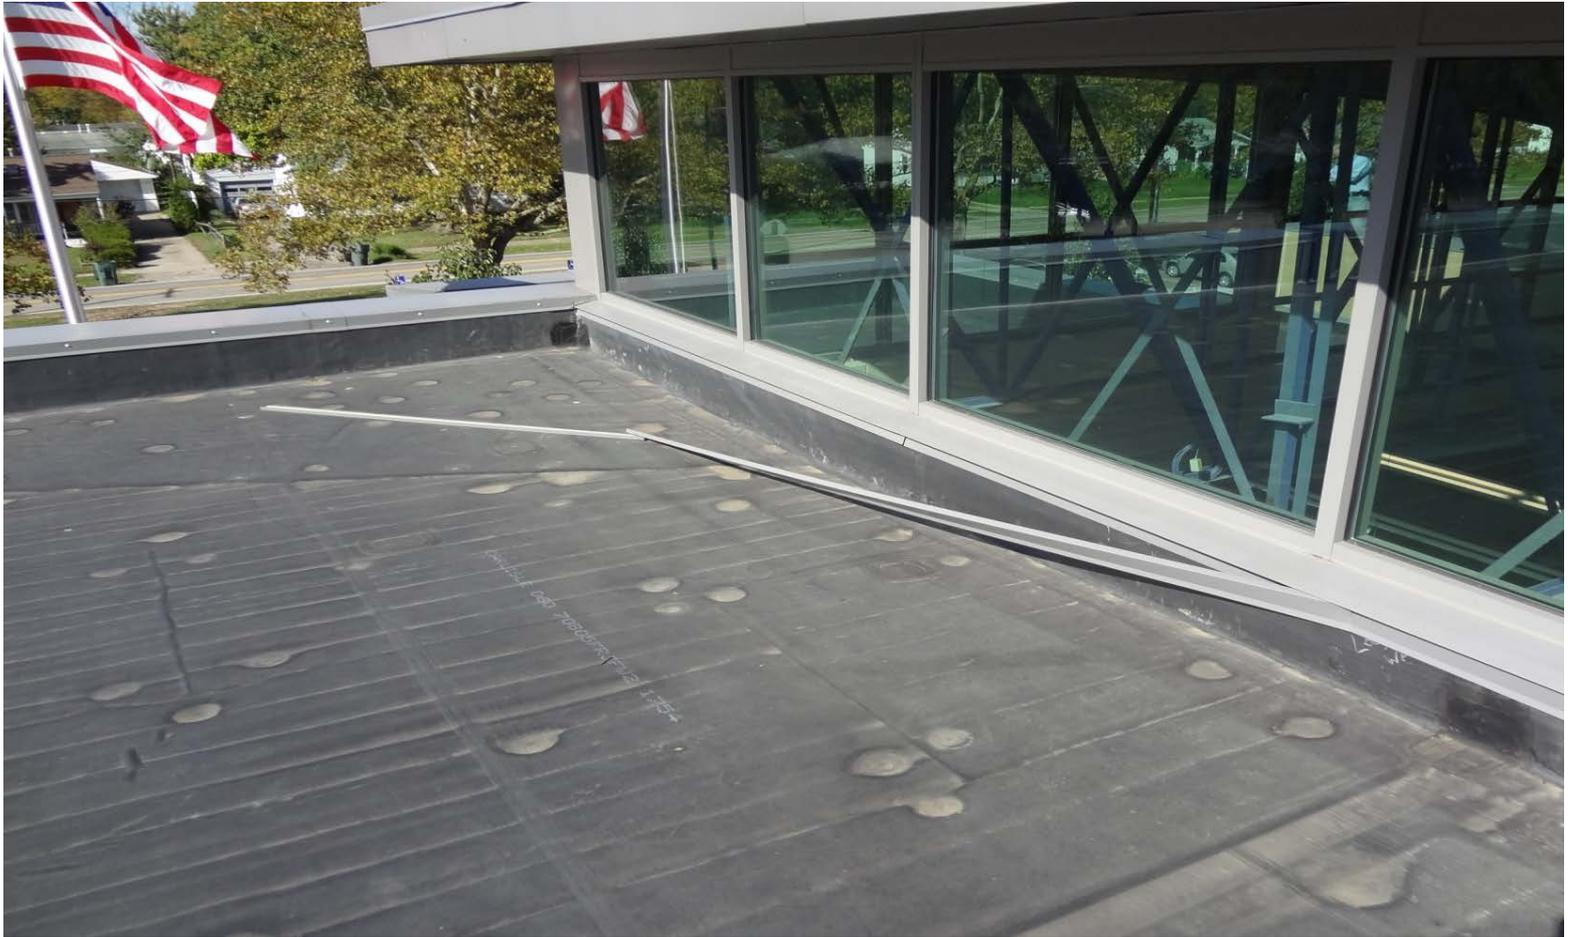
Damaged Flashing

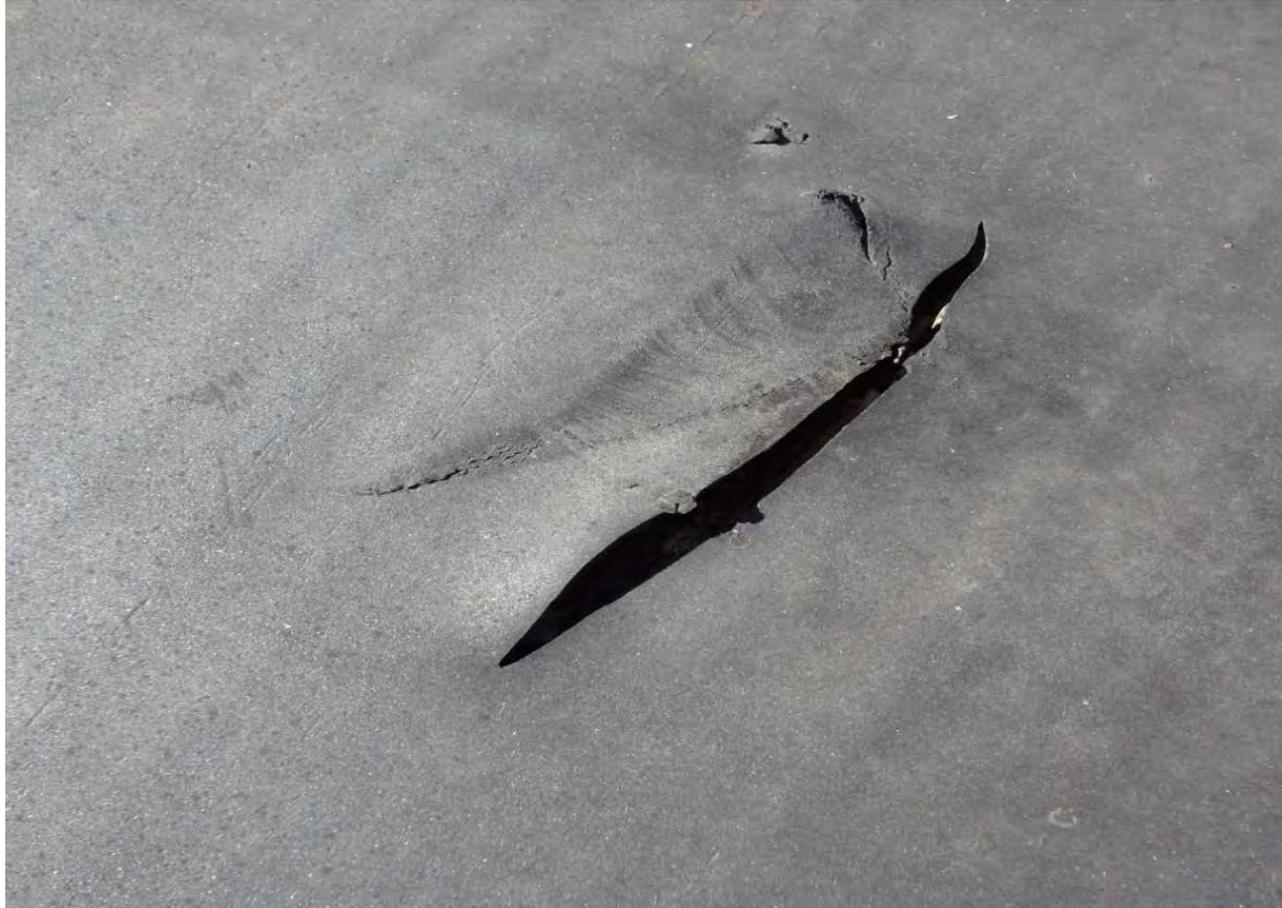
Hole in Membrane

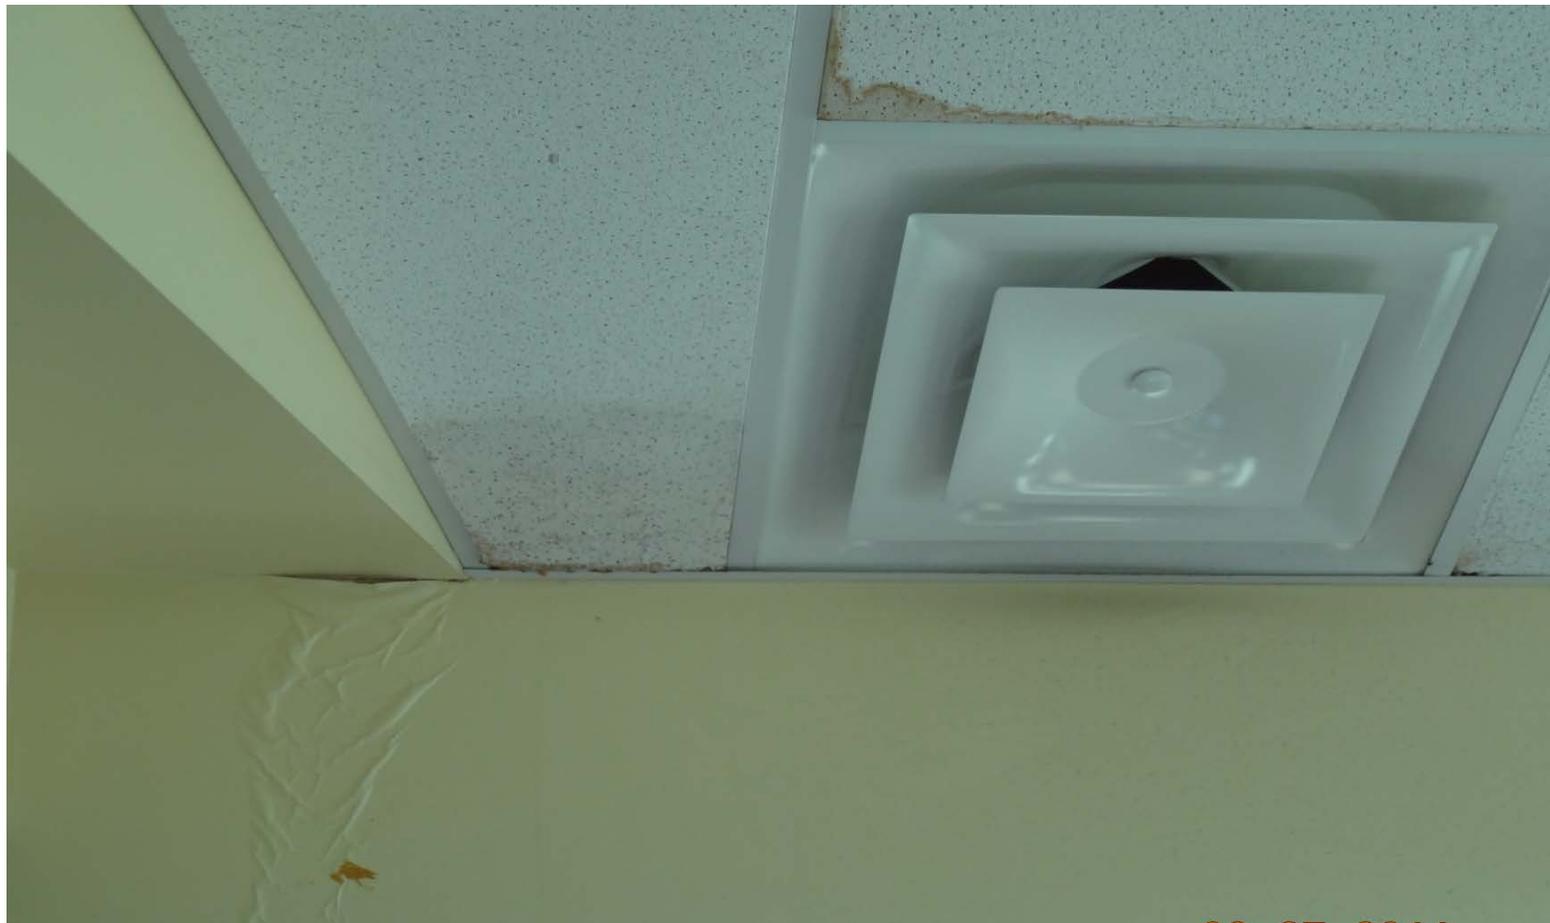
Water Infiltration

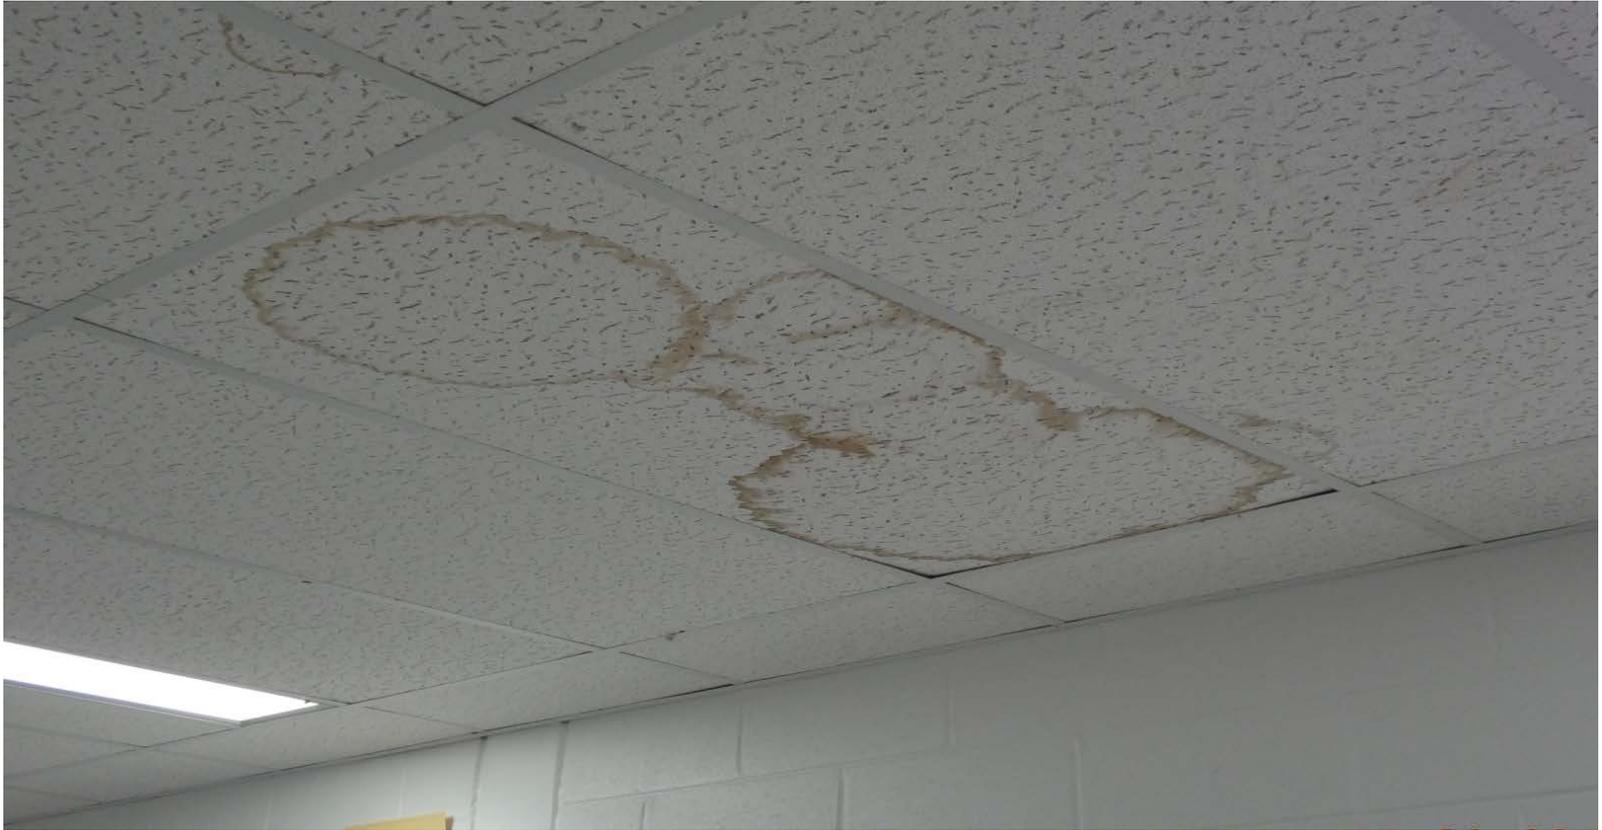
Water Infiltration

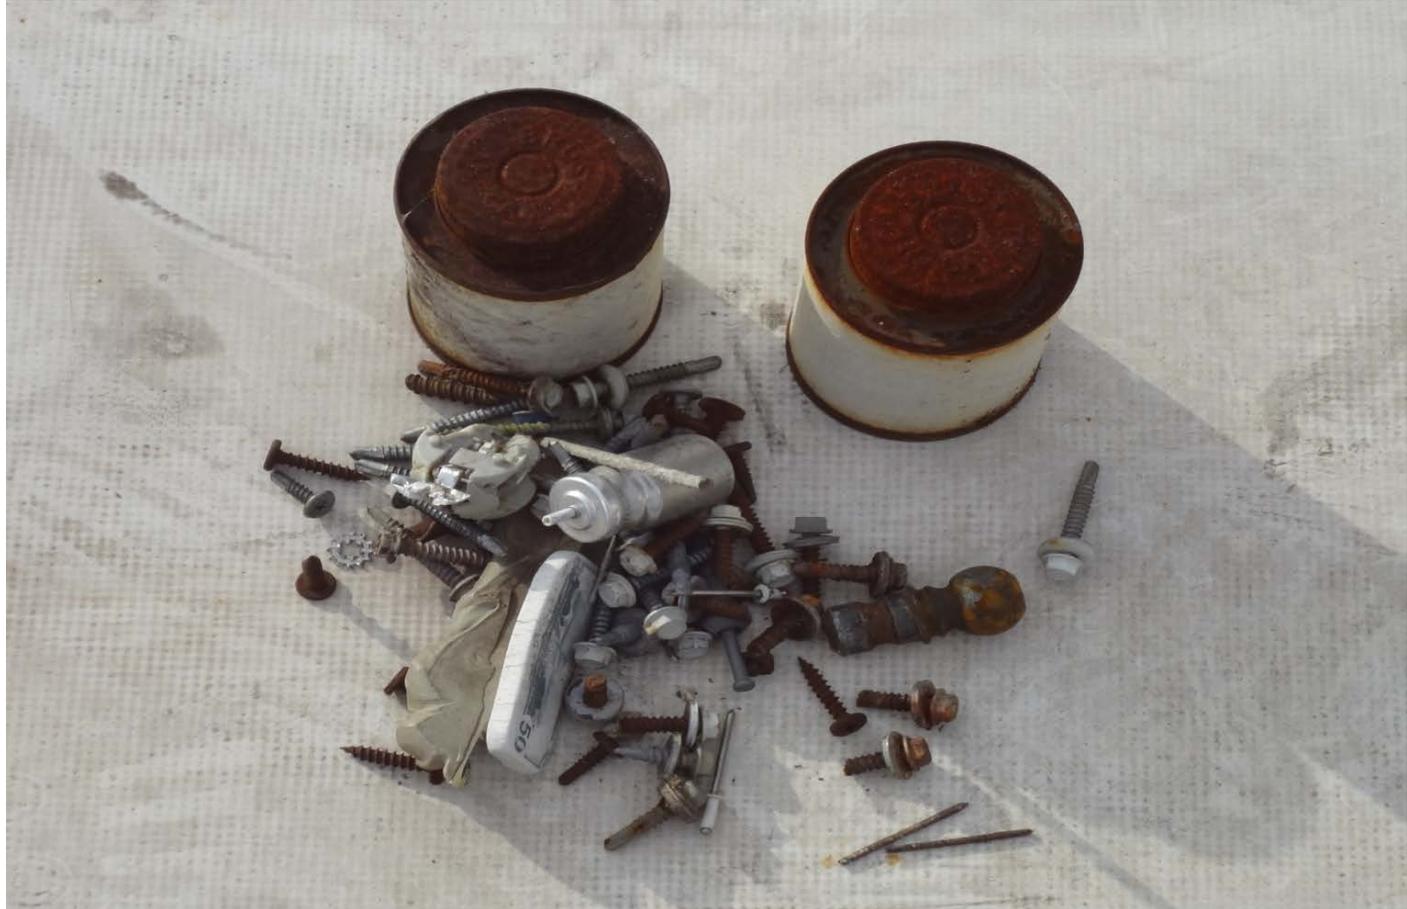
Items Found During a Roof Inspection

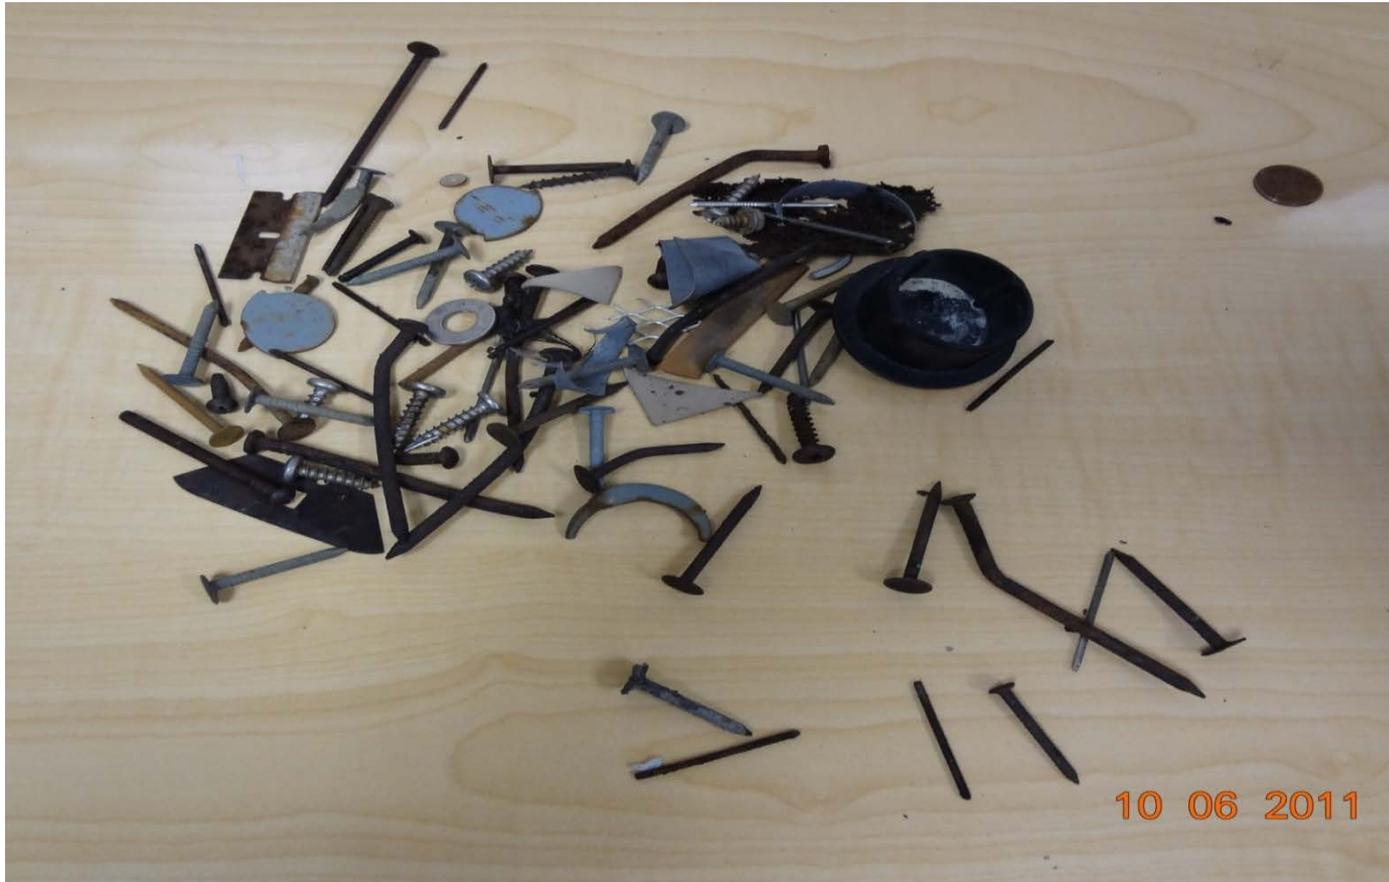
Items Found During Another Roof Inspection

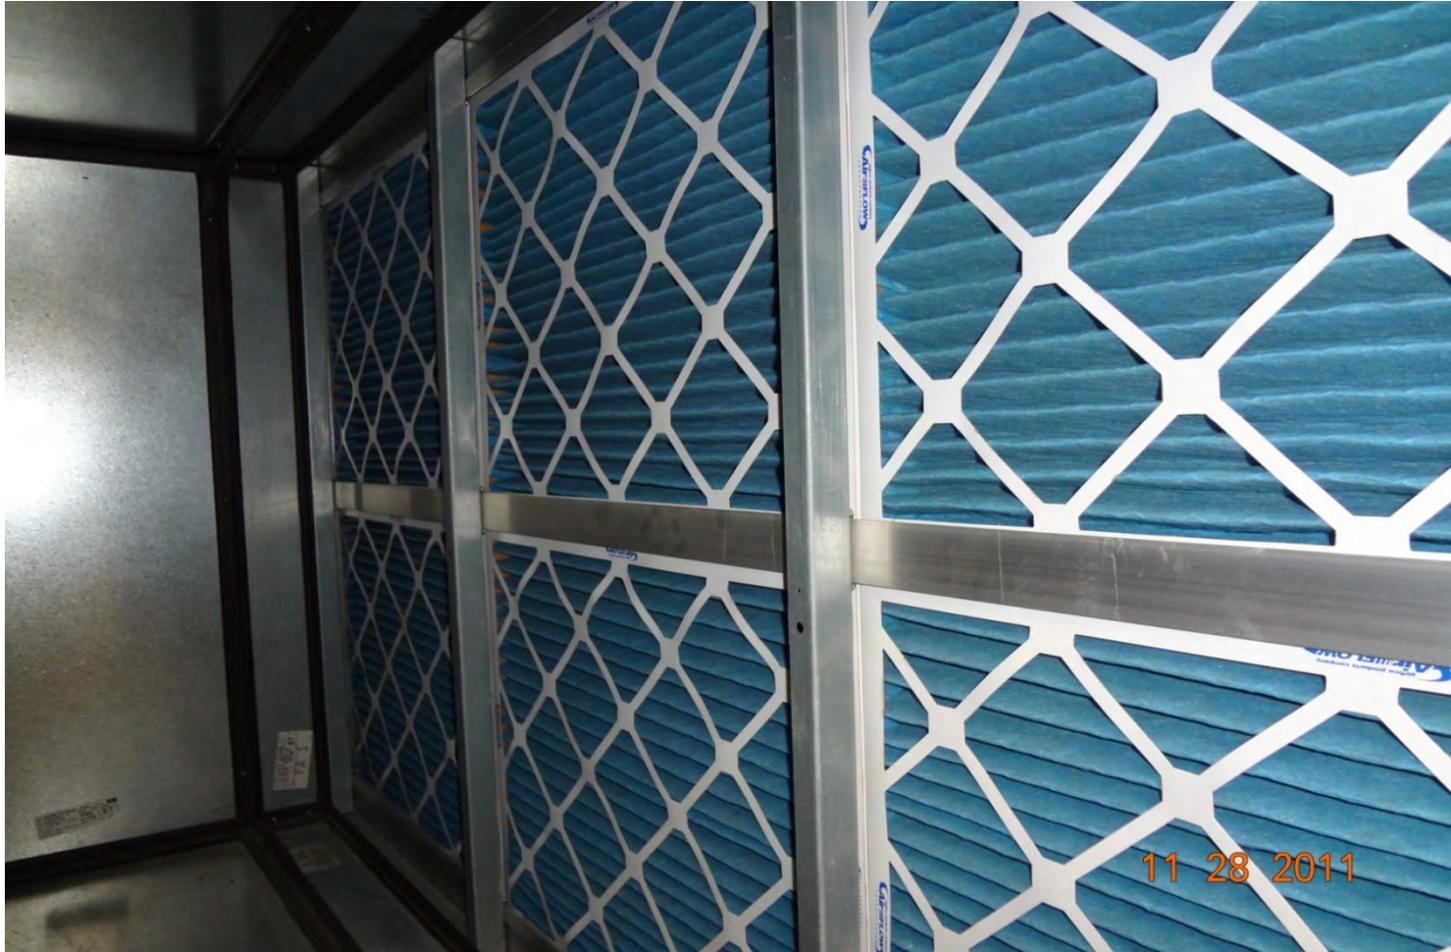
Filter Bank in Excellent Condition

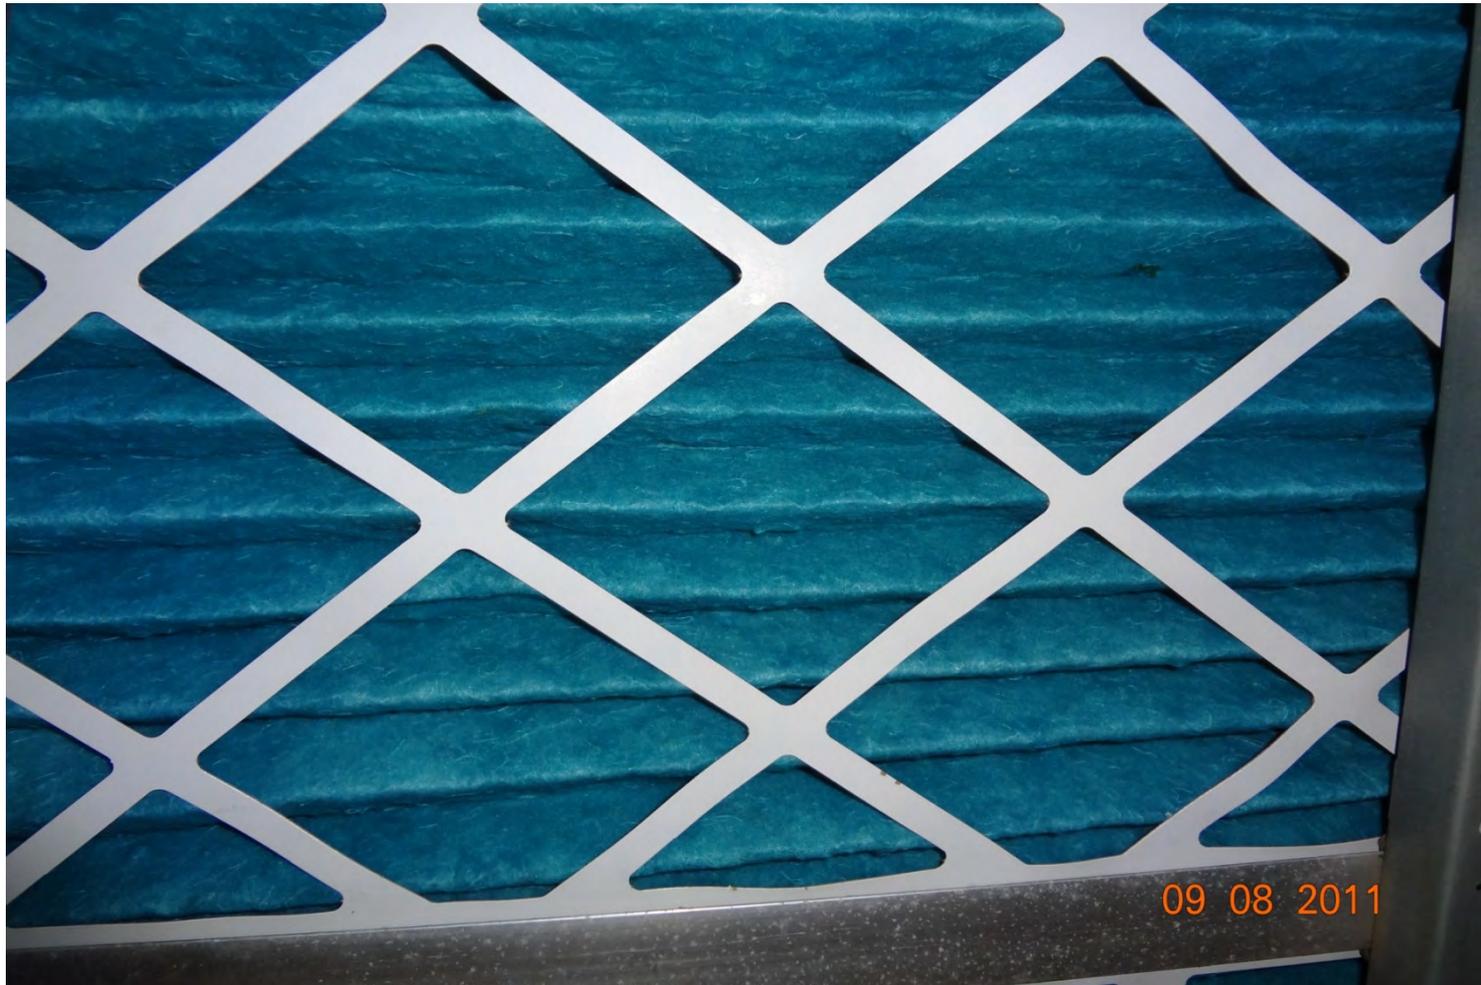
Filter in Excellent Condition

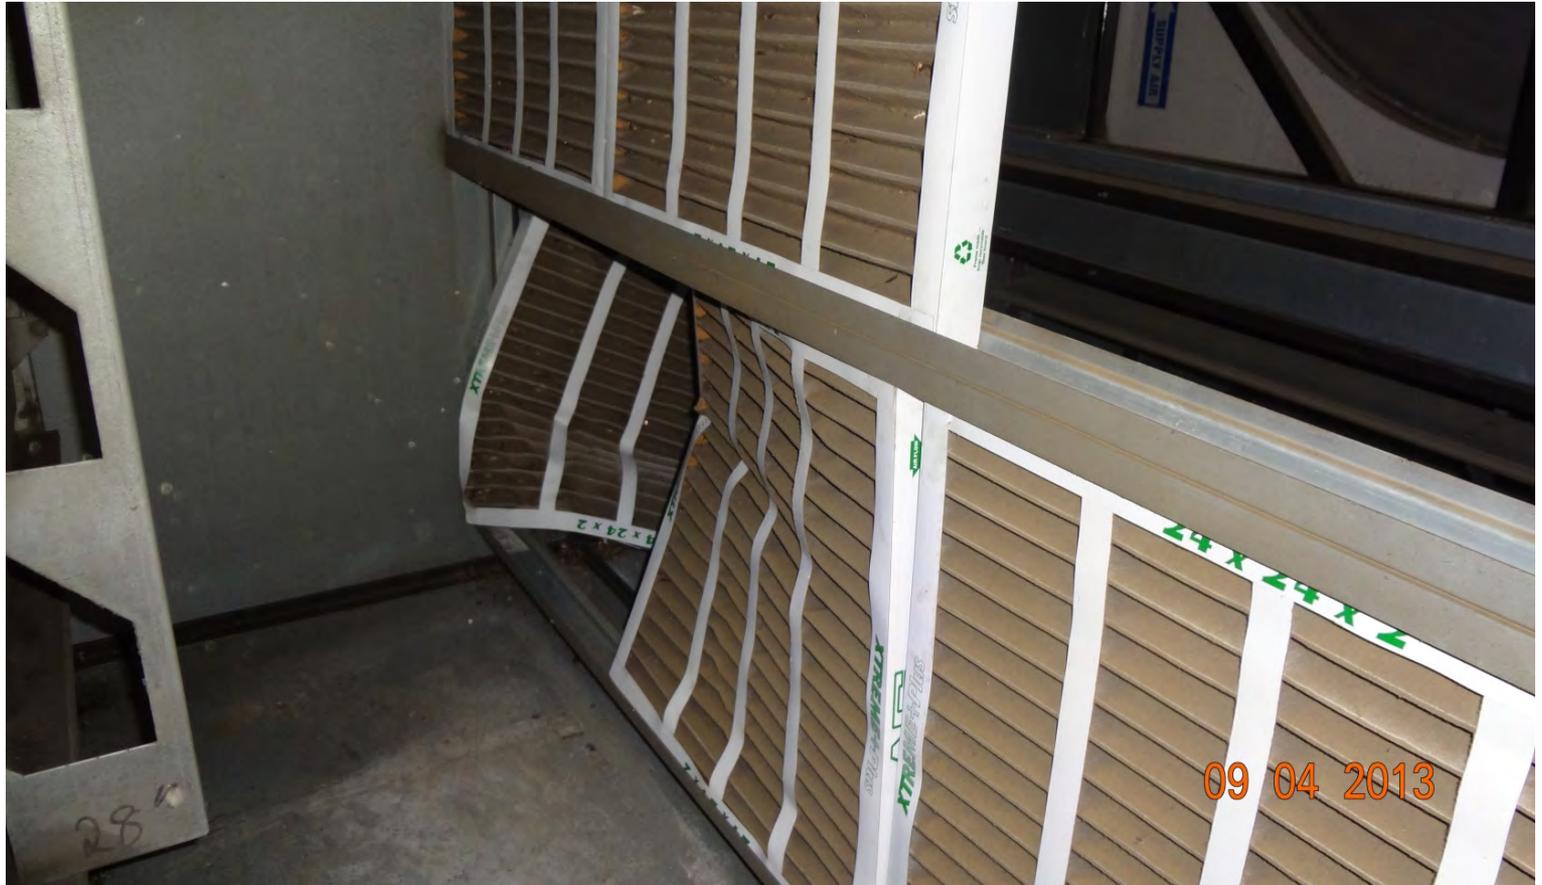
Filter Bank in Poor Condition
