Managing Maintenance and Post Construction Issues

**BASA School Facilities and Safety Conference
March 15, 2017**

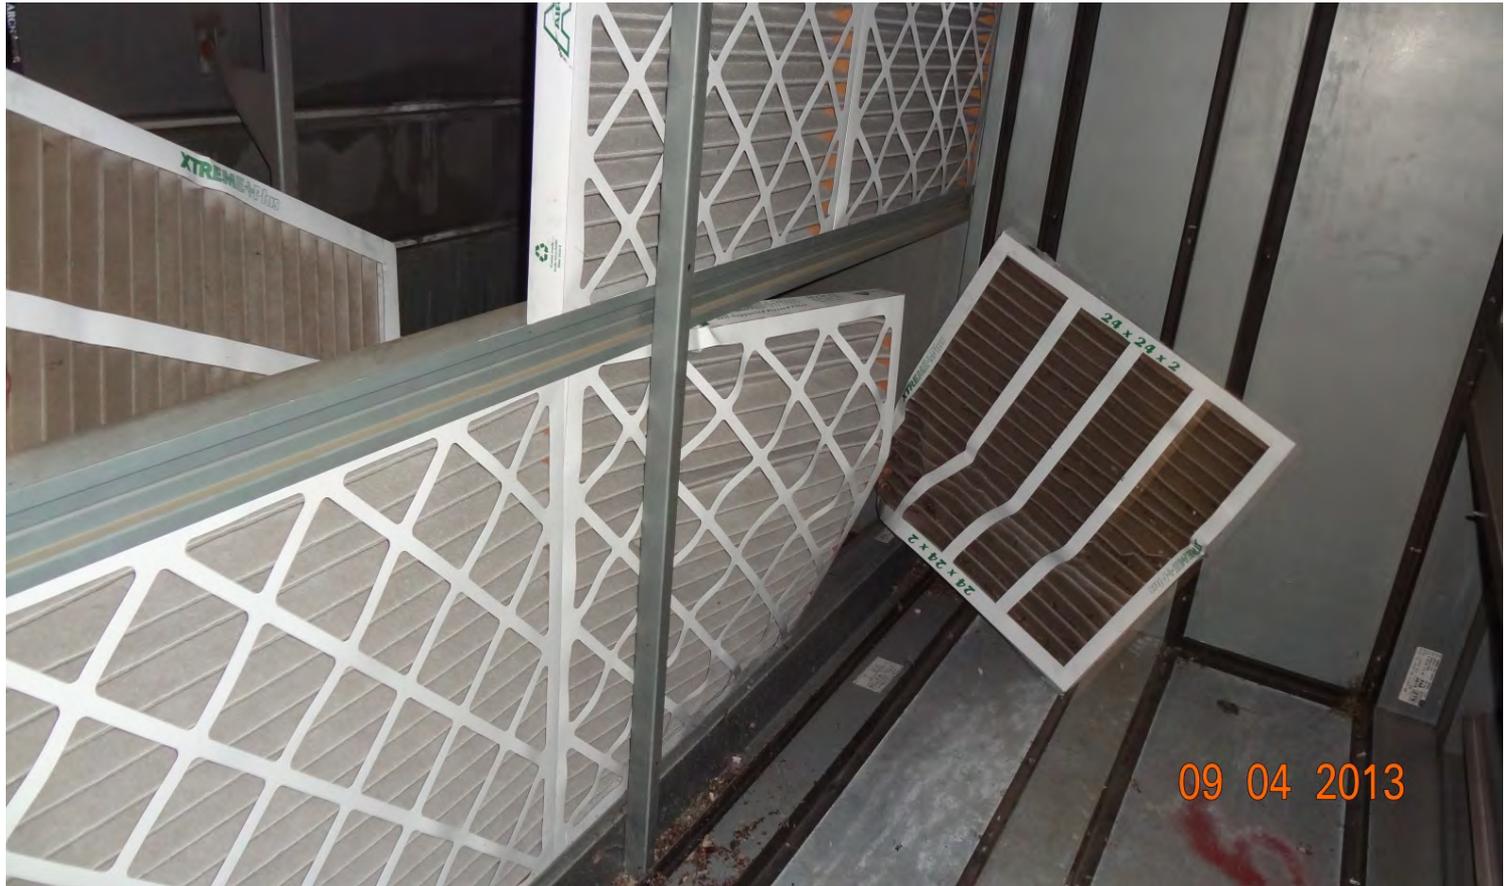
Filter Bank in Poor Condition

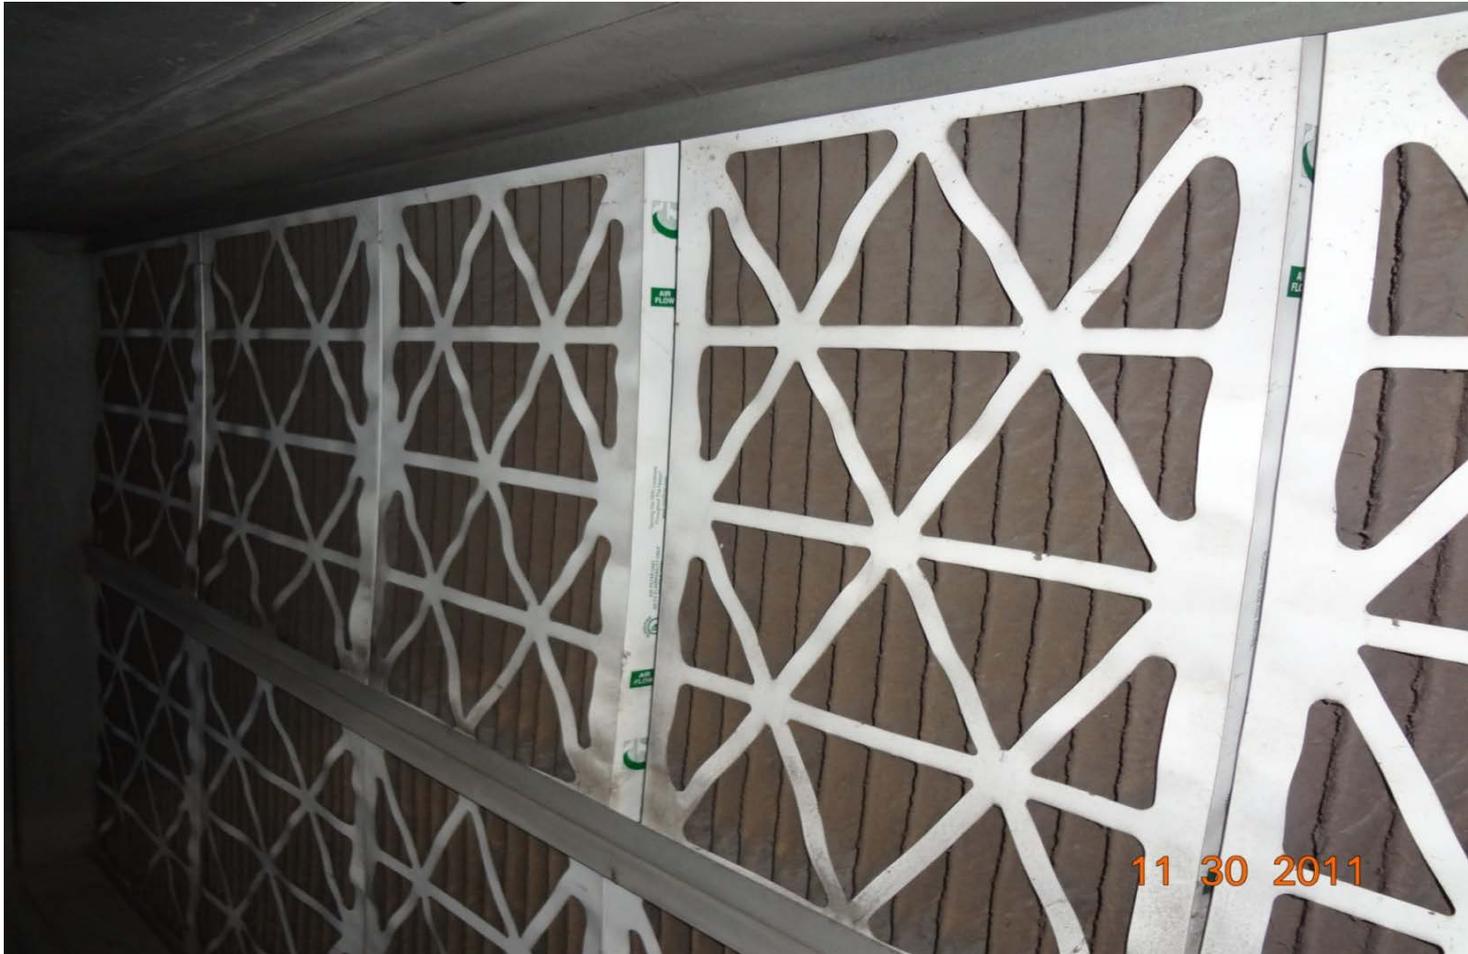
Filter Bank in Poor Condition

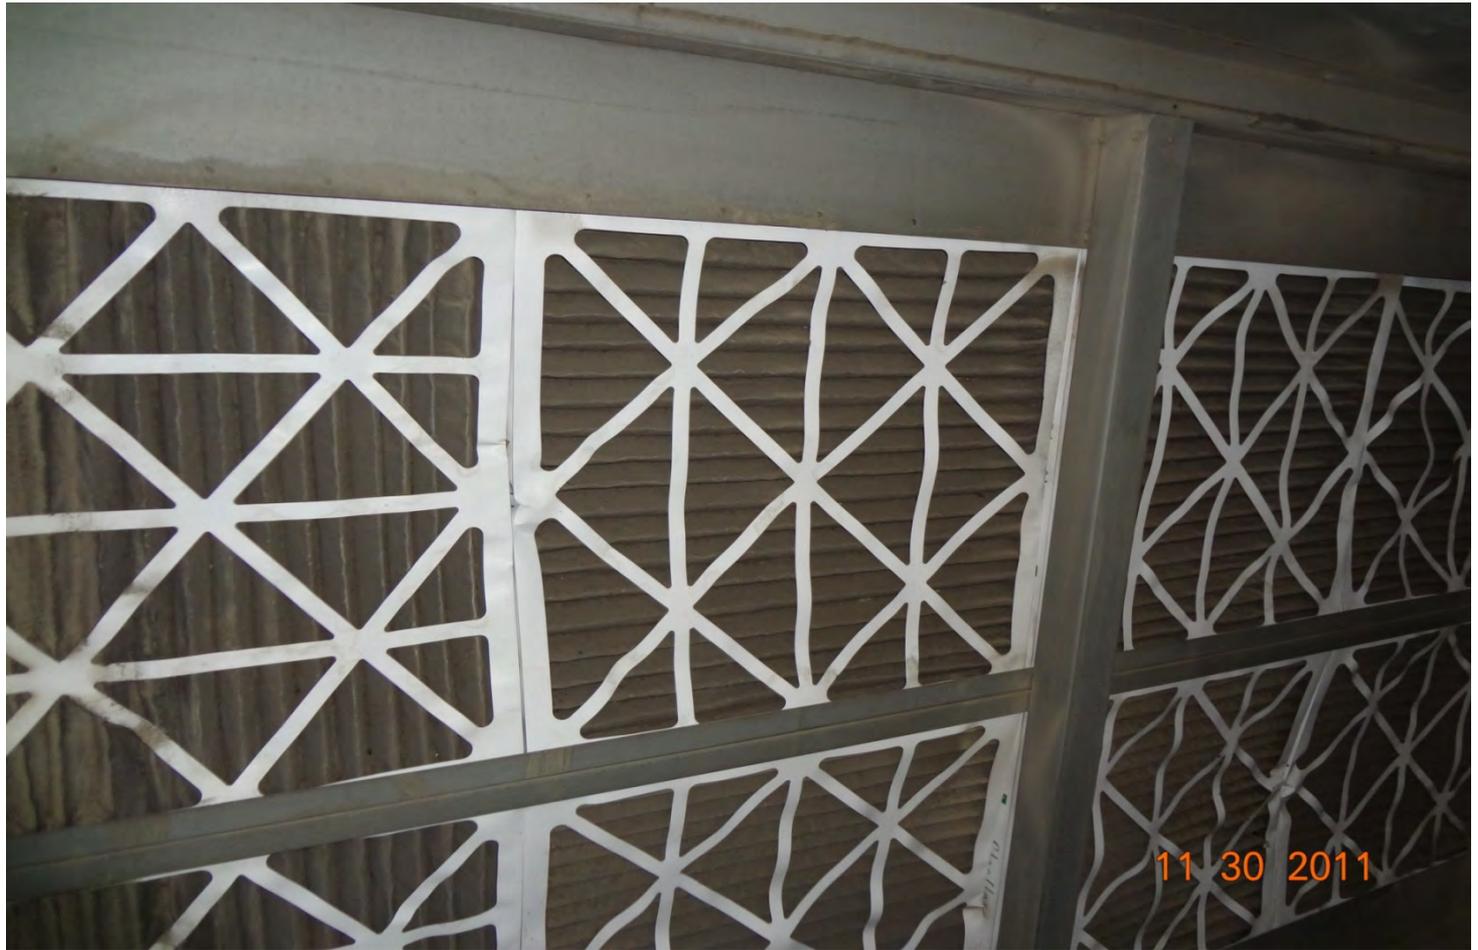
Filter Bank in Poor Condition

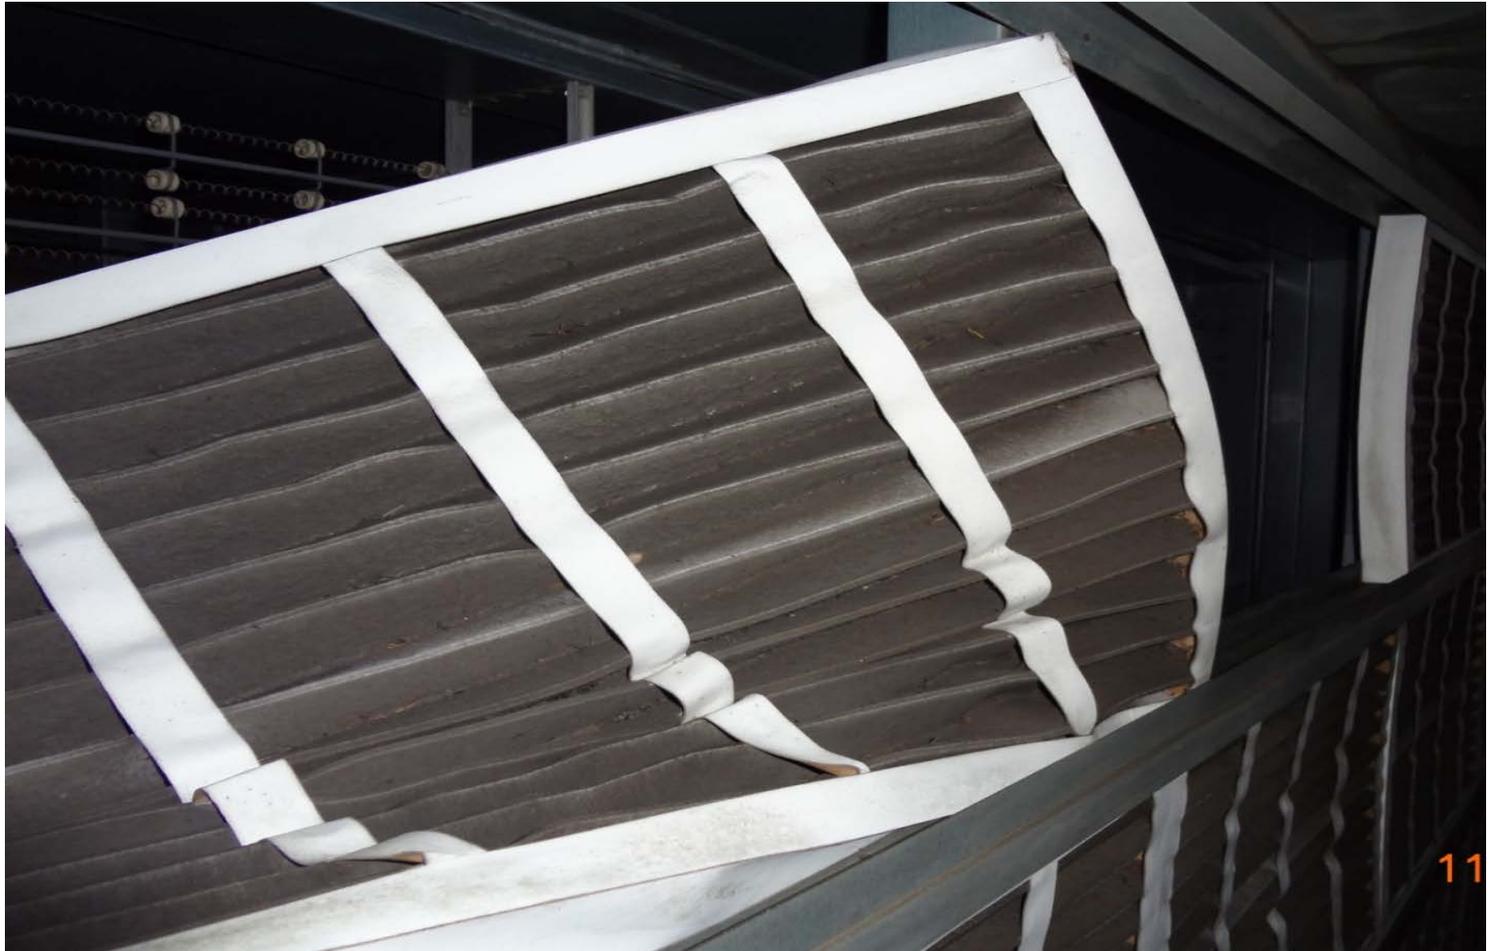
Filter Bank in Poor Condition

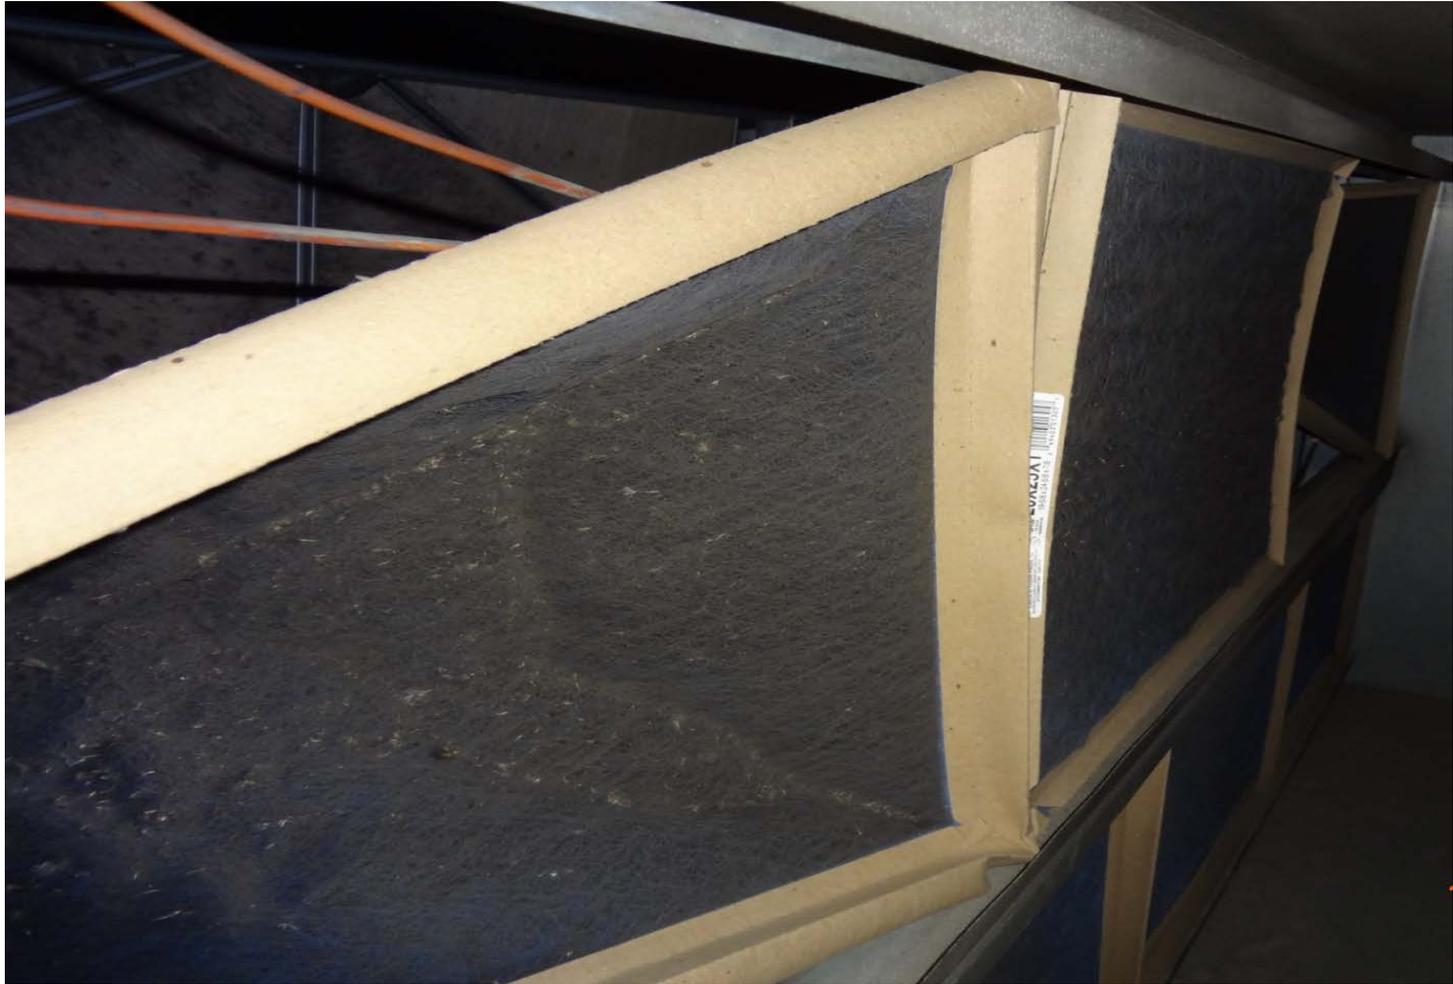
Incorrect Type of Filters for AHU

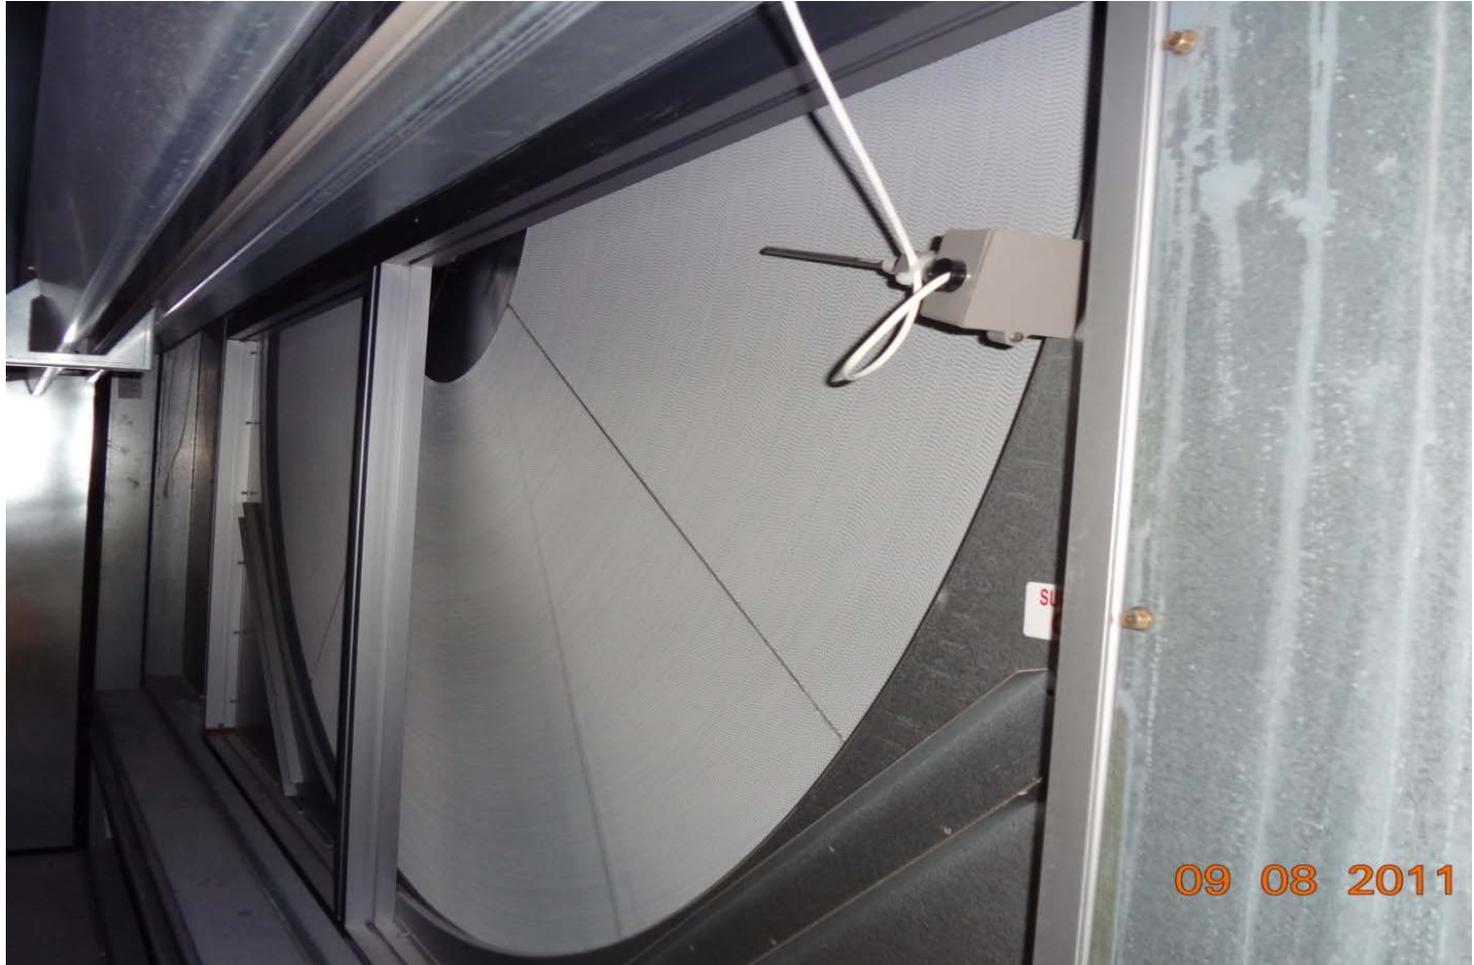
Heat Wheel in Good Condition

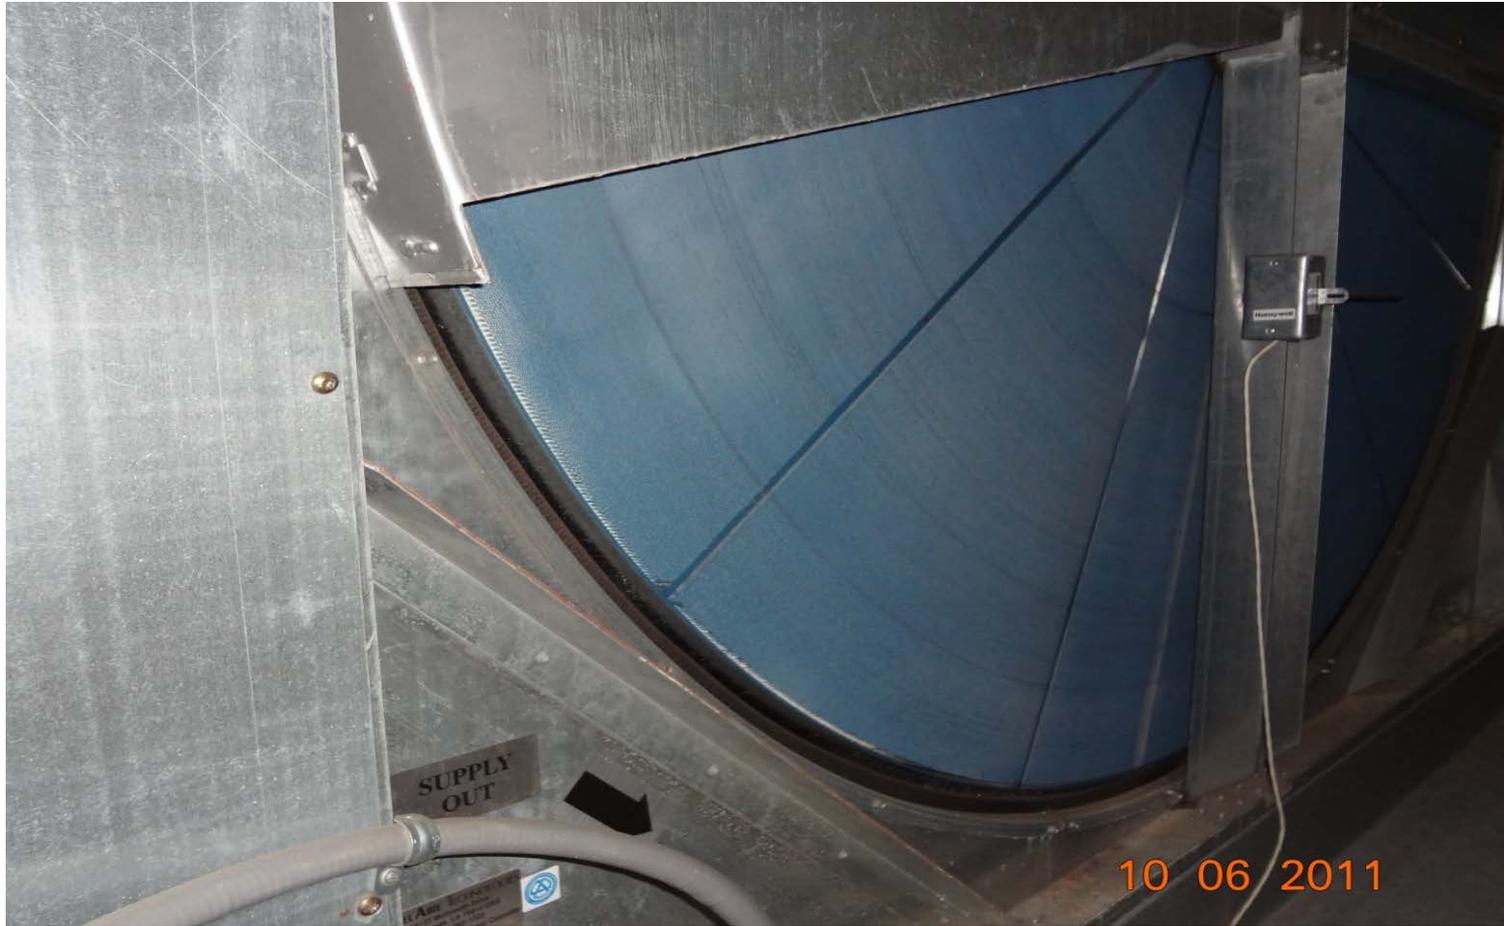
Heat Wheel in Good Condition

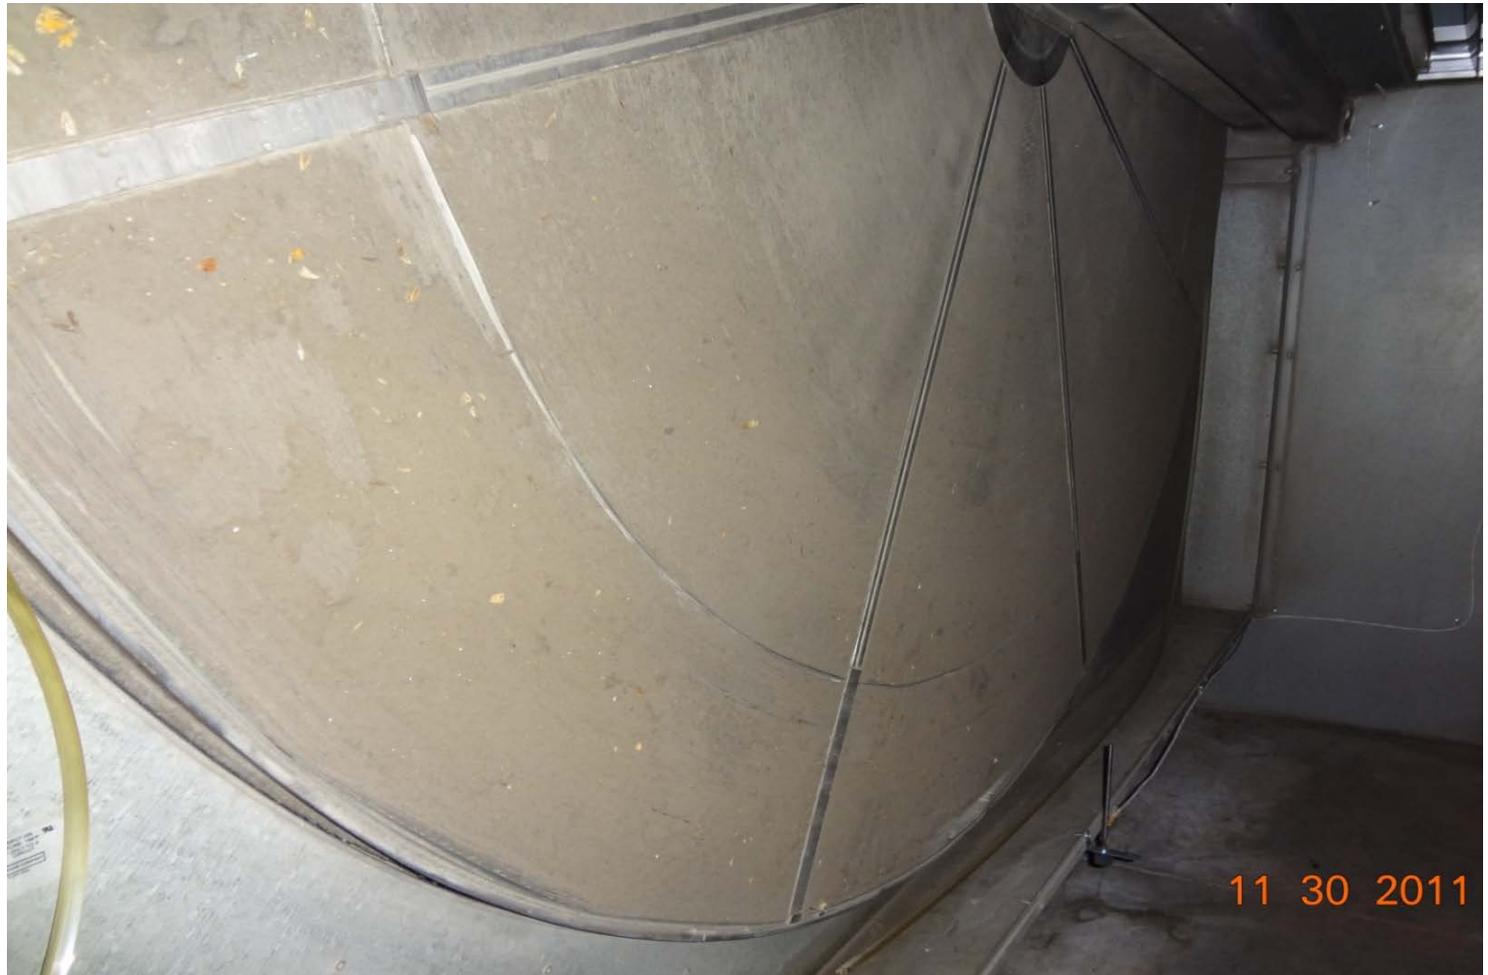
Heat Wheel in Poor Condition

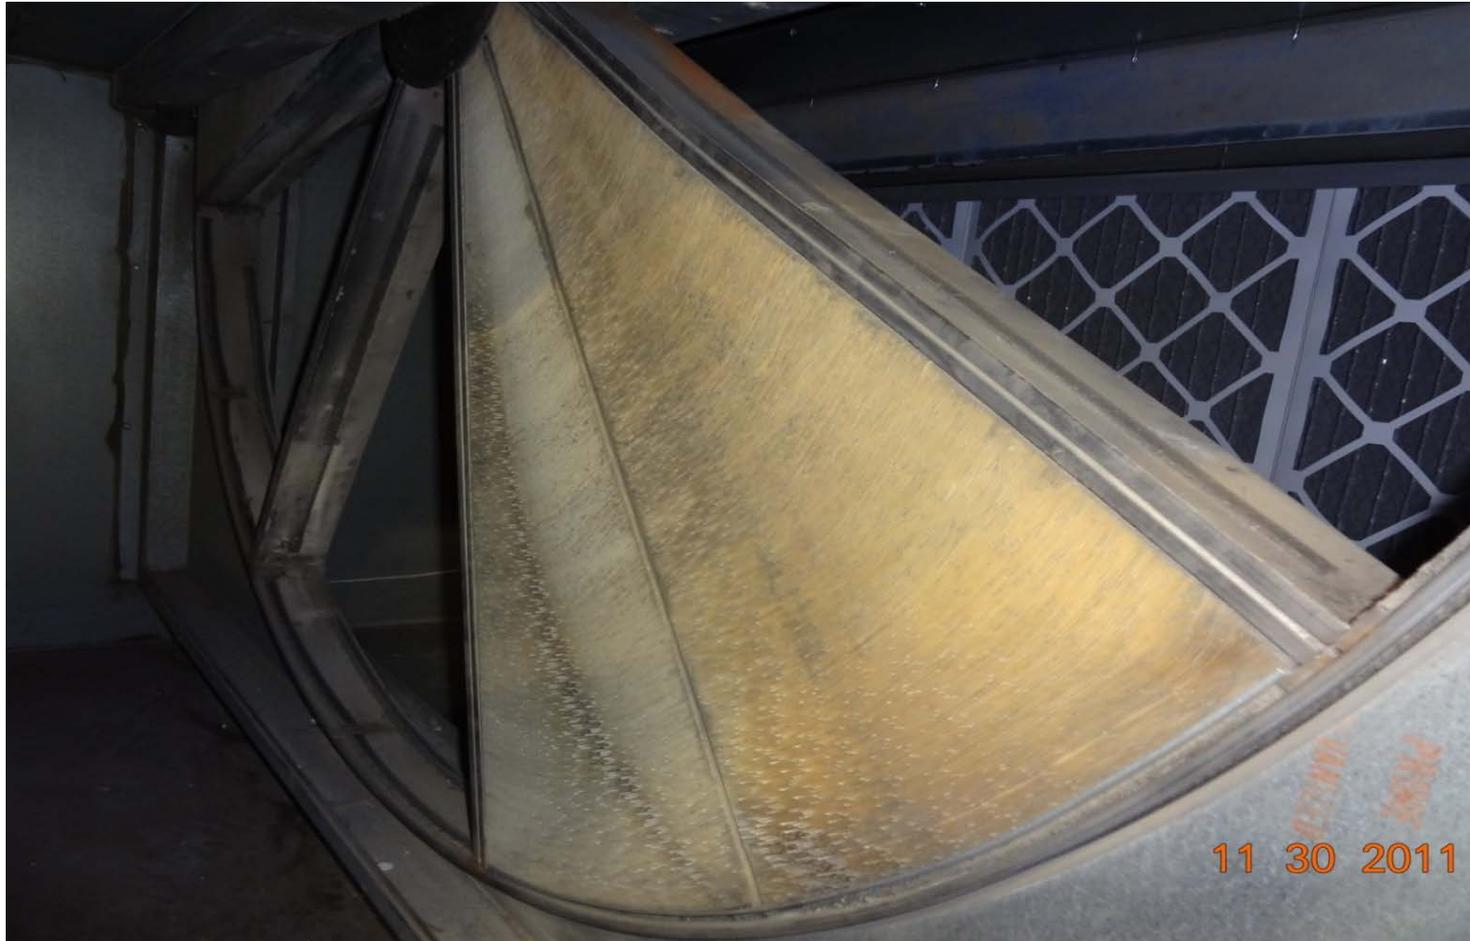
Heat Wheel in Very Poor Condition

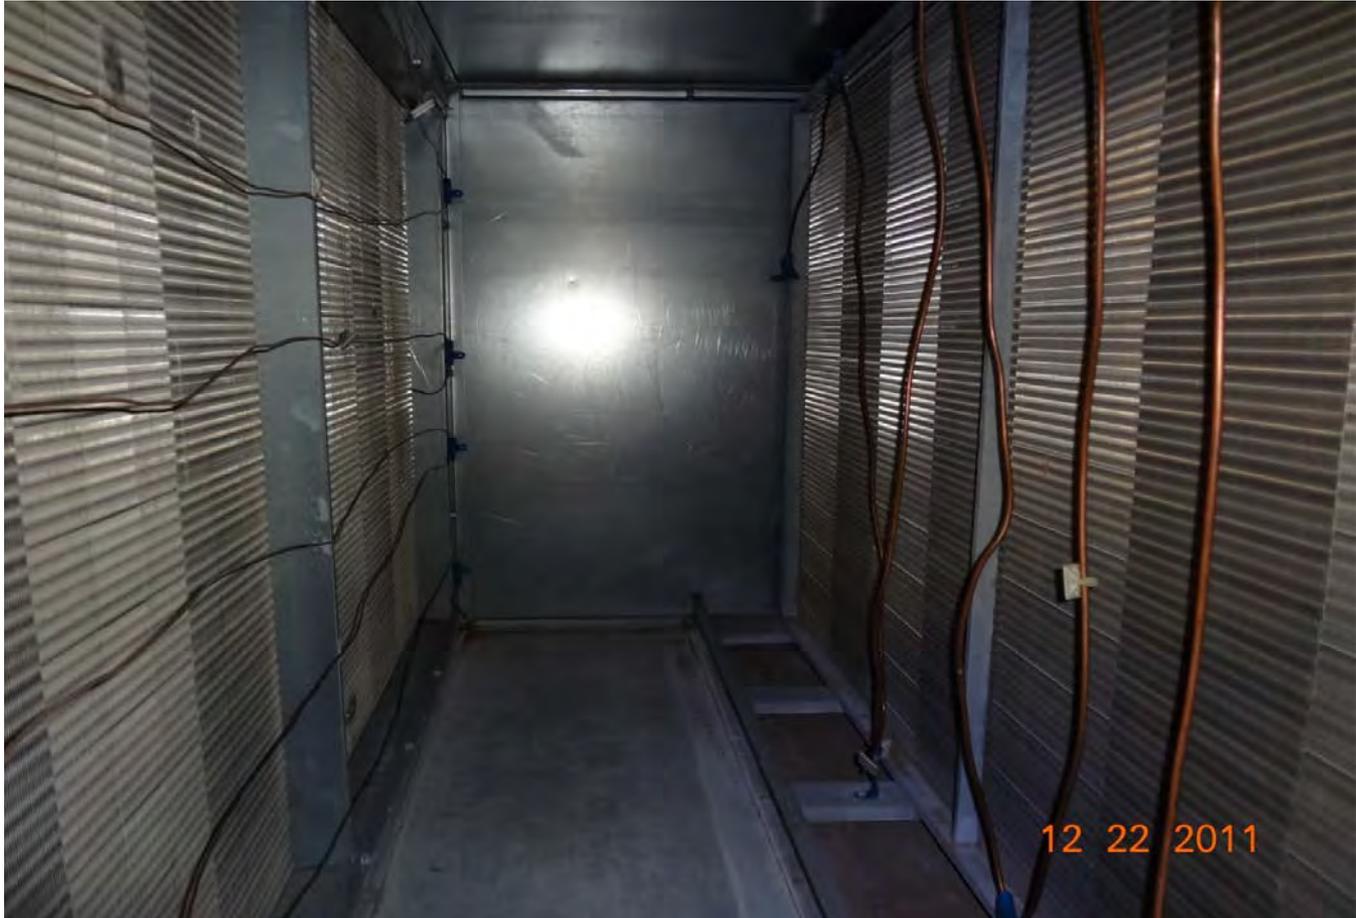
Inside AHU: Coils Excellent Condition

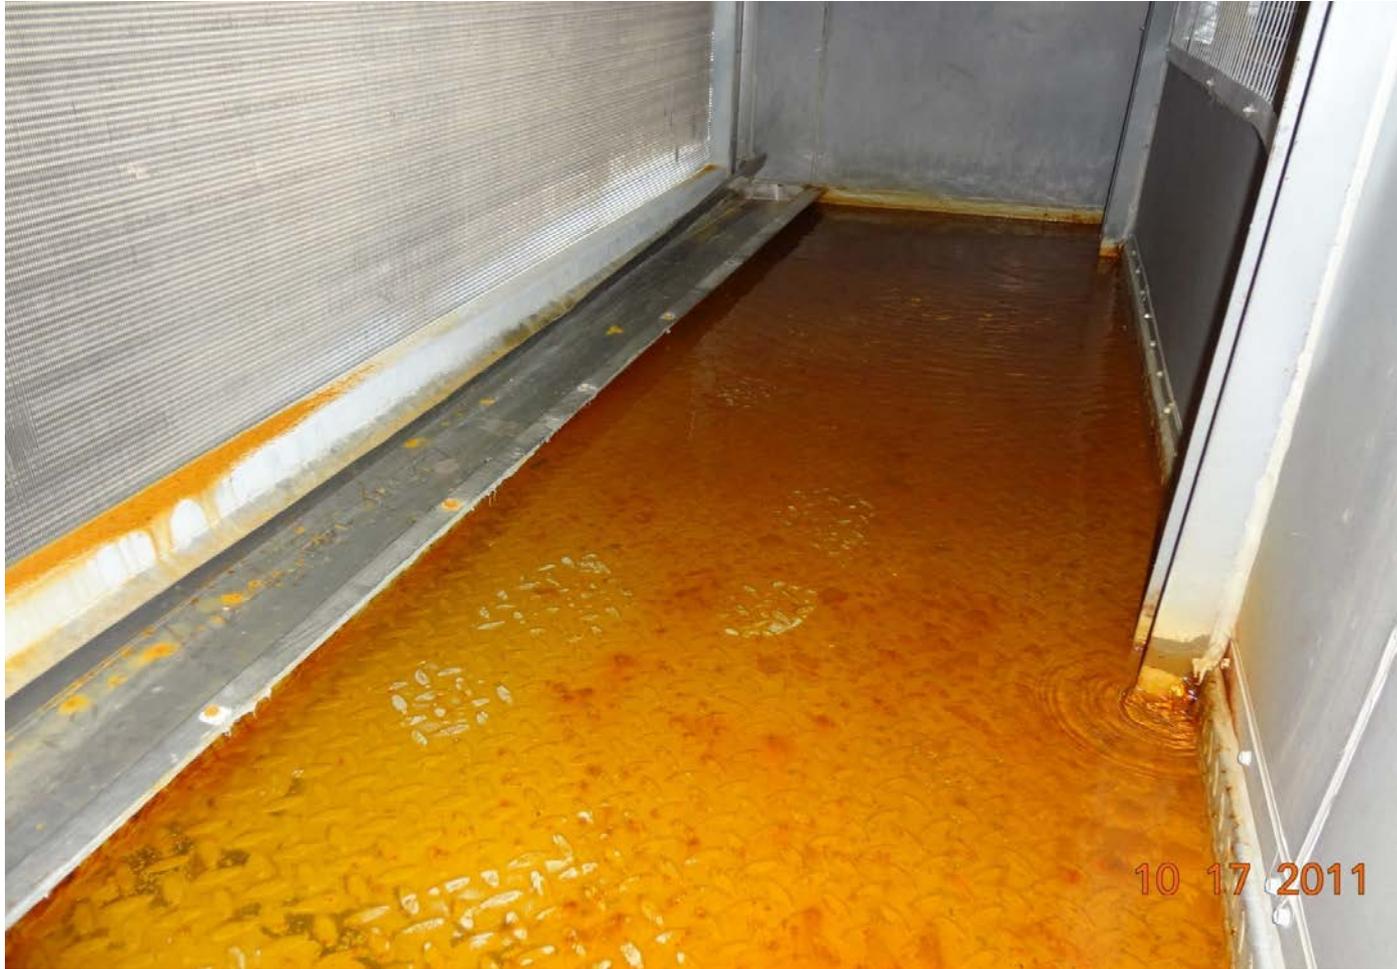
Sign of a Problem

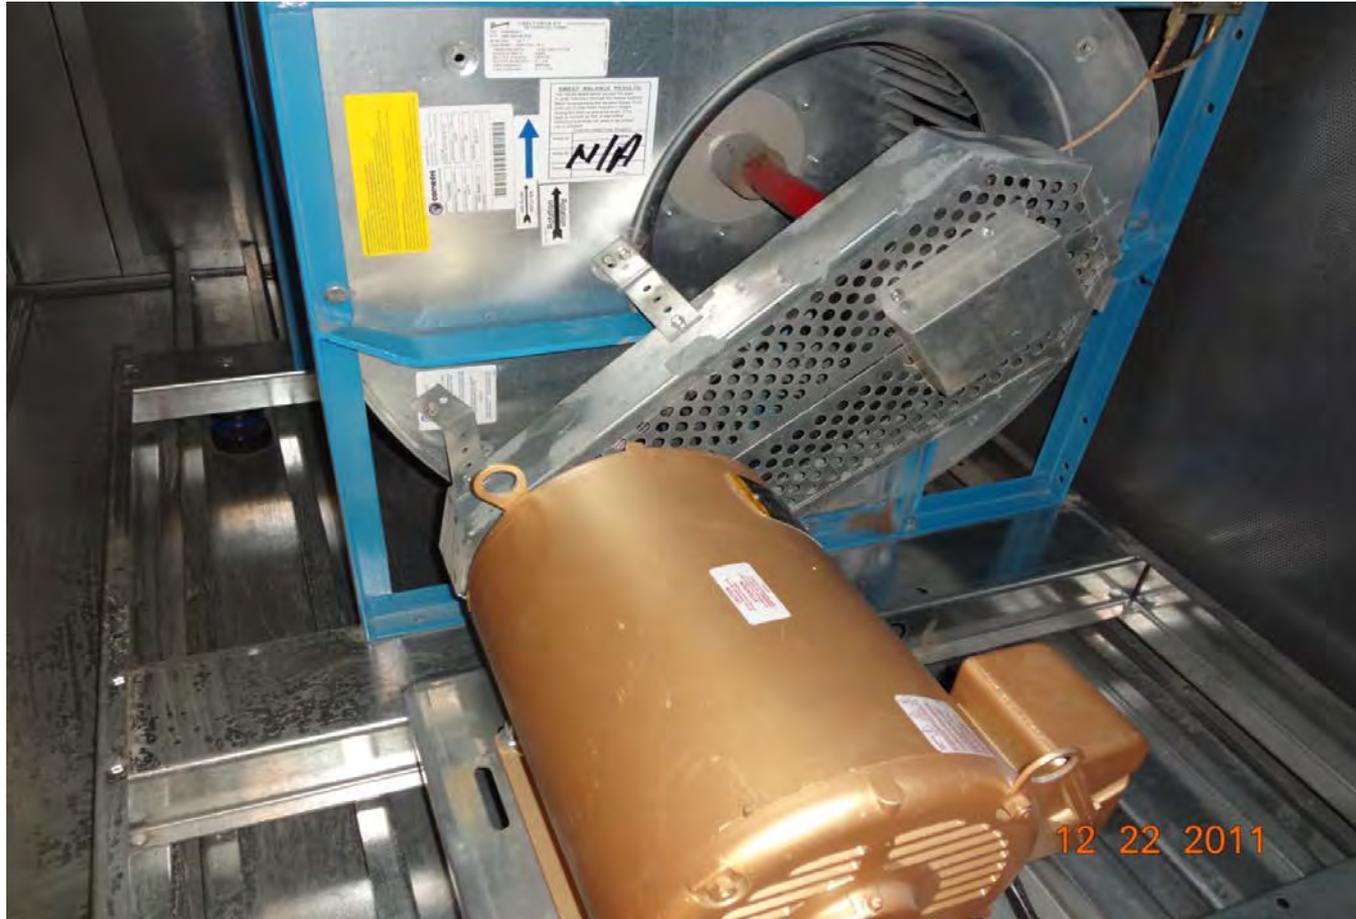
Inside AHU: Excellent Condition

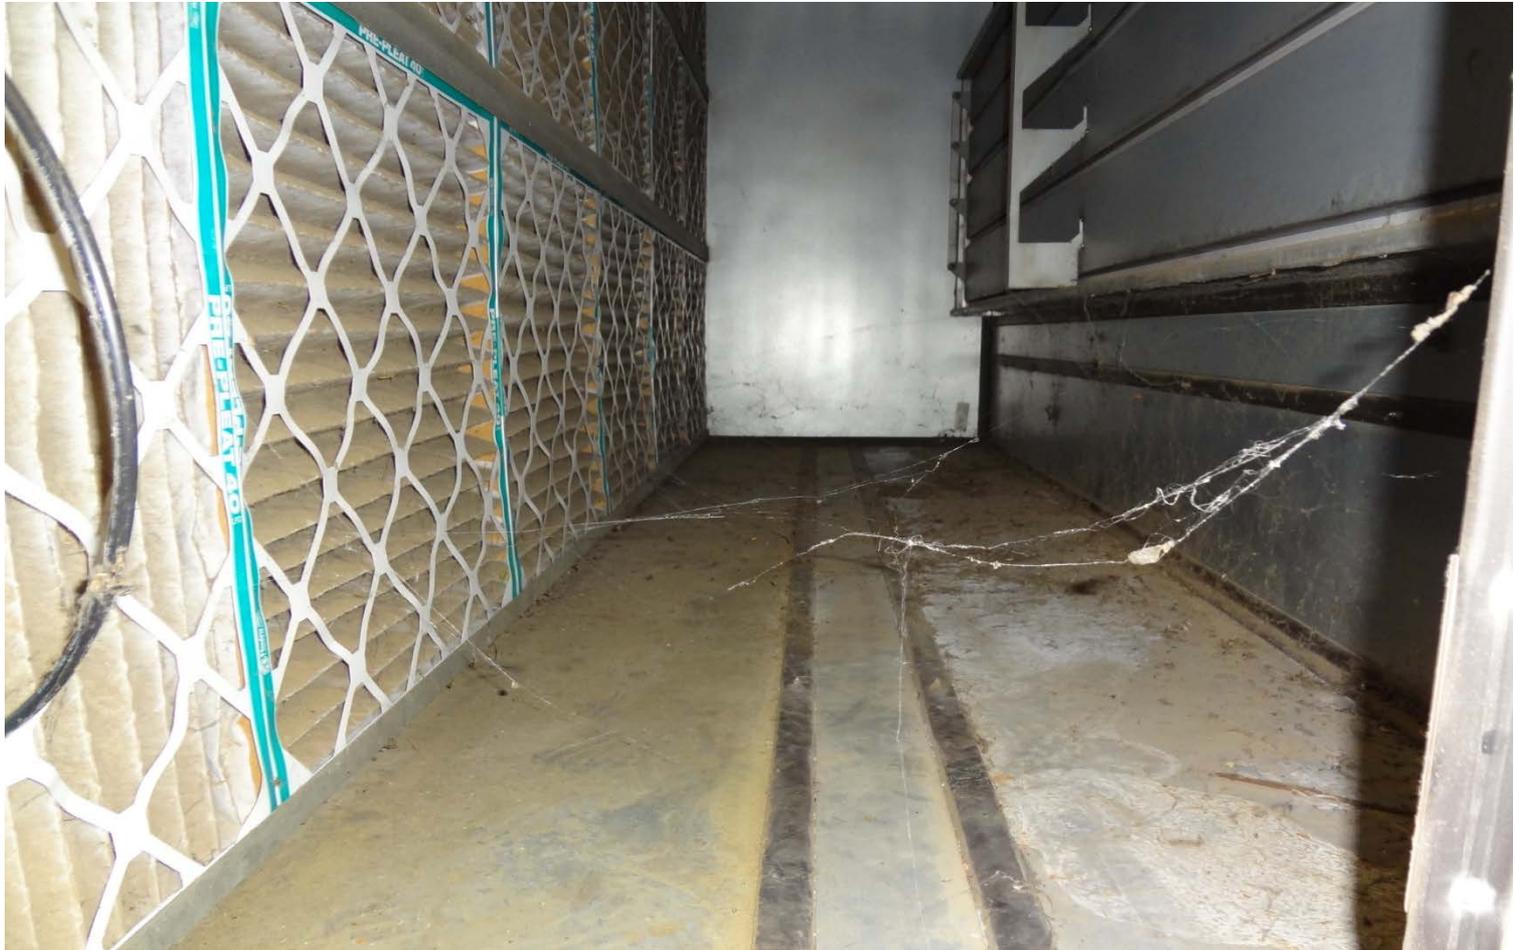
Inside AHU: Poor Condition

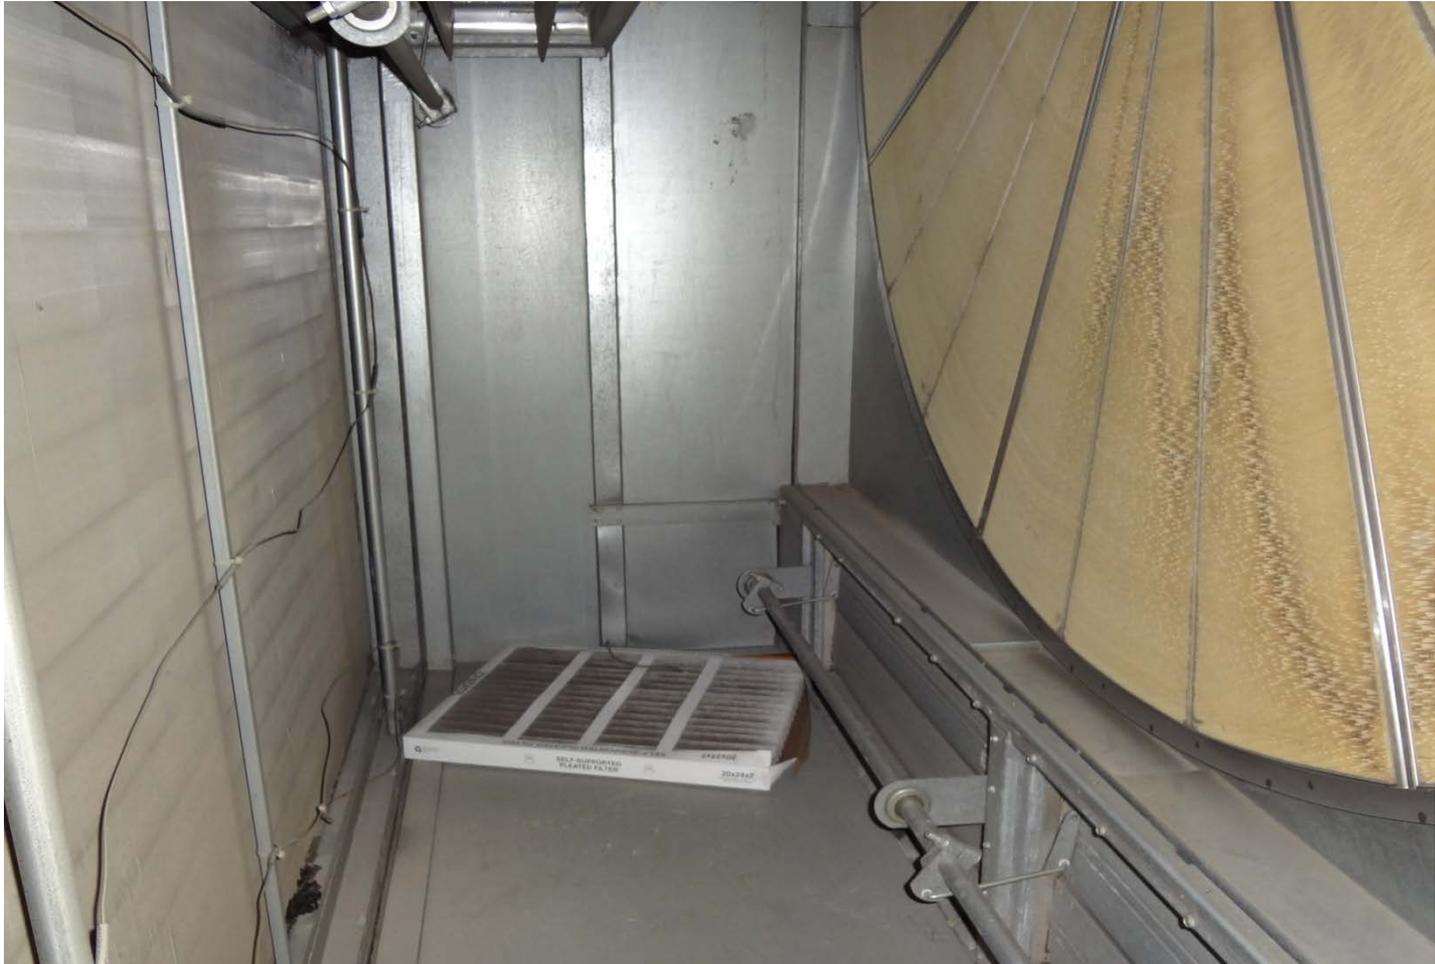
Dirty Filter Thrown Inside AHU. Why?

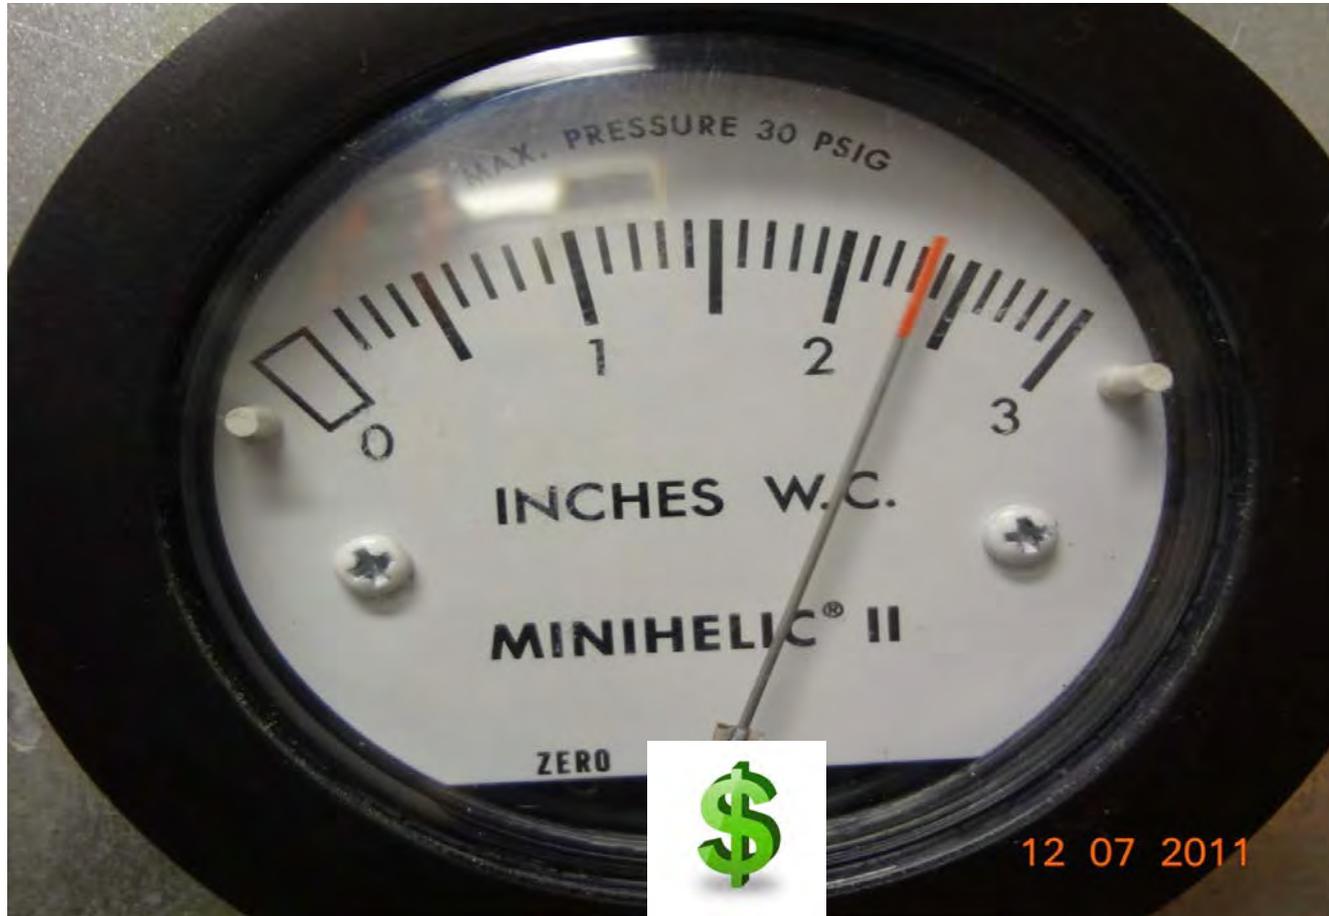
Reduced Air Flow Inside the AHU

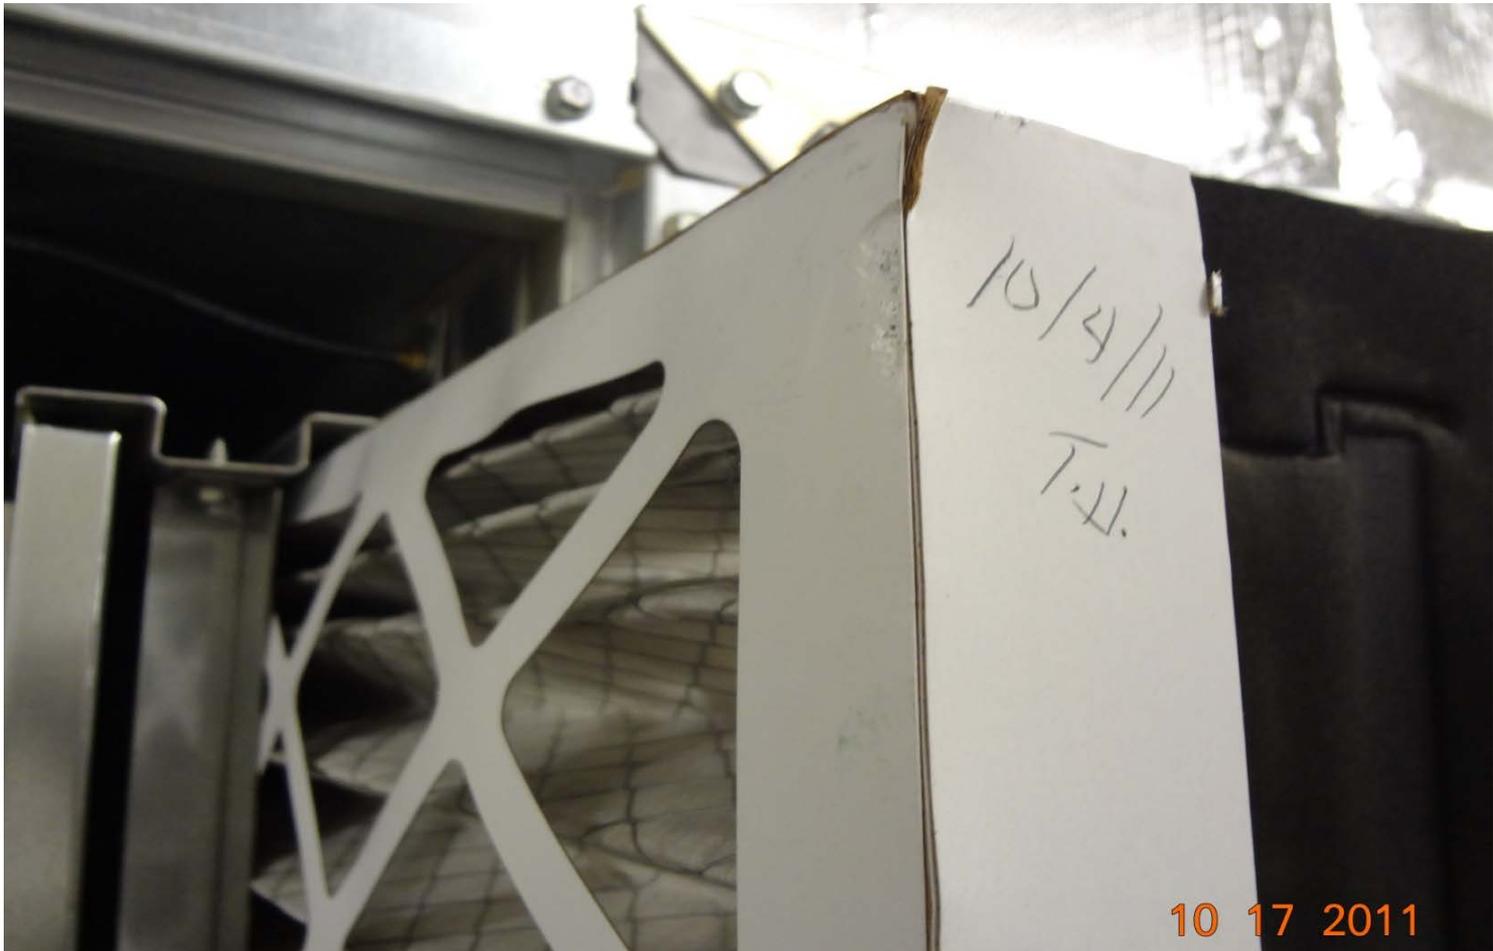
Always Date the Filter Change

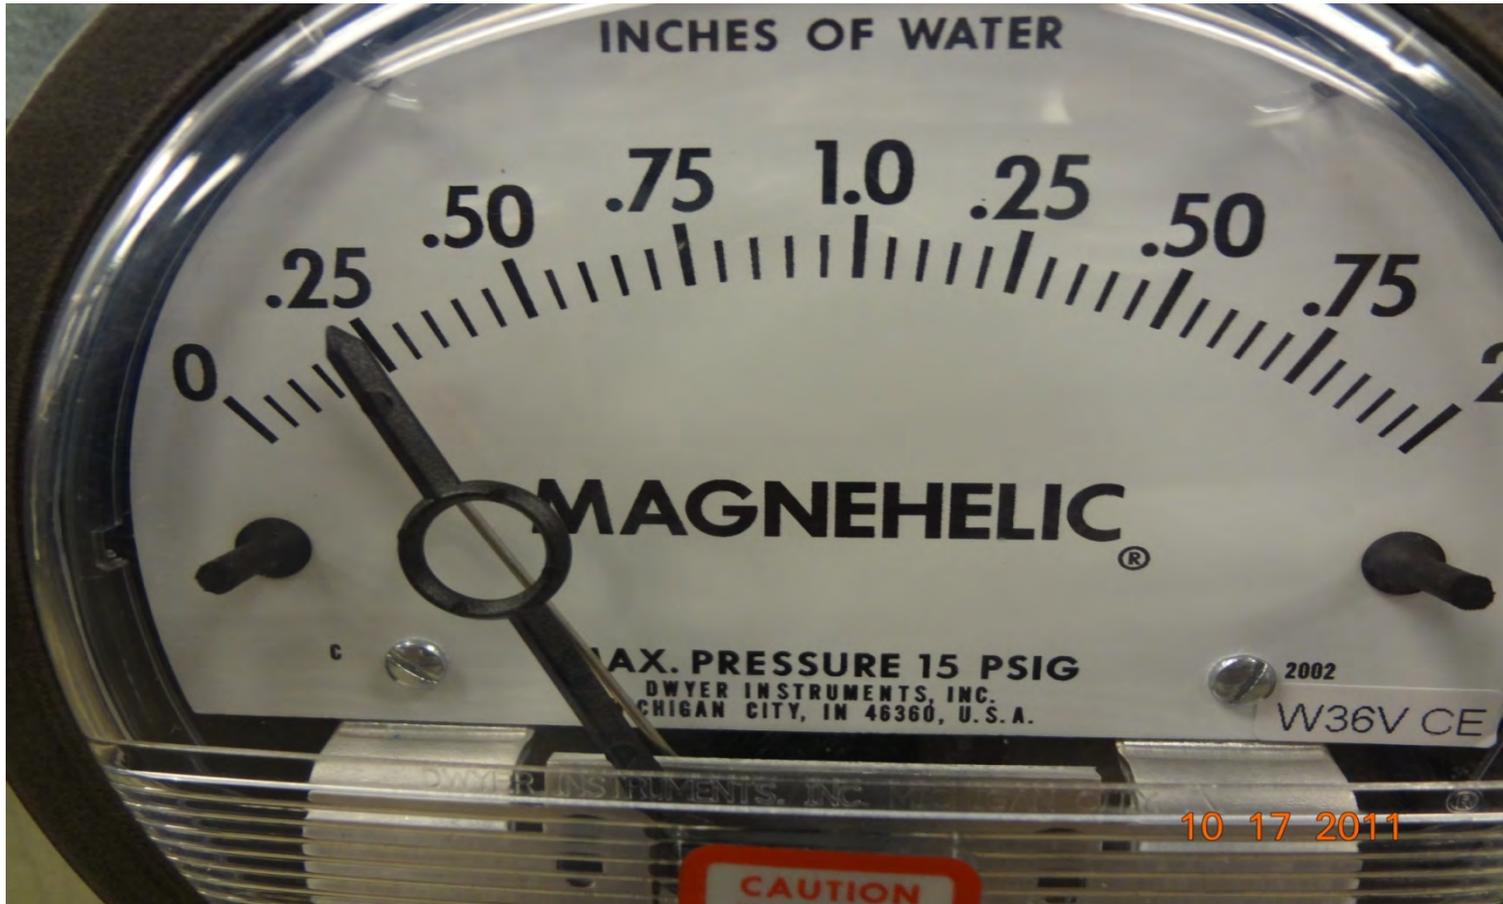
Gauges/BAS Alarms DO NOT Replace Need for Inspection
