Managing Maintenance and Post Construction Issues

**BASA School Facilities and Safety Conference
March 15, 2017**

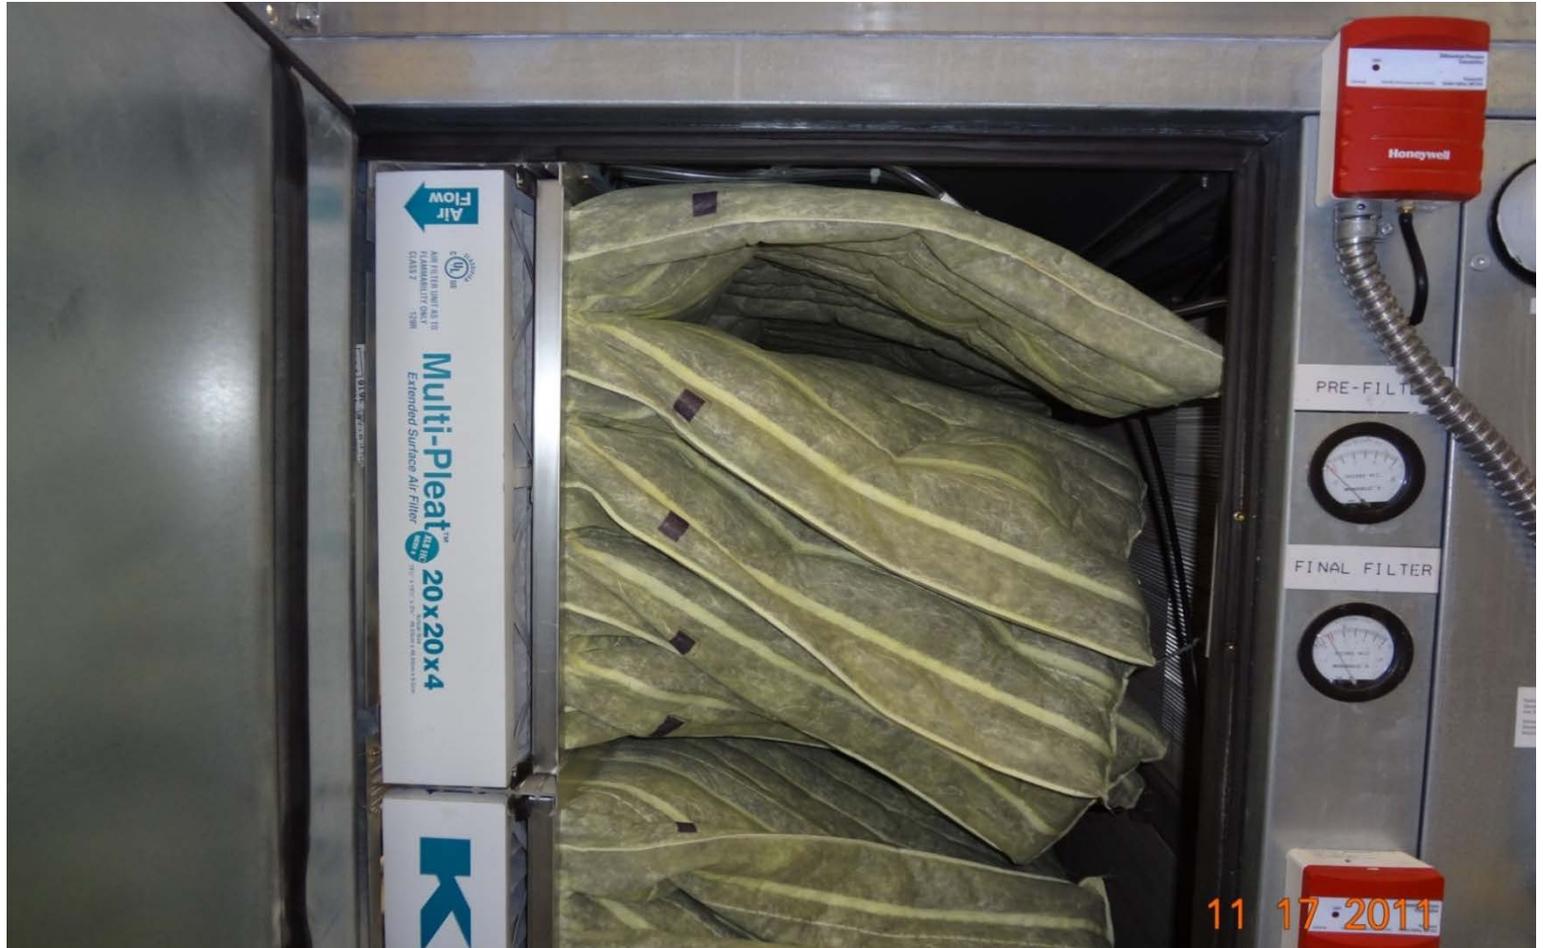
Filters Placed in Backwards

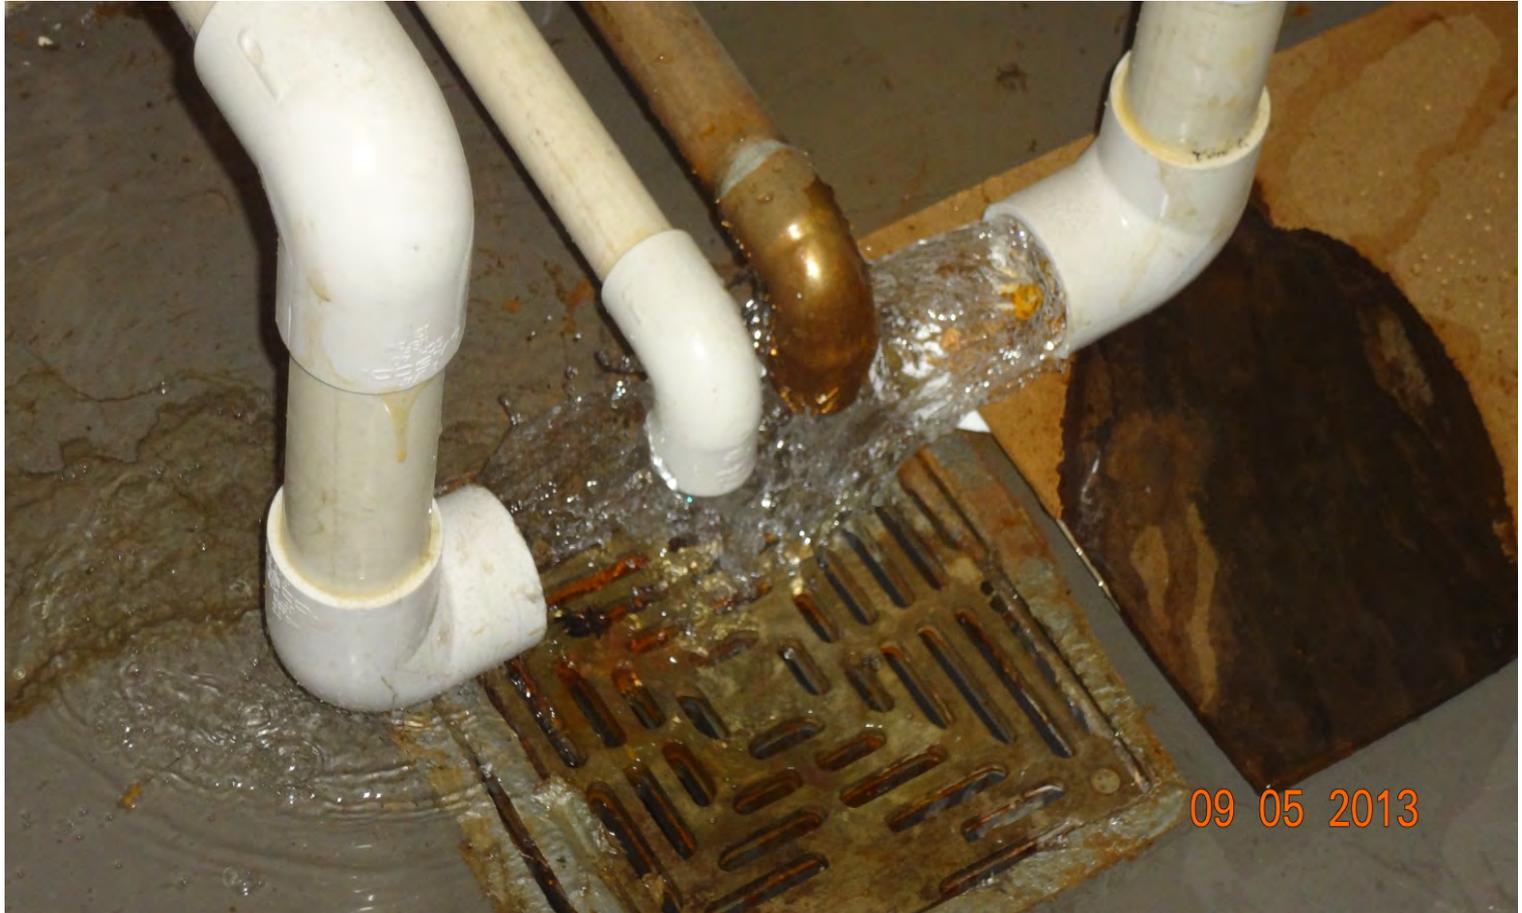
HVAC AHU Issue

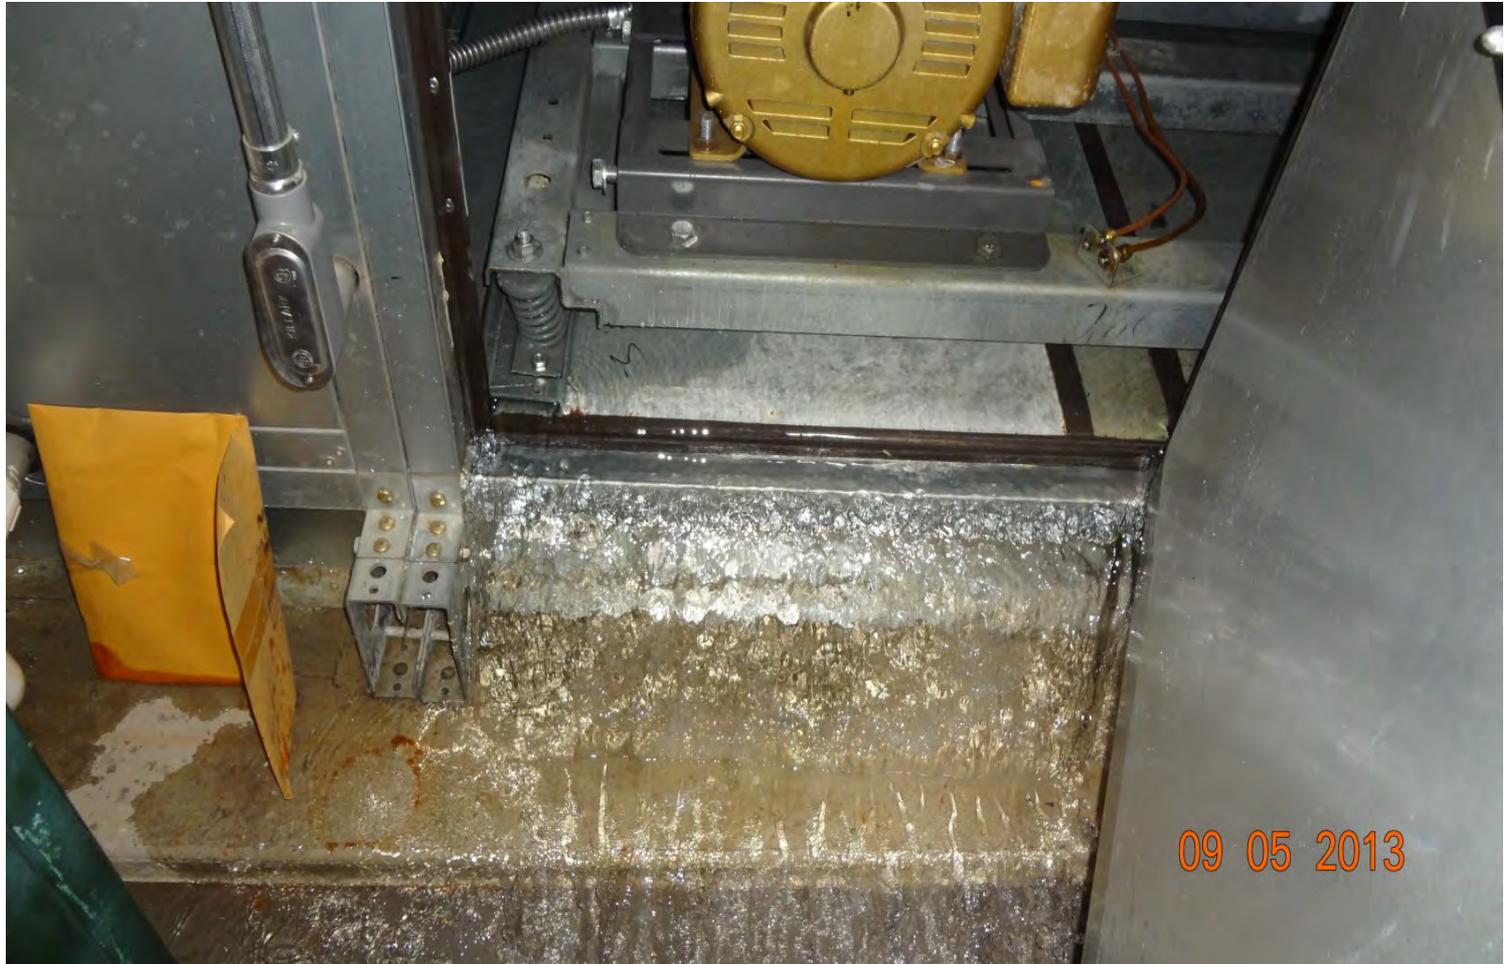
HVAC AHU Issue

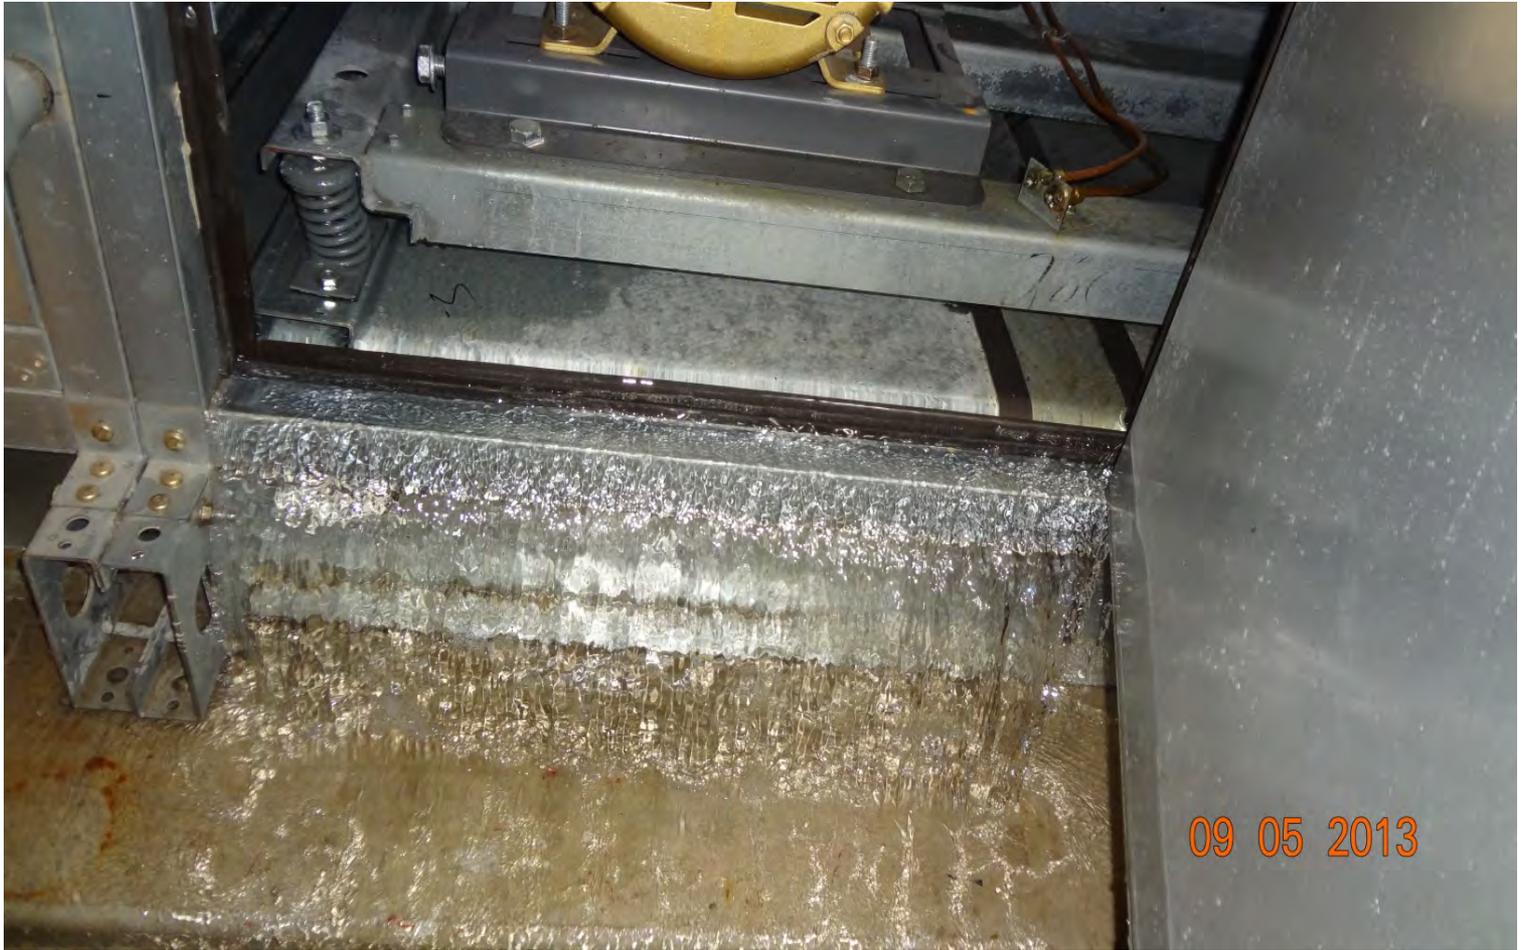
HVAC AHU Issue

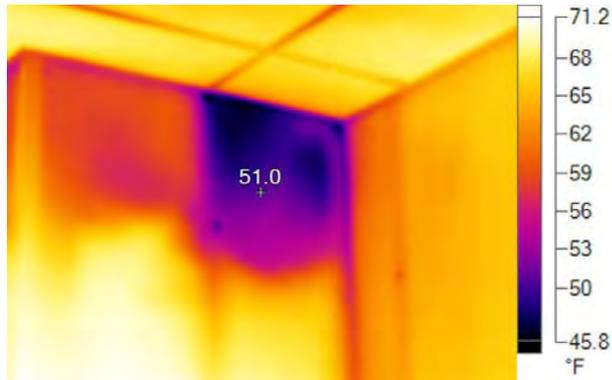
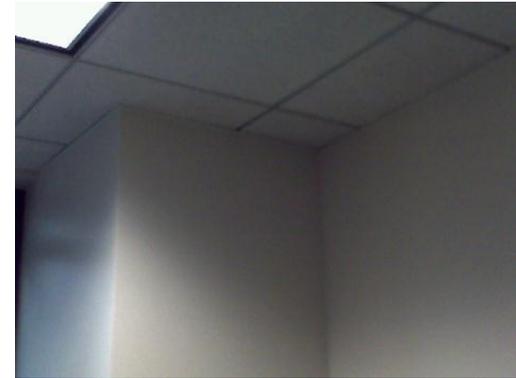
**Thermal image
indicating a void**

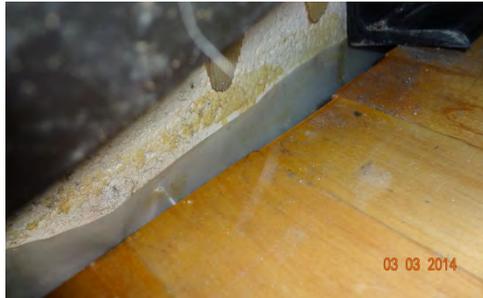
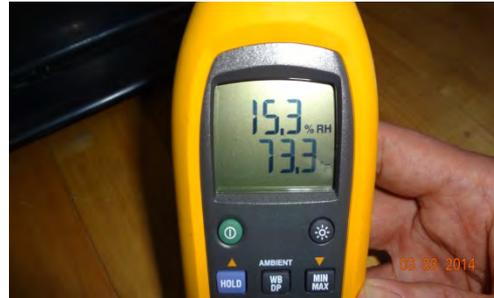
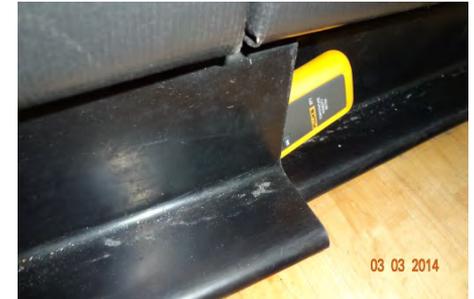
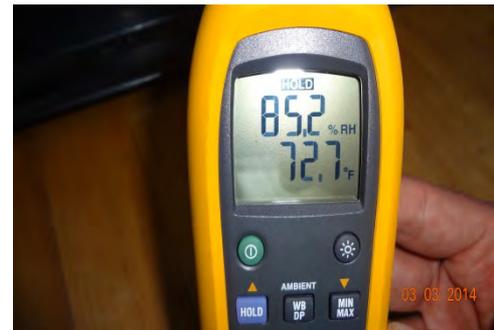
Detecting a moisture issue under gym floor

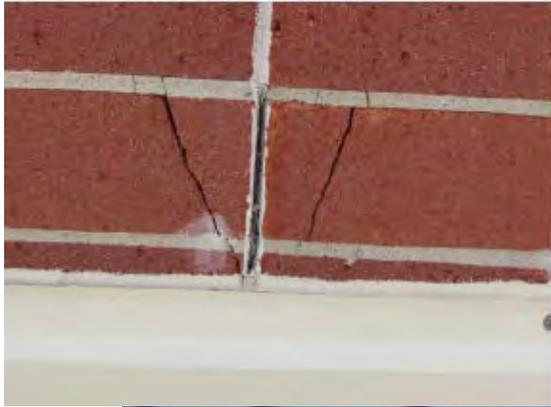
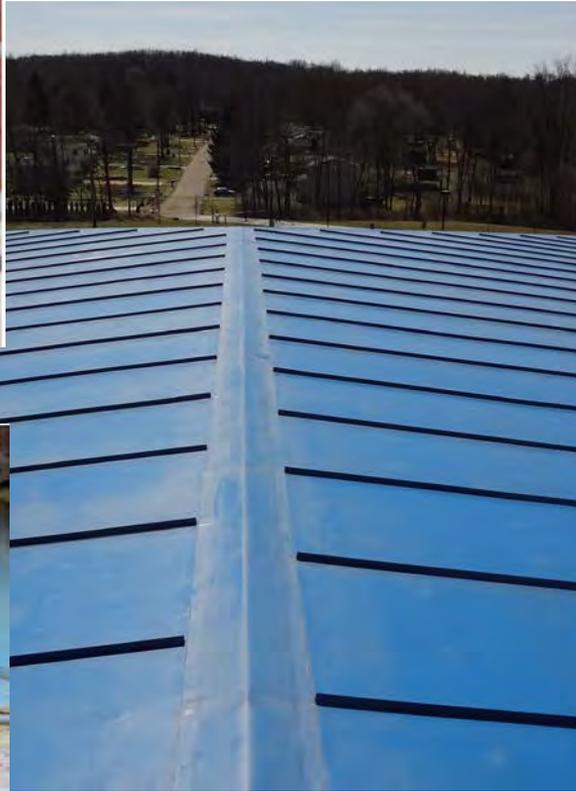
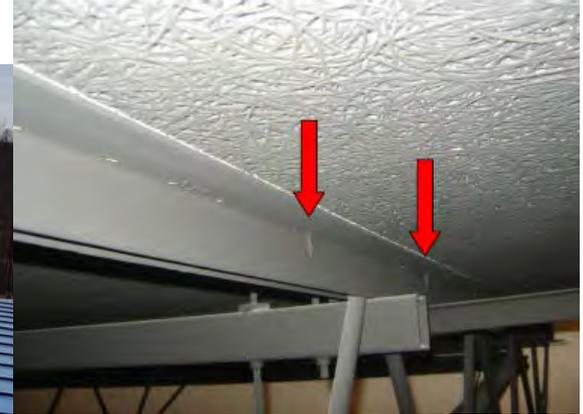
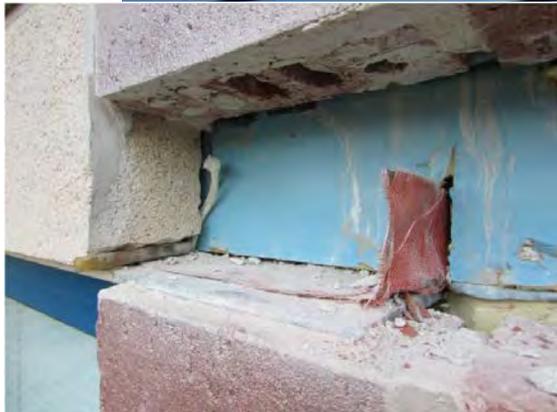
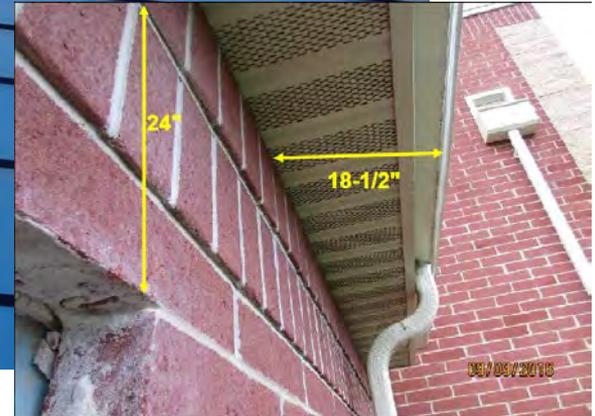
- Report
 - Roof fasteners do not meet spec
 - Flashings over windows improperly installed
 - Incorrect masonry expansion joints – distressed brick
- Conclusions
 - Replace roof?
 - Remove and re-install all window head flashings?
 - Re-do expansion joints?
