Request for Qualifications (Architect / Engineer)

Project Name	<u>Perry Stadium Phase II Renovations</u>	Response Deadline	<u>10/23/15</u>	<u>2:00 pm</u>	local time
Project Location	<u>Bowling Green State University</u>	Project Number	<u>BGU-156153</u>		
City / County	<u>Bowling Green / Wood</u>	Project Manager	<u>Brian Swope</u>		
Owner	<u>Bowling Green State University</u>	Contracting Authority	<u>Local Higher Education</u>		
Delivery Method	<u>N/A</u>	Prevailing Wages	<u>State</u>		
No. of paper copies requested (stapled, not bound)	<u>3</u>	No. of electronic copies requested on CD (PDF)	<u>1</u>

BGSU Doyt Perry Stadium, Bowling Green, Ohio/// FACILITY CONDITIONS ASSESSMENT

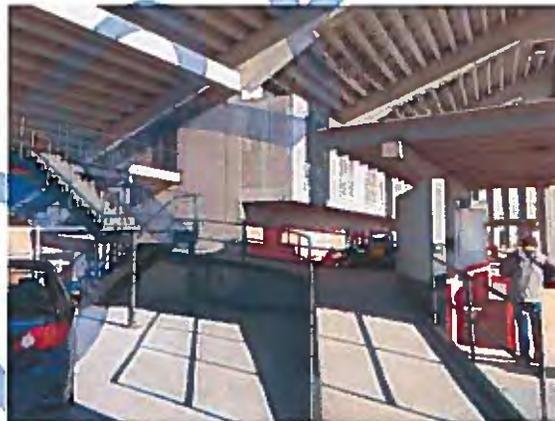
PUBLIC RAMPED WALKWAYS: The seating bowl is primarily accessed from (8) large ramped walkways, with a distinctive "Y" shaped entry into the seating bowl (refer to figure 3). These ramps are at a slope of 1" rise over 10" of run, as indicated on the original drawings, but they contain no landings, it is one constant slope for approx. 9 feet of vertical rise. The slope and the arrangement do not comply with current building and accessibility codes, which would require a maximum slope of 1" rise over 12" of run and a landing for every 30" of rise. In the case of this location, you would be required to provide (4) 5'-0" long level landings and revise the slope of the ramp. This would add almost 40 feet to the overall length of these ramps at each location. Handrails would also be required on each side to comply with the current building codes (refer to figure 4).

Figure 3- View of Ramped Walkway to Seating Bowl

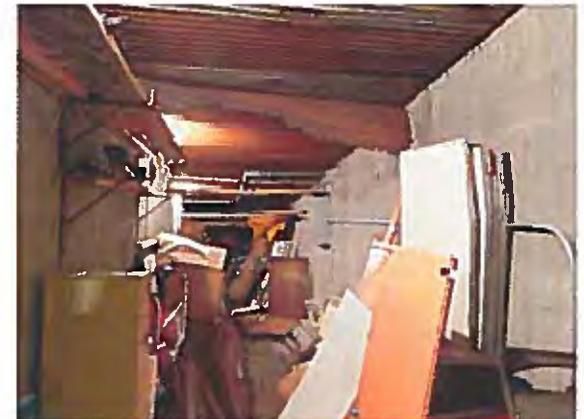
Figure 5- View of Underside of Ramped Walkway

However, the construction on the bottom side of these ramps is another issue (refer to figure 5). It was evident that the supporting metal deck has serious signs of deterioration and appears to be a safety issue for anyone accessing this space. Per the structural assessment, this is not specifically a structural concern, since this decking was used as a form for the ramp.

- Remove loose steel decking under walkway ramps
- Grouting of Sport Light pole bases
- Replace slabs within concession stands
- Replace Egress Stair at East side Elevator bridge

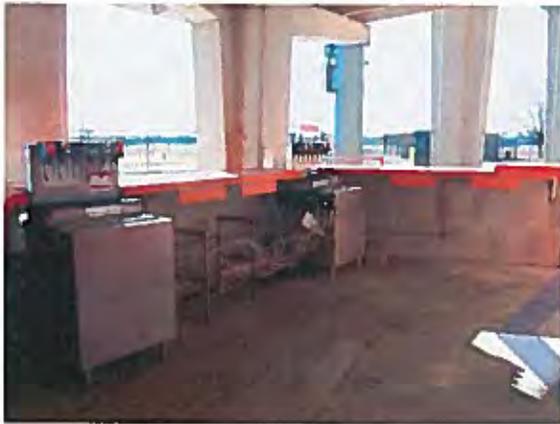
CONCESSION STANDS: The existing facility contains (8) freestanding concession stands with canopies located at the base of the ramped walkways (refer to figures 6 and 7). It is unclear how many point of sales (POS) machines are setup for each location, but 2-4 POS per stand seems reasonable. This would mean a total amount of 32 POS, which equates to approx. 1 POS for every 718 spectators. This is a very high ratio for a current college facility. We would recommend that the ratio should be closer to 1:200, which would mean a total amount of 115 POS, or an increase of around 83 POS. The public counter height is 3'-6" and would need to have a lowered portion at 3'-0" max. to comply with the current accessibility codes.

Figure 6- Interior of Concession Stand

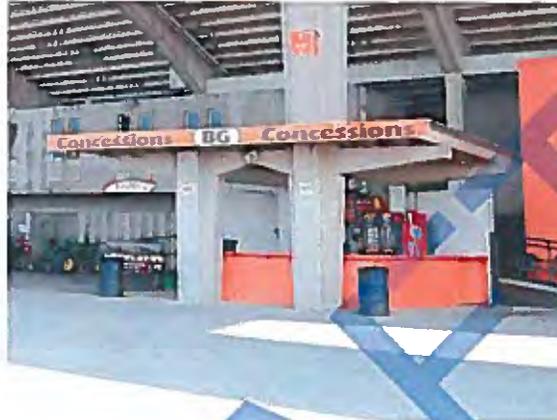
Figure 7- View of Concession Stand

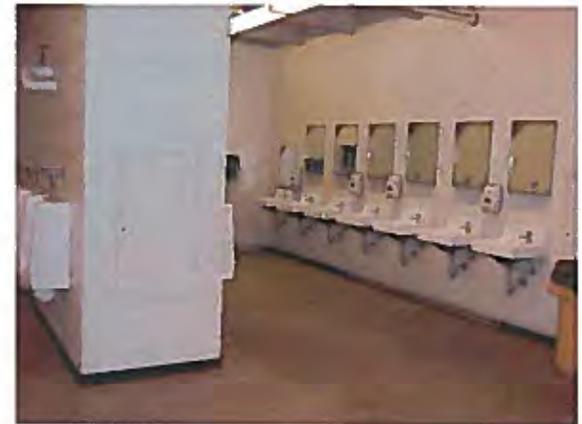
PUBLIC TOILETS: The existing facility contains a total of (4) Men's and (4) Women's Toilet Rooms. Generally these spaces were in good condition. The painted, floor mounted toilet partitions were in good condition and the ones tested appeared stable and structurally sound. A few locations showed signs of attempts to provide wheelchair accessible stalls, although it was observed that these did not appear to fully comply. These rooms also lacked the required ambulatory stalls and many of the toilet accessories were mounted higher than allowed (refer to figures 8 and 9). The rooms themselves had more than adequate turning clearances, however the existing entry and exit doorways do not. The quantity of existing toilets is well below the current code requirements and would need to be resolved in any future renovation.

Figure 9- Public Toilets- Lavs

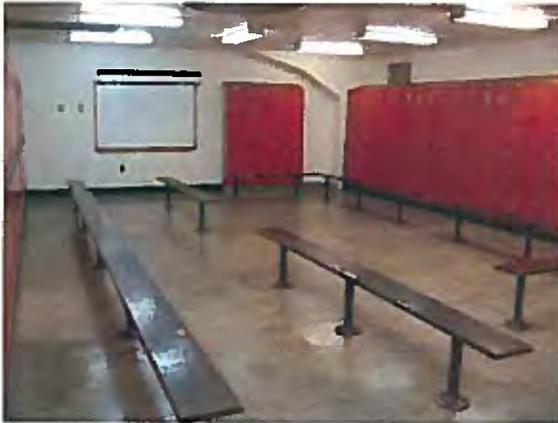
VISITING TEAM LOCKER ROOM: The Visiting Team locker room is located in the SE corner of the facility. The room is very dated and simple, but it does appear to have enough space for the intended use. We assume this room is used for all visiting teams (Football, Track, Soccer, etc...). We did not observe separate training facilities for the Visiting Teams, and all areas including the toilet and shower areas appear to be non-compliant with accessibility guidelines (refer to figure 13).

Figure 13- View of Visiting Team Lockers

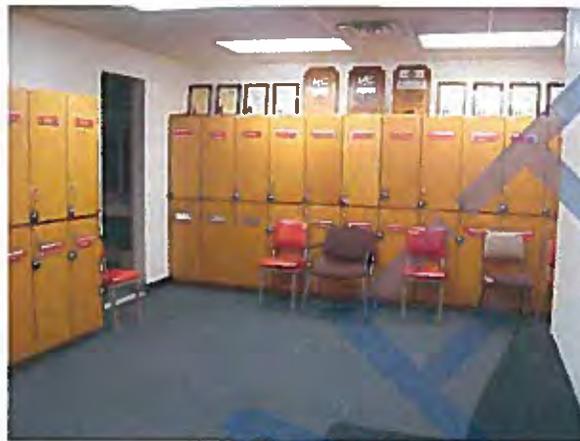
FALCON'S TEAM LOCKER ROOMS (Track/Cross Country, and Men's Soccer): The various BGSU teams noted above located within the facility are generally dated and in need of revisions (refer to figures 14 and 15).

Figure 15- View of BGSU Track/Cross Country Lockers

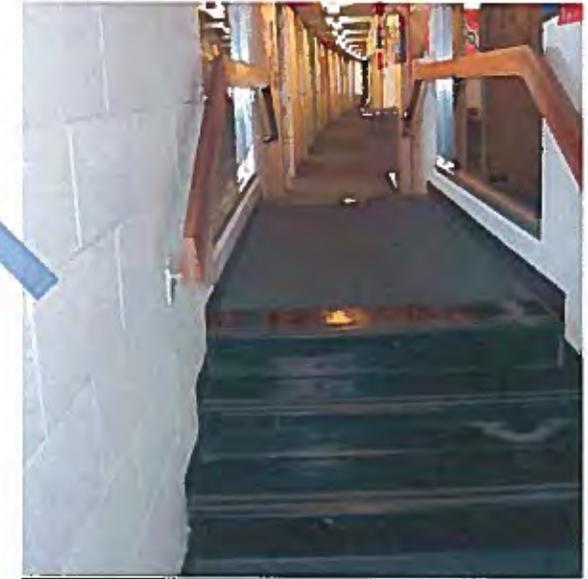
Figure 25- View of East Corridor Steps

OFFICE CORRIDOR: The East side Mezzanine Level runs under the full length of the seating. It contains various athletic and coaches offices and some associated conference, storage and related mechanical rooms. The enclosed portions like toilets and conference rooms on the North side have been constructed with a sub-roof system under the precast stadia. Many of these areas show signs of previous water damage over the years. The East office hallway is clean and well lit. Besides the water intrusion issue, the major item of note was the non-accessible hallway with the stairs located at each of the ramped walkways (2 locations within corridor). Actually, although a few offices on this level actually comply with the ADA due to the addition of the elevator in 1995, none of the toilet rooms do. This area would need to be resolved in any proposed renovation (refer to figure 25).

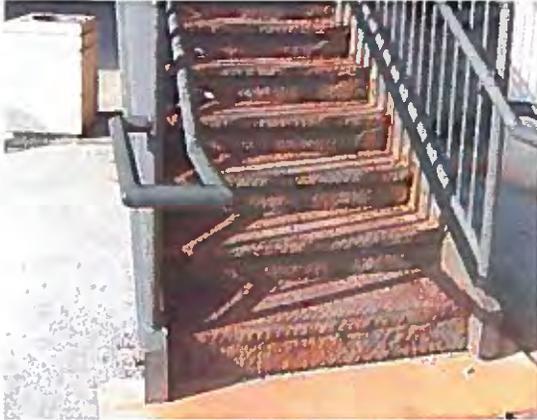
Figure 26- East Side Elevator Bridge Exit Stair- Corroded Steel

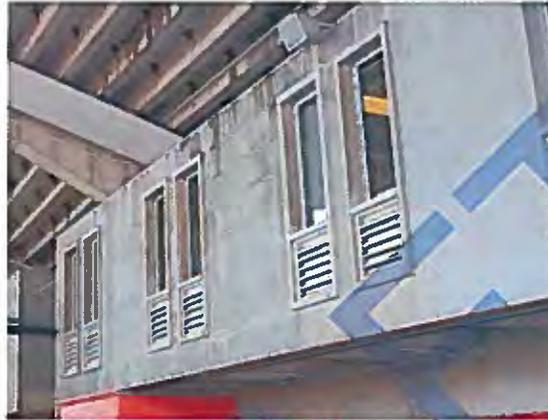
The Mezzanine Level is enclosed with CMU walls and have small windows for each office area. These offices have separate mechanical units mounted under the windows with an attached louver. Based on the existing drawings, it is not clear if any coating or sealer was installed over the exterior surface. The exterior wall is showing signs of water intrusion, noticeable from the visible staining seen on the walls (refer to figure 27). We would recommend the walls be cleaned and an appropriate sealer or coating be applied to limit water from entering the wall system. The construction of the Mezzanine also has an overhang condition that has the floor slab exposed to the exterior, we would suggest an insulated soffit be constructed to provide a more complete envelope.

Figure 27- Mezzanine Exterior Wall- Staining

The windows appear to be original to the facility and are 3/16" gray tinted single pane units per the drawings. These units should be replaced with insulated glass and associated sealant in order to extend the life of the facility. The insulation of the walls and roof should be increased as well.

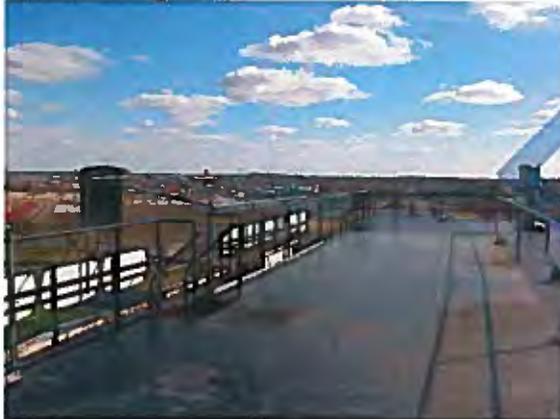
ROOFING: The single ply roofing above the Suite and Pressbox Levels appears generally in good condition. There are some minor areas that felt spongy when walking over, we would suggest a more formal review of the roofing from the manufacturer to determine the remaining life of the current roofing, we would estimate at least 5-8 years with some minor repairs (refer to figure 31).

Figure 31- View of Roof above PressBox

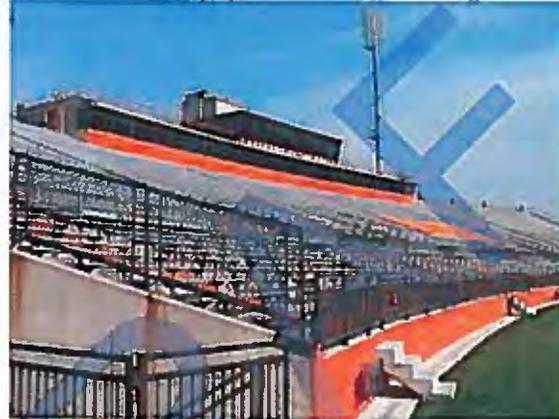
PRESSBOX (WEST SIDE): The Pressbox Level was similar to the Suite Level on the opposite side except that it includes a second story (refer to figure 32). The spaces in general appeared to be very tight. Some of the spaces on the North side have been revised to Suites. There was a lot of space allowed for Visiting Teams including; Coaches, Radio and Athletic Director. The area allocated for the Working Press seems adequate. The use of the Dark Rooms was not clear today, it would seem possible for these rooms to be re-purposed in a renovation.

Figure 32- View of West Side PressBox

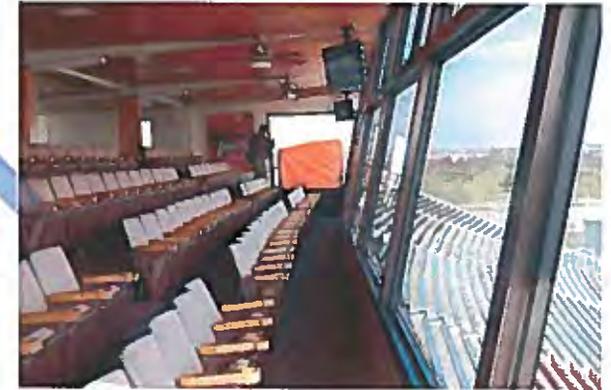
STADIUM CLUB: Situated atop the Pressbox on the West side of the stadium is the plush Stadium Club. The Stadium Club's 106 theatre-type seats provide loyal BGSU fans with the best view of the game (refer to figure 33). The access to the Club is either from the West side elevator up to this level or access to the Pressbox and then up a dedicated stair. Associated with this interior portion, there are two exterior roof decks that are used for more spectators to view the game. There is only a single means

of egress from this level, two should be provided to comply with the Building Code.

Figure 33- Stadium Club

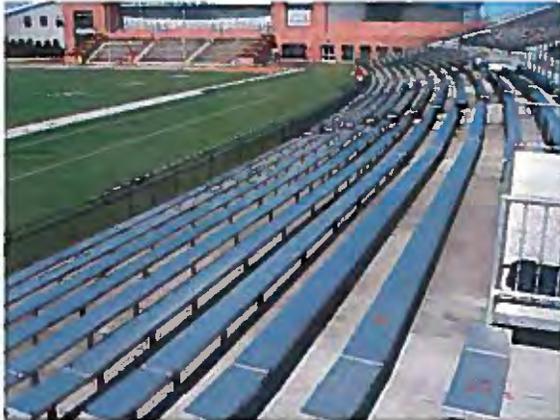
The main seating bowl consists of aluminum bench seating. This seating allows for approx. 18" of width per person. This is fairly tight by stadium standards today (refer to figure 34).

Figure 34- View of General Admission Bench Seating

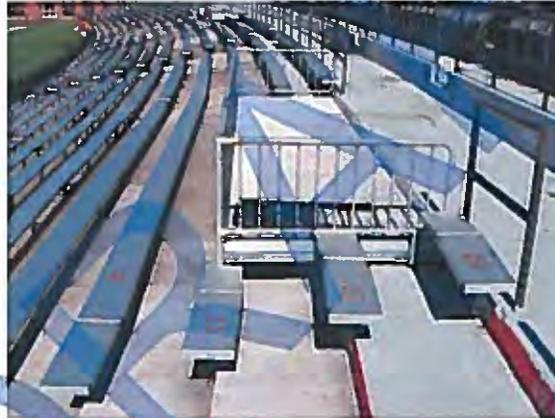
ACCESSIBLE SEATING PLATFORMS: In recent years accessible seating platforms have been installed over three existing rows (refer to figure 36). This occurs within the stadium at (4) locations on each side. These platforms appear to provide capacity for roughly 4 wheelchair and 4 companion seats. This would mean the facility has roughly 32 wheelchair and 32 companion total locations. This is less than what is required in the 2010 ADA Guidelines. Per these guidelines, 126 wheelchair and 126 companion seating is required. Also when the elevators were added to the facility, vertical dispersion should likely have been provided as well, this would allow for seating locations at the top of the bowl as well on both sides.

Figure 36- View of Accessible Seating Platform

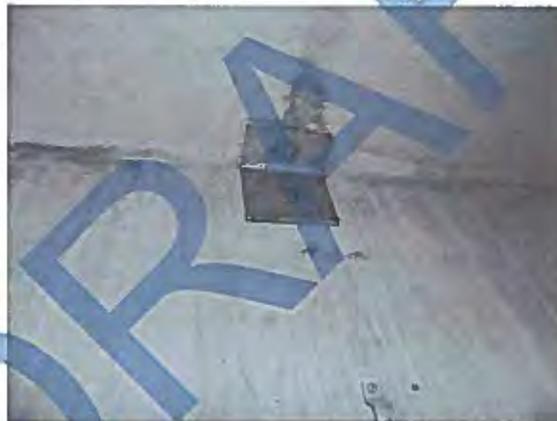
Few connectors were found to be in near to original condition (refer to figure 42). However, majority of the connectors that connect precast risers together show signs of corrosion.

Figure 42- Steel Connector in Near to Original Condition

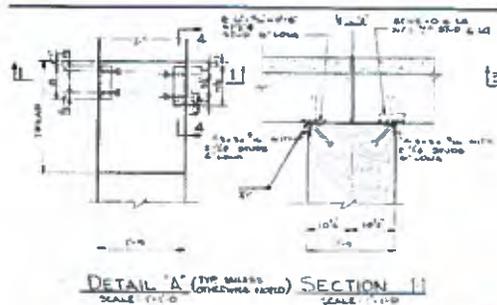
Figure 44- Precast Riser to Cast in Place Frame Typical Connection

Steel plates and angle embeds in the ends of the precast risers and concrete frame transfer load from the precast riser to the concrete frame. These plates and angles are welded together to transfer lateral loads between members. The details are clearly illustrated on Osborn-Papesh drawings sheet S-3 (refer to figure 44).

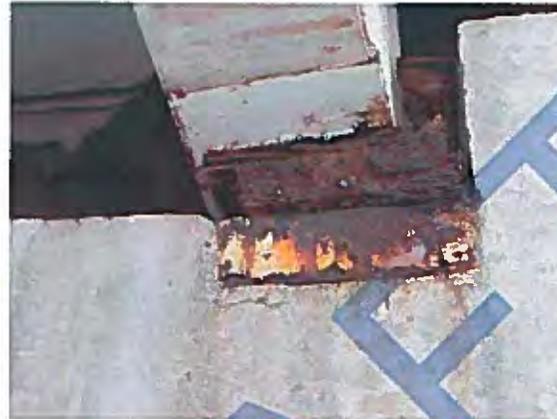
Figure 46- Corrosion of High Shim Stack - Note Rotation of Precast Beam

Rust jacking due to expansion of steel as it corrodes has broken most of the welds required to tie the structure together (refer to figure 46).

This condition occurs at over 2,000 locations.

- **Comment:** Rust jacking due to corroding steel plates is a major issue that needs to be dealt with. This condition is causing joint damage, resulting in increased water leaking through the structure, potential trip hazards as observed on the south east end, as well as compromising the integrity of the structure by leaving the components of the structure un-restrained or attached. Due to the number of locations, this single issue may be cost prohibitive to address. An order of magnitude cost estimate is possible only after the results of testing have been reviewed and possible repair solutions developed (short term).

- **Testing:** The extent and severity of the corrosion needs to be established to determine the best repair. At least 10 locations need to be tested showing varying states of deterioration. All rusted material should be removed to expose any remaining virgin steel or intact welding. Samples of the steel shim plates should be analyzed for chemical composition (short term).

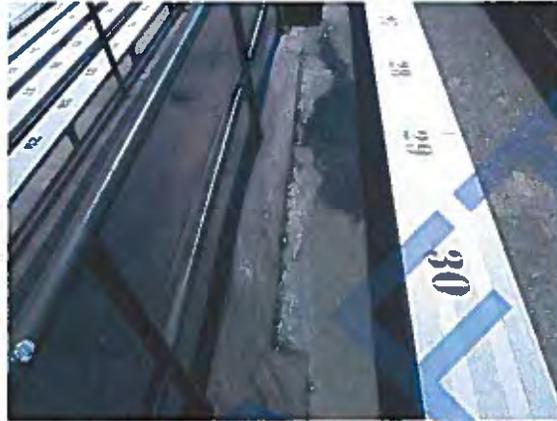
Delamination, cracking and failure of the waterproofing membranes and applied traffic coating was observed through the structure (refer to figures 53, 54 and 55). In some areas the waterproofing is trapping water under the membrane allowing it to penetrate through the structure.

Figure 54- Waterproofing Membrane at Precast Top - Failure

Comment: To reduce the amount of water leaking through the structure into occupied spaces below and corroding the steel connections, a traffic coating is recommended to be applied to the entire top surface of the elevated precast risers and cast-in-place top slab areas. This work should only be carried out after all the other structural issues identified have been addressed (short term/future depending on severity of leaks).

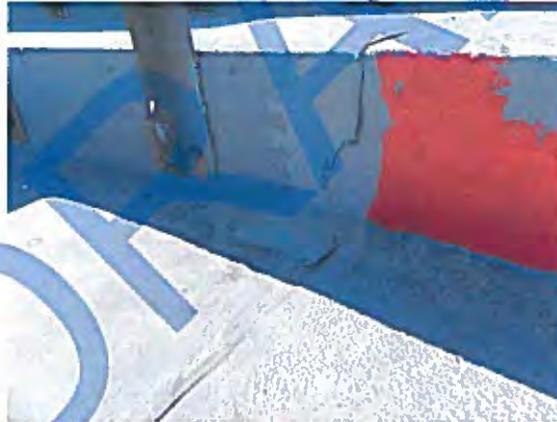
Figure 55- Applied Traffic Coating – Failure at Joint

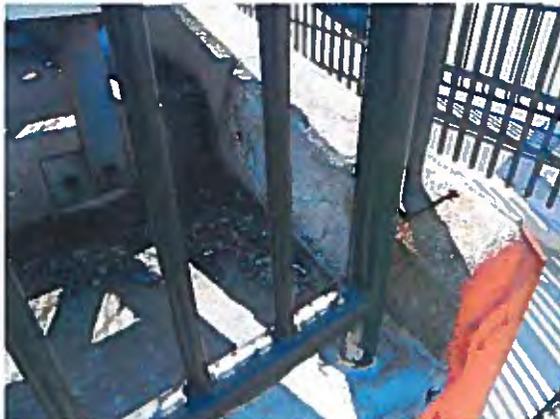
The lower bowl retaining wall deterioration (refer to figures 62 and 63) has been previously assessed in the Schooley Caldwell Associates Report and Concrete Microscopy Petrographic Examination. Visual observations and the review of these reports concludes that the wall is deteriorating due to breakdown of concrete due to combination of the effects of alkali-aggregate reactions, freeze/thaw cycles in low air content concrete and high permeability.

Alkali-aggregate reaction is an expansive chemical reaction between certain minerals found in coarse aggregate and the alkalis in Portland cement resulting in expansion, cracking and failure of the concrete matrix. Standard practice is to entrain air at a rate of approximately 6% for concrete, with 3/4 inch nominal aggregate, subjected to severe exposure. Air content was measured at 2% to 3% in the damaged portion of the wall.

Figure 62- Deterioration of Concrete Retaining Wall

Comment: The Schooley Caldwell Associates Report underestimates the extent of the repairs required to address this issue. Future modifications/enhancement of the stadia should consider reworking or re-constructing at least the front and side retaining walls as well as the first four rows of seating if not more of the lower bowl (short term).

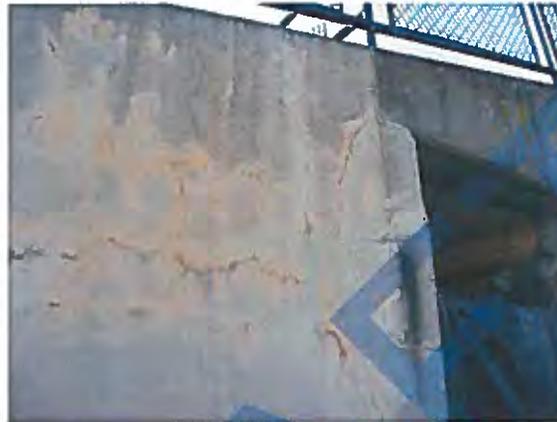
Figure 63- Deterioration of Concrete Return Walls

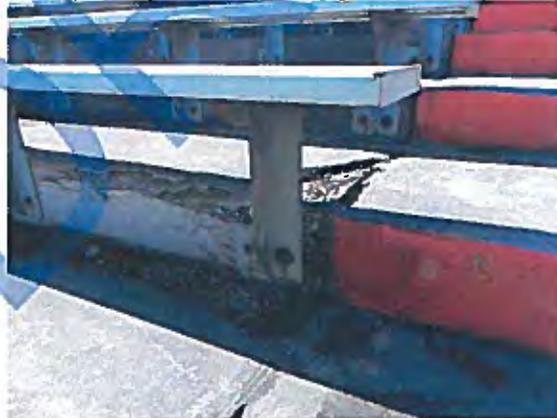
Damage and deterioration of the concrete was also observed on the second and third riser of the stadia, the side retaining walls and steps down to the field (refer to figures 64 and 65).

Figure 64- Deterioration of Cast-In-Place Concrete Risers

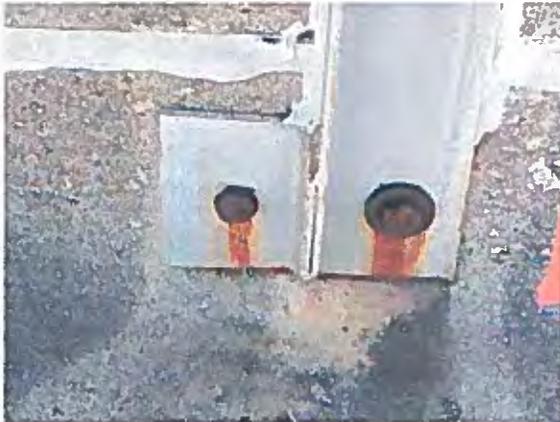
The design drawing shows steel inserts cast into the precast risers for attaching the vertical seat supports. Although the bolts used are not galvanized they appear to be in acceptable condition considering their age (refer to figure 71). Replacing seats may require a custom connection to take advantage of the existing embeds or the use of expansion or adhesive anchors.

Figure 71- Typical Seat to Precast Connection

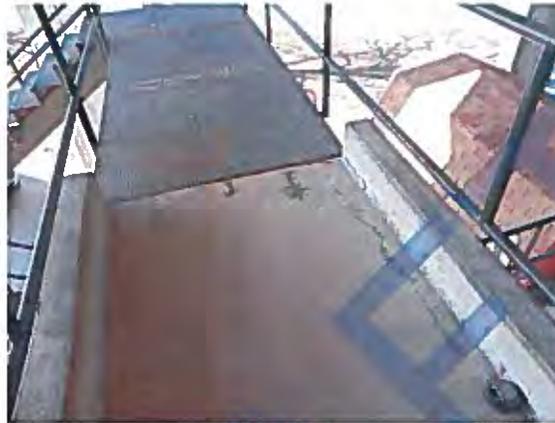
The original steel stairs accessing the ends of the stadia are constructed of raised lug steel plate floor plate. Considering the age of the structure they are in reasonable condition. Minor steel corrosion and some concrete spalling at steel embedded connectors were observed at these stairs (refer to figure 72).

Figure 72- Minor Corrosion of Checkered Plate Stair

Comment: Cleaning and patching of the original steel stairs and concrete will restore these elements and extend their serviceable life (future).

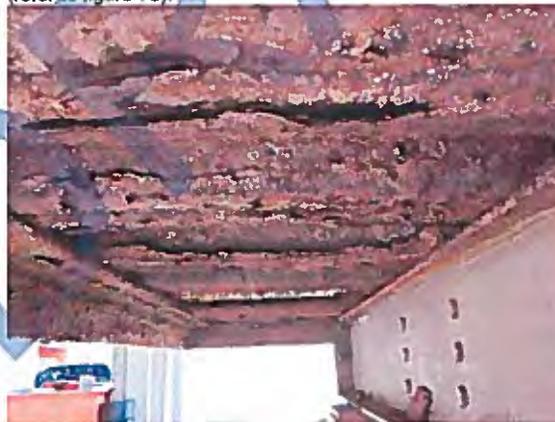
The newer stair on the east side that provides access to the bridge linking the elevator tower to the mezzanine offices is in very poor conditions. The composite metal floor deck is completely destroyed by corrosion. Most of the supporting steel members are showing signs of moderate to severe corrosion (refer to figure 73).

Figure 73- Severe Corrosion of Steel and Deck at Bridge Stair

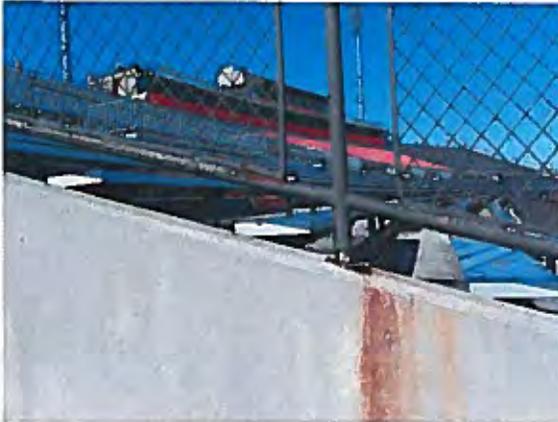
Figure 75- Corrosion of Embed Plates and Steel Mesh Framing

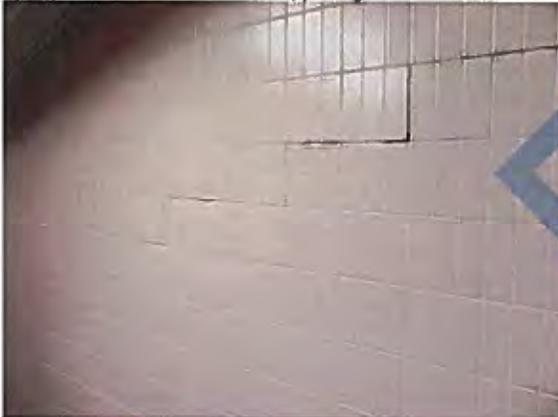
Stepped cracking in two CMU bathroom divider walls were observed (refer to figure 76). The cracking appears to be caused by excessive deflection of the supporting structural members.

Figure 76- Stepped Crack in CMU Wall

Comment: Structurally, the cracks are minor and can be filled with a flexible sealant. If they are aesthetically un-acceptable then the tile will need to be removed. Additional vertical control joints cut into the CMU wall, the cracks repaired and wall re-tiled, with proper jointing (future).

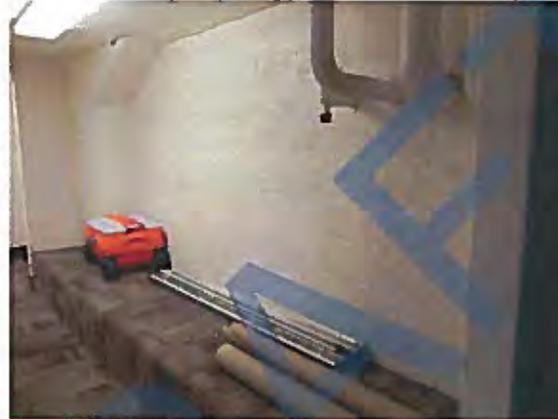
Moisture penetrating through the painted CMU wall was observed in the golf practice space (refer to figure 77). Water is leaking into the CMU from damaged or deteriorated control joint sealing along the edges of the concrete ramps supported by the wall. This moisture penetration could be occurring at more locations, but is highlighted here by the peeling paint.

Figure 77- Moisture Penetrating into CMU Wall From Above

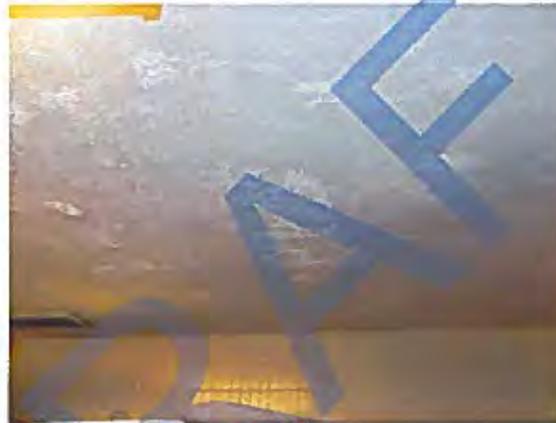
In the occupied mezzanine toilets, hard steel ceilings have been provided to protect the space from water leaking through the stadia risers. No insulation is provided above the hard ceiling and it appears that condensation due to a dew point induced by the steel ceiling is causing the paint to peel (refer to figure 81).

Figure 81- Humidity Corroding Underside of Hard Pan Ceiling

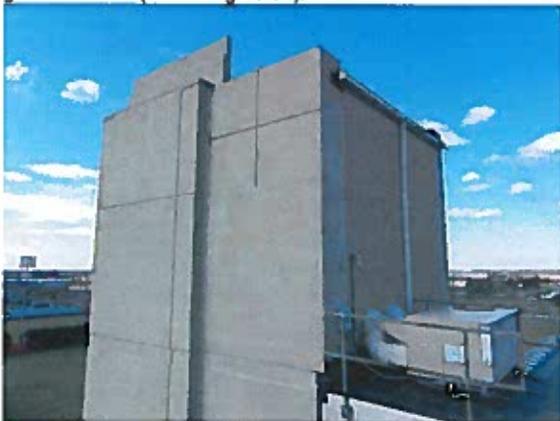
The precast panels surrounding the elevator towers appear in good condition (refer to figure 84).

Figure 84- Elevator Tower

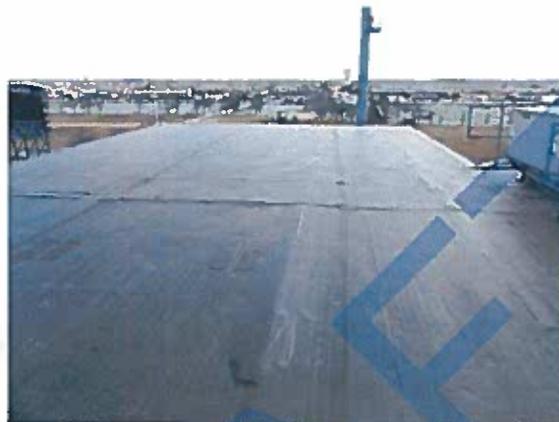
Figure 85- High Roof Membrane

The high roofs above the boxes areas appear to be sound with no signs of cracking, delamination or hardening. There are areas underfoot that appeared soft and/or bulging (refer to figure 85).
