# RFQ Question and Answer List

Project Name Perry Stadium Phase 1 Repairs/Upgrades Project Number BGU 156088  
Project Location Bowling Green State University

# BGSU Doyt Perry Stadium, Bowling Green, Ohio/// FACILITY CONDITIONS ASSESSMENT

ARCHITECTURAL 04/11/13

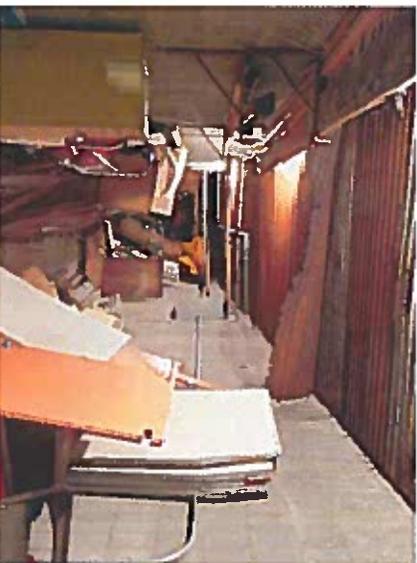
Figure 5- View of Underside of Ramped Walkway

However, the construction on the bottom side of these ramps is another issue (refer to figure 5). It was evident that the supporting metal deck has serious signs of deterioration and appears to be a safety issue for anyone accessing this space. Per the structural assessment, this is not specifically a structural concern, since this decking was used as a form for the ramp.

- Remove loose steel decking under walkway ramps
- Grouting of Sport Light pole bases
- Replace slabs within concession stands
- Replace Egress Stair at East side Elevator bridge

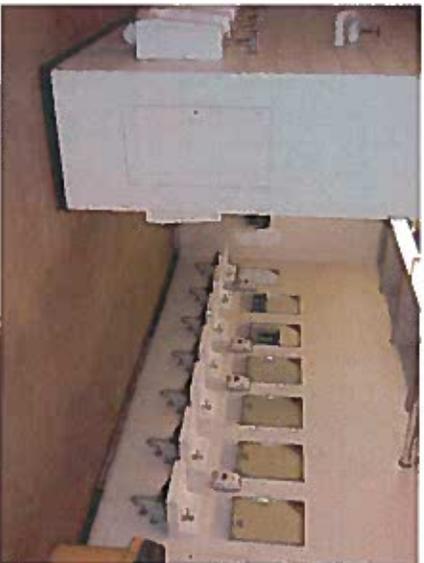
**PUBLIC TOILETS:** The existing facility contains a total of (4) Men's and (4) Women's Toilet Rooms. Generally these spaces were in good condition. The painted, floor mounted toilet partitions were in good condition and the ones tested appeared stable and structurally sound. A few locations showed signs of attempts to provide wheelchair accessible stalls, although it was observed that these did not appear to fully comply. These rooms also lacked the required ambulatory stalls and many of the toilet accessibles were mounted higher than allowed (refer to figures 8 and 9). The rooms themselves had more than adequate turning clearances, however the existing entry and exit doorways do not. The quantity of existing toilets is well below the current code requirements and would need to be resolved in any future renovation.

Figure 9- Public Toilets- Lavs

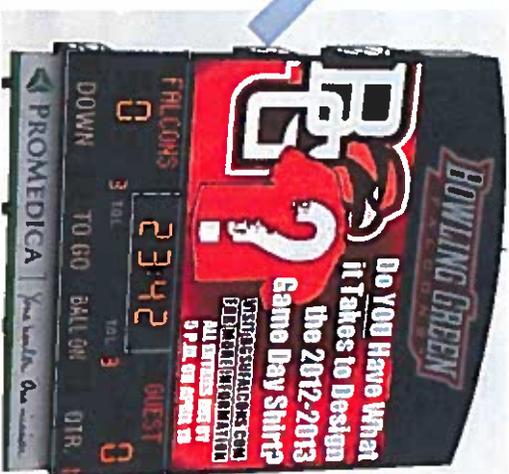
**SCOREBOARD:** Located at the South end of the field is the main video scoreboard for the facility. The scoreboard was built by Daktronics, originally installed in 2004, was upgraded for the 2012 season has a 15 mm pixel pitch-spacing, and approx. 19' x 35' dimensions. The size of this board is on the smaller size for NCAA Division I football (refer to figure 12).

Figure 12- BGSU Video Scoreboard

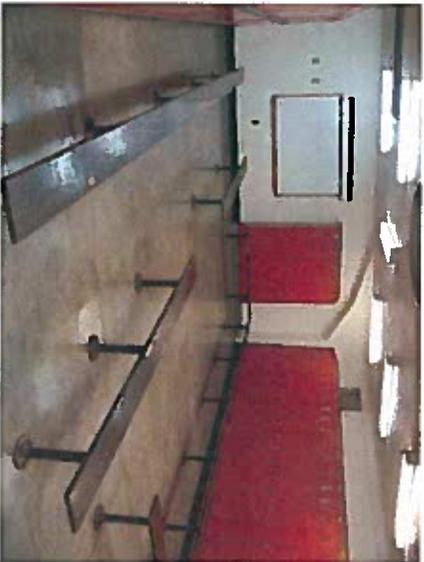
**VISITING TEAM LOCKER ROOM:** The Visiting Team locker room is located in the SE corner of the facility. The room is very dated and simple, but it does appear to have enough space for the intended use. We assume this room is used for all visiting teams (Football, Track, Soccer, etc...). We did not observe separate training facilities for the Visiting Teams, and all areas including the toilet and shower areas appear to be non-compliant with accessibility guidelines (refer to figure 13).

Figure 13- View of Visiting Team Lockers

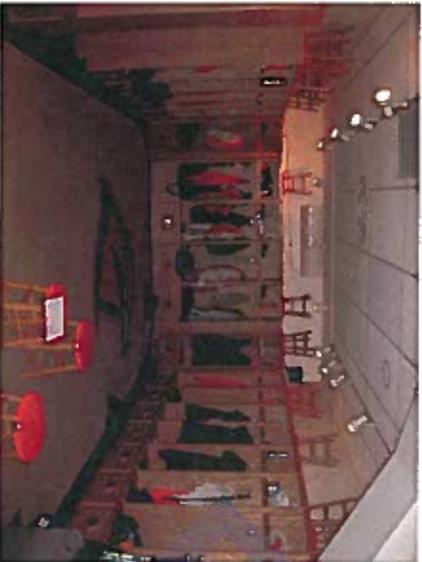
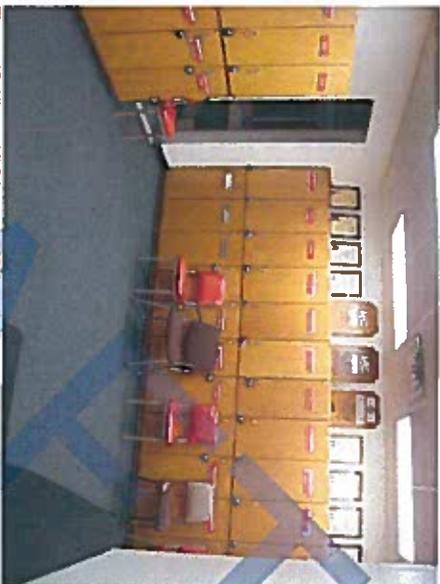
**FALCON'S TEAM LOCKER ROOMS (Track/Cross Country, and Men's Soccer):** The various BGSU teams noted above located within the facility are generally dated and in need of revisions (refer to figures 14 and 15).

Figure 14- View of BGSU Men's Soccer Lockers

Figure 15- View of BGSU Track/Cross Country Lockers

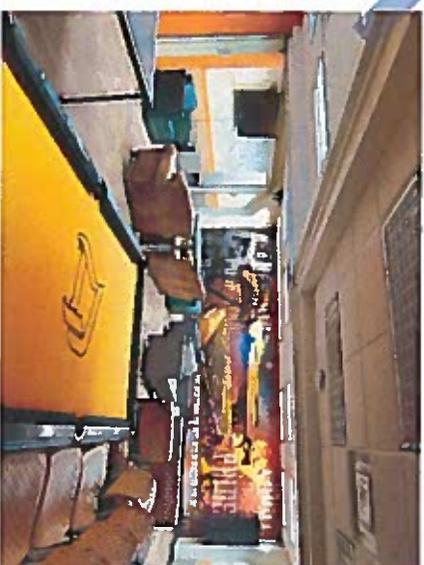
**PLAYER'S LOUNGE:** The Player's Lounge appears to be very small in size for the number of athletes it should serve. The current layout appears to have four activities, but it would be difficult to accommodate the number of people needed. The room is also dividable into three smaller spaces for multiple meetings. We would recommend that this room be increased in size to allow for more comfort and relaxation for the athletes (refer to figure 17).

Figure 17- View of Player's Lounge

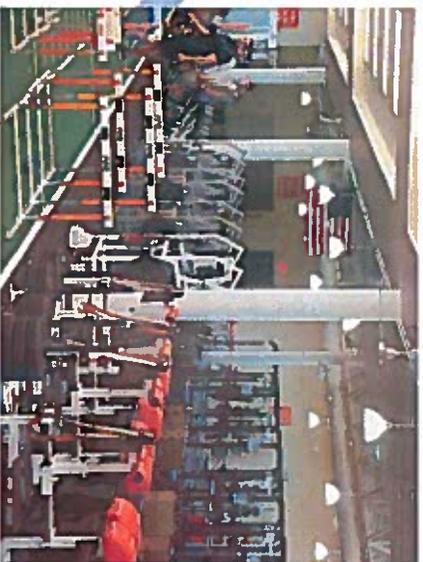
**WEIGHT ROOM** (located in the Sebo Center): The Weight Room for all associated BGSU sports is located in the Sebo Center and was also constructed in 2007. The room seems well equipped and in good condition. The issue is that the room is primarily used by the football team and the other sports have limited access for using this space. It would be recommended to either increase the size of the room or to provide a separate room for the other sports to utilize (refer to figure 21).

Figure 21. View of Sebo Weight Room

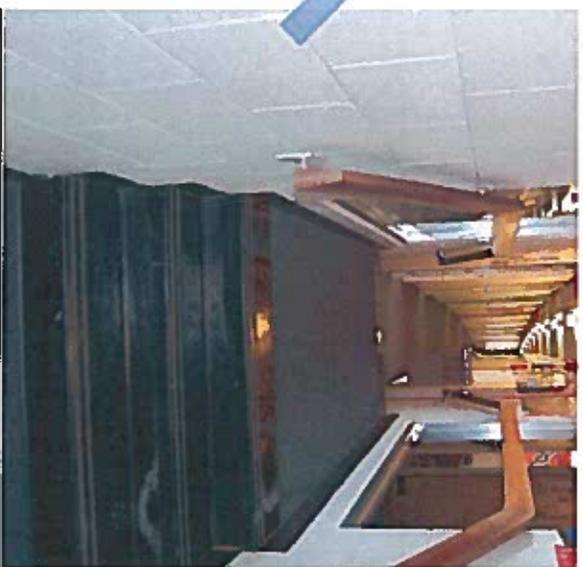
**OFFICE CORRIDOR:** The East side Mezzanine Level runs under the full length of the seating. It contains various athletic and coaches offices and some associated conference, storage and related mechanical rooms. The enclosed portions like toilets and conference rooms on the North side have been constructed with a sub-roof system under the precast stadia. Many of these areas show signs of previous water damage over the years. The East office hallway is clean and well lit. Besides the water intrusion issue, the major item of note was the non-accessible hallway with the stairs located at each of the ramped walkways (2 locations within corridor). Actually, although a few offices on this level actually comply with the ADA due to the addition of the elevator in 1995, none of the toilet rooms do. This area would need to be reworked in any proposed renovation (refer to figure 25).

Figure 25- View of East Corridor Stairs

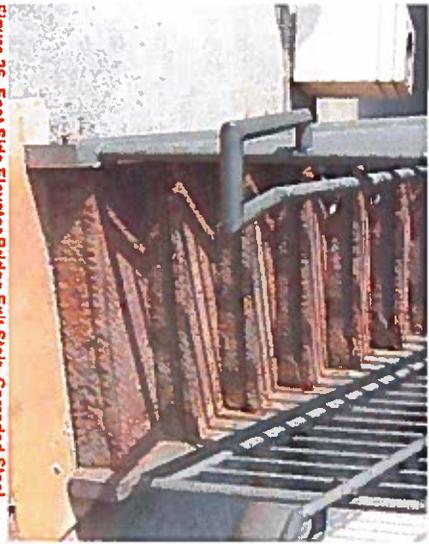
Figure 26- East Side Elevator Bridge Exit Stair- Corroded Steel

**EGRESS STAIR TOWERS:** The Mezzanine Levels on both sides of the facility have some interior and exterior egress stairways. Generally these stairs are in need of repair and re-painting to extend their life. The existing steel stairways from the Mezzanine floor and the Elevator access bridge all appear in various states of deterioration. The worst location is the egress stair on the South side of the stadium from the Elevator bridge. This stair is in immediate need or repair, due to the amount of rusting that is visible. This stair should not be used for fear of injuring visitors or spectators.

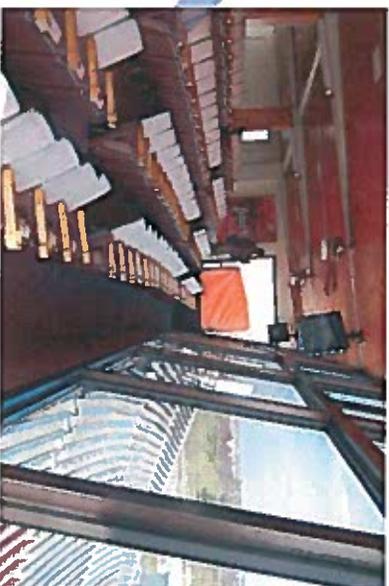
**STADIUM CLUB:** Sitting atop the Pressbox on the West side of the stadium is the plush Stadium Club. The Stadium Club's 106 theatre-type seats provide loyal BGSU fans with the best view of the game (refer to figure 33). The access to the Club is either from the West side elevator up to this level or access to the Pressbox and then up a dedicated stair. Associated with this interior portion, there are two exterior roof decks that are used for more spectators to view the game. There is only a single means

of egress from this level, two should be provided to comply with the Building Code.

Figure 33- Stadium Club

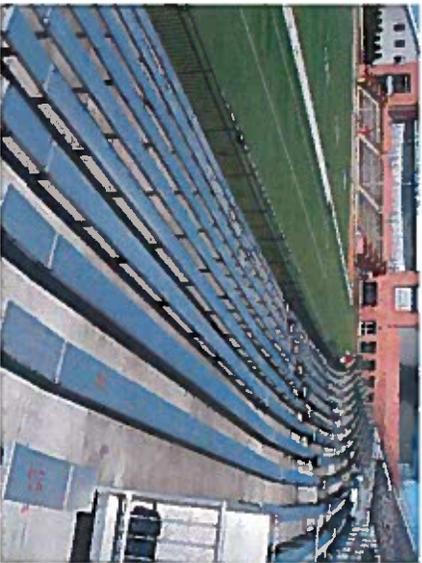
The main seating bowl consists of aluminum bench seating. This seating allows for approx. 18" of width per person. This is fairly tight by stadium standards today (refer to figure 34).

Figure 34- View of General Admission Bench Seating

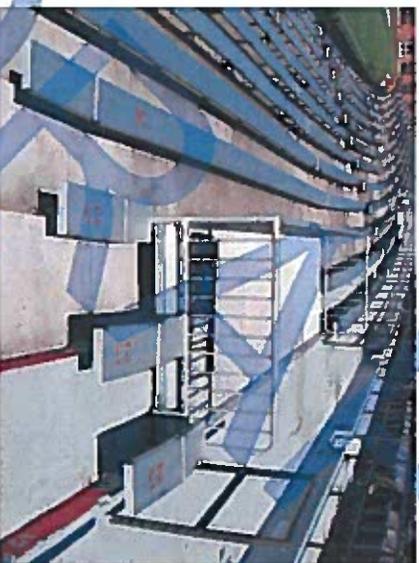
**ACCESSIBLE SEATING PLATFORMS:** In recent years accessible seating platforms have been installed over three existing rows (refer to figure 36). This occurs within the stadium at (4) locations on each side. These platforms appear to provide capacity for roughly 4 wheelchair and 4 companion seats. This would mean the facility has roughly 32 wheelchair and 32 companion total locations. This is less than what is required in the 2010 ADA Guidelines. Per these guidelines, 126 wheelchair and 126 companion seating is required. Also when the elevators were added to the facility, vertical dispersion should likely have been provided as well, this would allow for seating locations at the top of the bowl as well on both sides.

Figure 36- View of Accessible Seating Platform

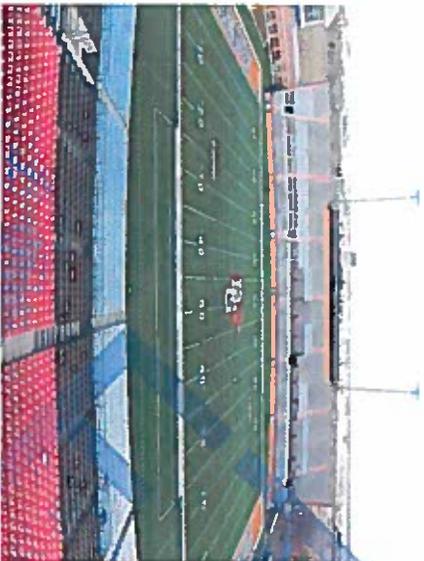
Figure 41- View of Stadium from West Side

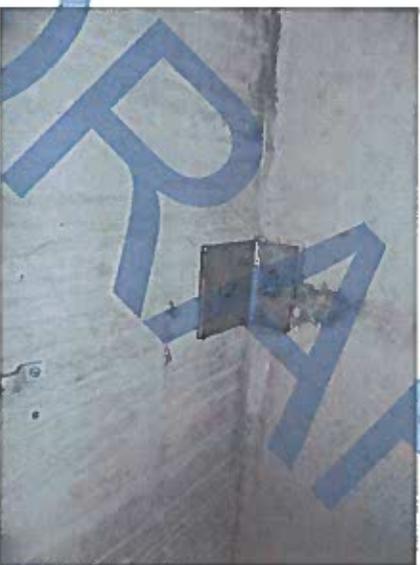
Few connectors were found to be in near to original condition (refer to figure 42). However, majority of the connectors that connect precast risers together show signs of corrosion.

Figure 42: Steel Connector in Near to Original Condition

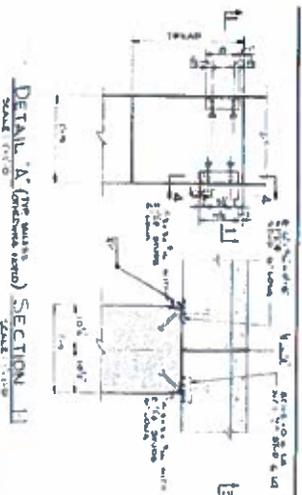
Steel plates and angle embeds in the ends of the precast risers and concrete frame transfer load from the precast riser to the concrete frame. These plates and angles are welded together to transfer lateral loads between members. The details are clearly illustrated on Osborn-Papesh drawings sheet S-3 (refer to figure 44).

**Figure 44- Precast Riser to Cast in Place Frame Typical Connection**

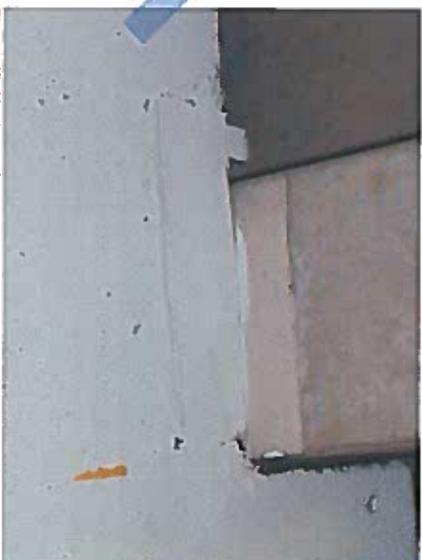
The only location where no corrosion of the embedded plates was observed was at the expansion joint where the plates were not welded together (refer to figure 47).

**Figure 47- No Corrosion at Expansion Joint – No Welds**

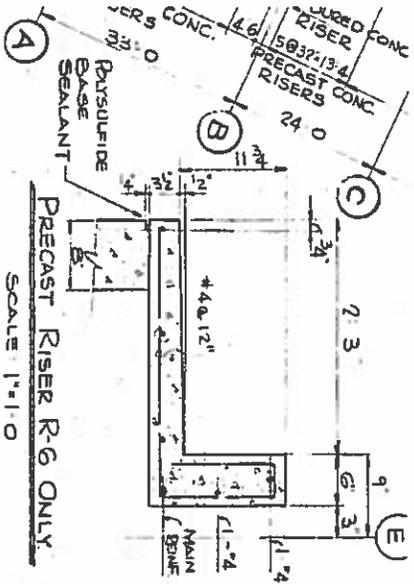
The horizontal and vertical joints between the precast risers are filled with polysulfide base sealant, according to the original drawings (refer to figures 48 and 49). The sealant observed in these joints appears to be mainly the original sealant, other than locations where various repairs and patches have been applied below layers of waterproofing and traffic coating.

Figure 48- Precast Riser Joint Sealant Details - Horizontal Joint

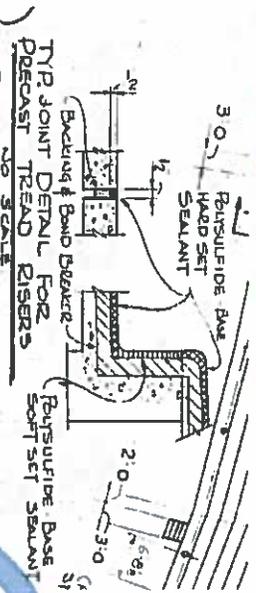
Figure 49- Precast Riser Joint Sealant Details - Vertical Joint

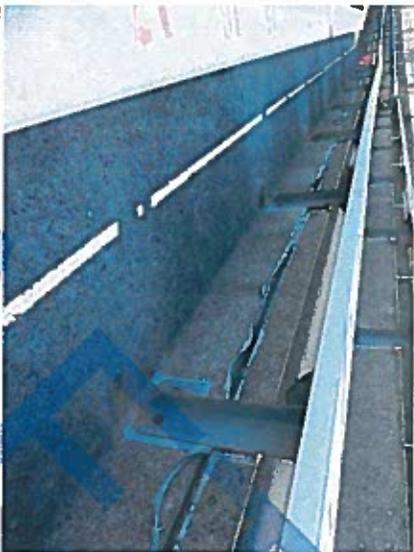
This hard compound can resist limited movement due to expansion and contraction of the structure. The joint, especially the vertical has been damaged by the amount of movement observed due to jacking of the shim stacks allowing water to leak through the joint accelerating the corrosion of the steel embeds and shim stacks below (refer to figures 50 and 51). The joint sealant is beyond its serviceable life and should be removed. There is over 35,000 lf of joint sealant.

Figure 50- Horizontal Joint Sealant Failure

**Comment:** Joint sealant should be removed and replaced with a durable compound that can expand and contract as required. Replacing the joint sealant should only occur after the corrosion of the steel embeds and shim stacks has been addressed (future).

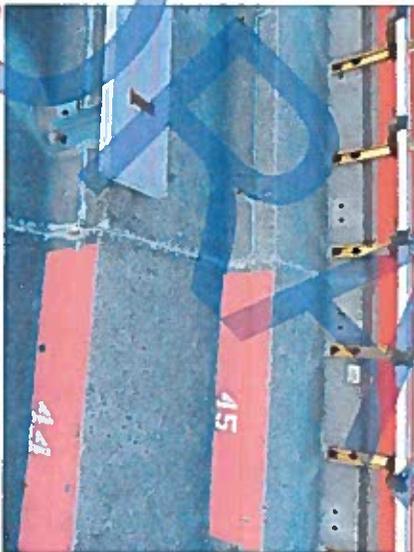
Figure 51- Vertical Joint Sealant - Failure

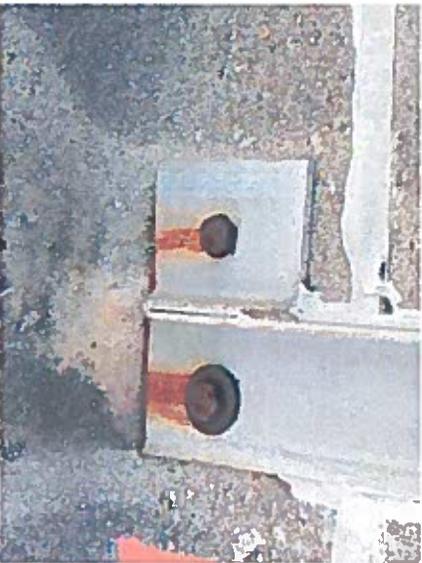
The design drawing shows steel inserts cast into the precast risers for attaching the vertical seat supports. Although the bolts used are not galvanized they appear to be in acceptable condition considering their age (refer to figure 71). Replacing seats may require a custom connection to take advantage of the existing embeds or the use of expansion or adhesive anchors.

Figure 71 - Typical Seat to Precast Connection

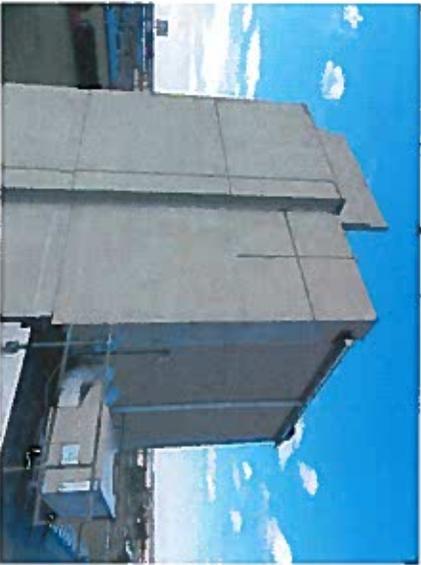
The precast panels surrounding the elevator towers appear in good condition (refer to figure 84).

Figure 84- Elevator Tower

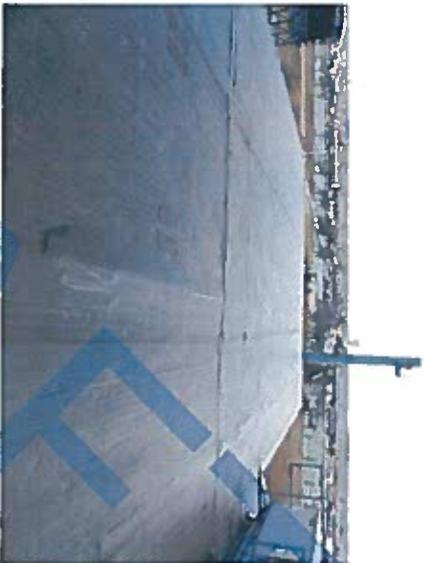
The high roofs above the boxes areas appear to be sound with no signs of cracking, delamination or hardening. There are areas underfoot that appeared soft and/or bulging (refer to figure 85).

**Comment:** Soft spots in the roofing along with signs of leaking due to discoloration of spray-on material indicate the need for further investigation (future).

Figure 85- High Roof Membrane

**Testing:** The membrane roofing should be inspected by a qualified roofing specialist to determine the need for repairs and remaining serviceable life (short term).
